A Post Fire Geomorphic Assessment of Tributary Streams at Lobs Hole

March 2021

Report prepared for:
EMM Consulting and Snowy Hydro Ltd

By:
P. G. Johnston.
BSc, MSc
Fluvial Geomorphologist
Flow and Loam Environmental

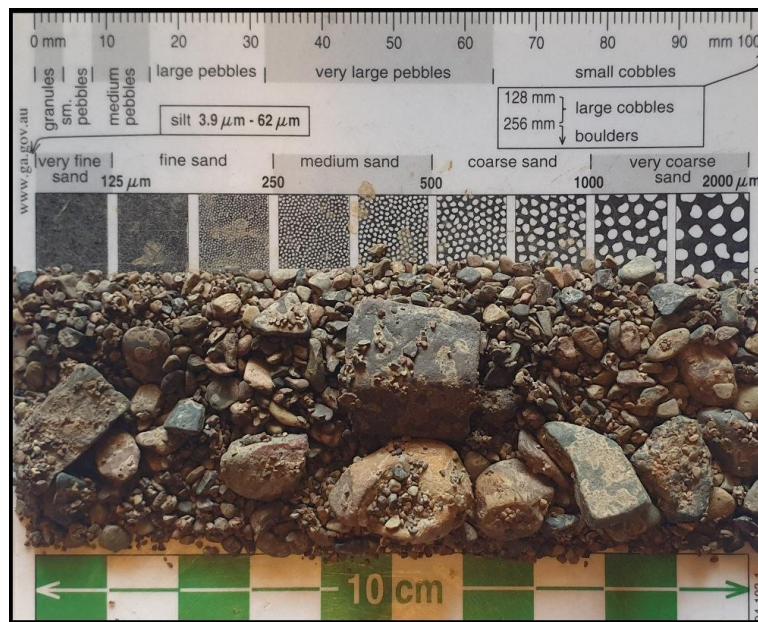
The channel widens out to greater than 8 m on exit from confinement and left bank is undercut and susceptible to block falls. The channel bed is fundamentally a gravel bed river but there are no cobbles or boulders in evidence.

Figure 7 Grainsize distribution of poorly sorted sediment in channel at Watercourse 3, Site 1.

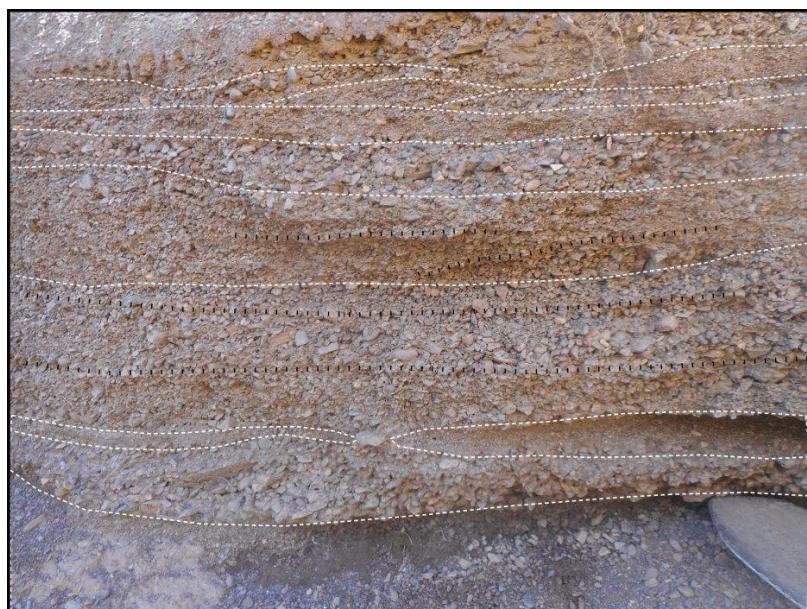
Figure 8 Sediment stack proximal to banktop on Watercourse 3. Multiple stages of deposition are indicated by changes in grainsize due to changes in available stream power.

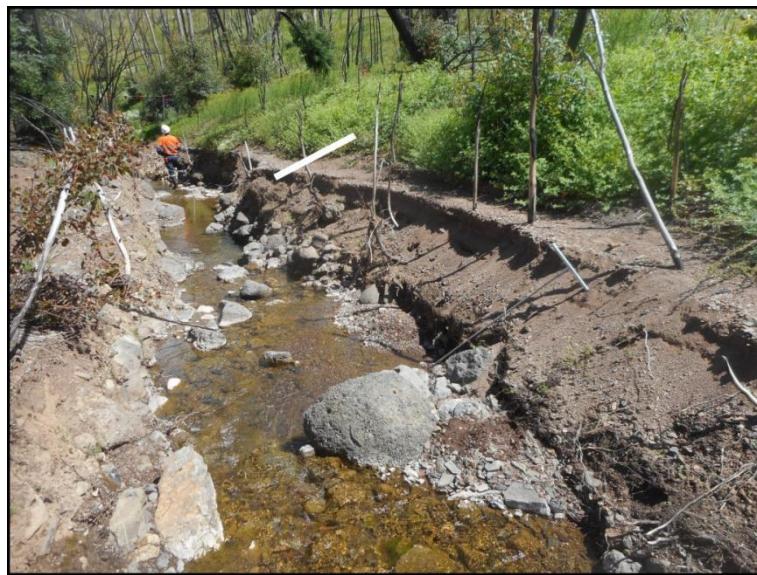
The base flows that are evident when flowing across bedrock (Figure 9 and Figure 10) rapidly infiltrate into the floodplain sediments that are the remnant lag deposits of the paleo Yarrangobilly River.

Figure 9 Watercourse 3 shows evidence of recent incision and is scoured to bedrock and has large cobbles and boulders exposed in the base. Proximal overbank deposits shows multiple stages of deposition and incision

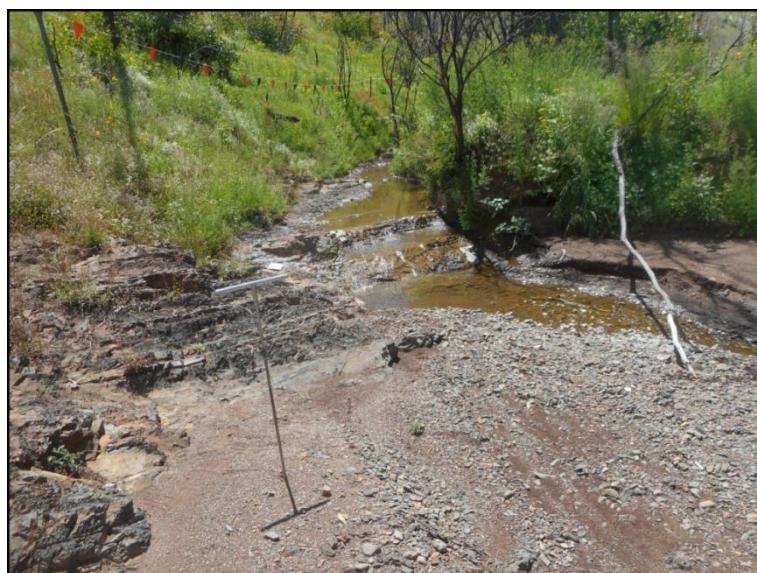
Figure 10 Watercourse 3 exits from confinement across the last cross channel bedrock bar. Site 6

Upon exit from bedrock confinement (Figure 10) the flows that are contained within the channel infiltrate the underlying coarse sediment, boulders, and cobbles, thereby progressively diminishing stream discharge and stream power as the flow becomes subterranean. This process is very similar to a ‘floodout’ (*sensu* Tooth 1999) and only the largest flows extend to, or beyond, the sediment fans.

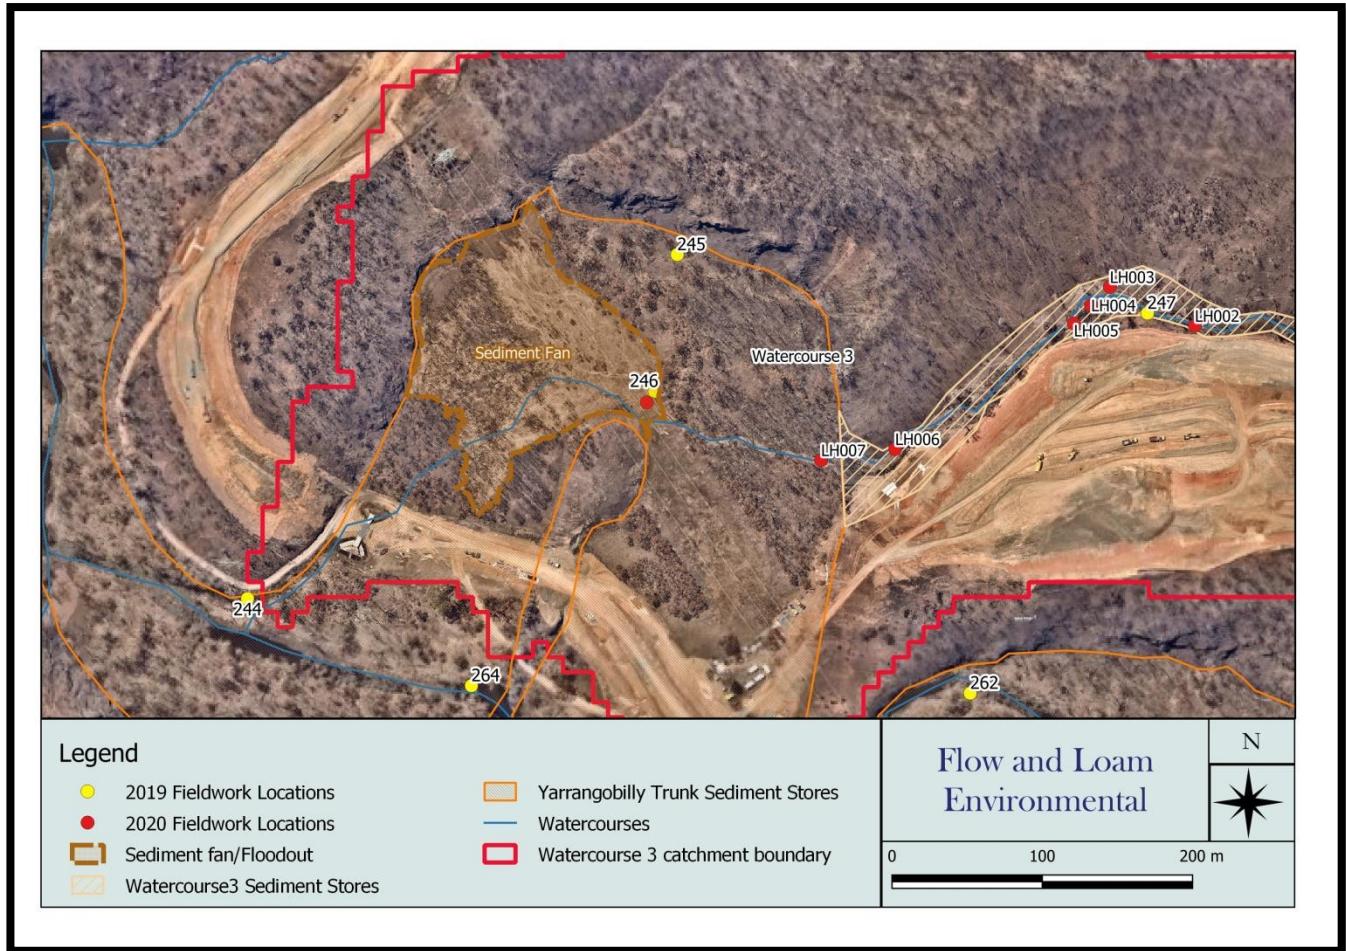
- ❖ Channel definition is completely lost at recent deposition of a sediment fan (Figure 11) that has interred the channel that was in evidence in 2019 during the previous field inspections here (Figure 12). This morphology is analogous to floodouts of central Australia (*sensu* Tooth, 1999).

Figure 11 Watercourse 3 exits from bedrock control at LH007 and channel capacity decreases downstream to LH008/246 where channel definition is lost in a floodout.

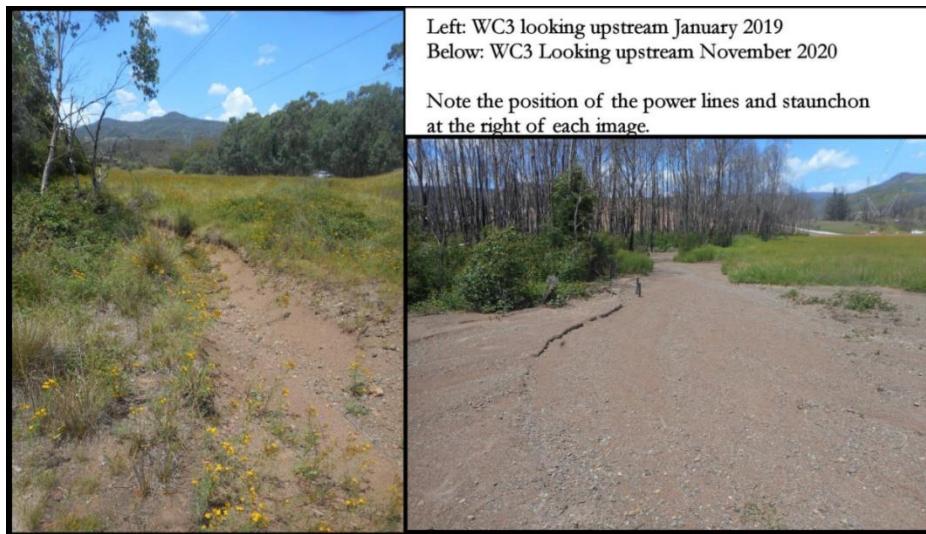
Figure 12 Images looking upstream from the beginnings of the distributary fan at location LH008/246

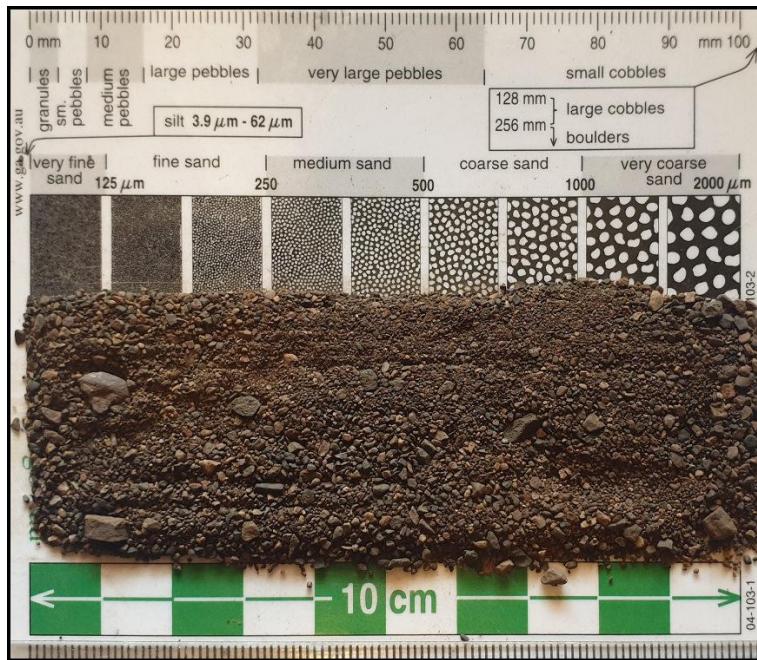
fragments (Figure 13). This indicates very juvenile sediment that has not been extensively worked by fluvial processes.

Figure 13 Poorly sorted proximal overbank deposition on small tributary of Sheep Station Creek.

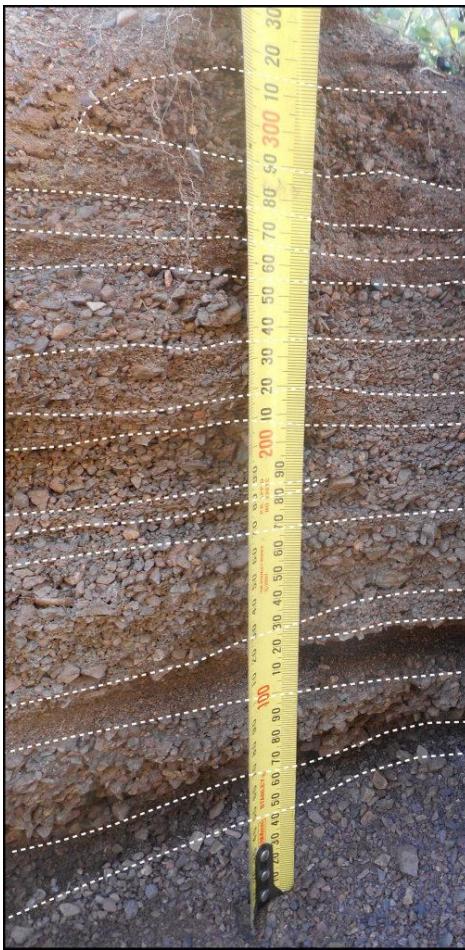
Figure 14 Multi phase proximal overbank sediments near to confluence of Sheep station Creek and small tributary.

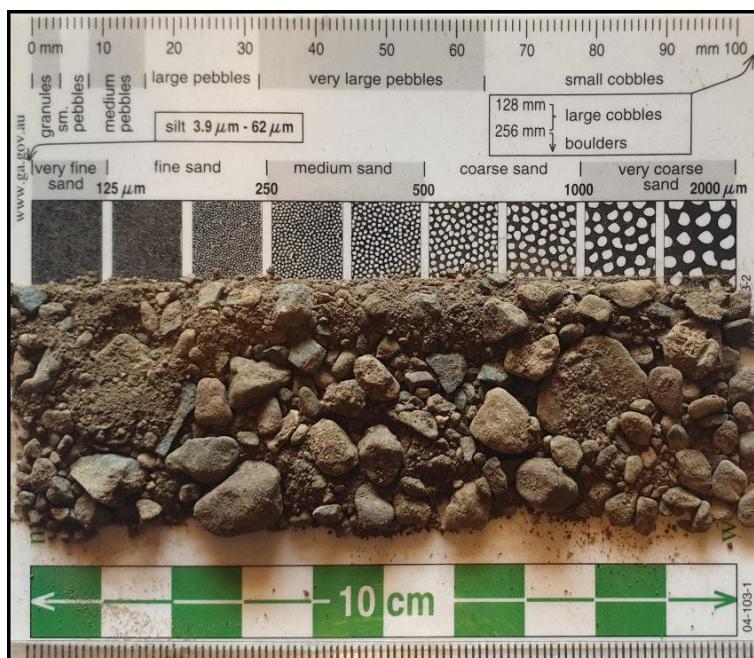
Figure 15. Grainsize of poorly sorted sediment filling detention basin at Lick Hole Gully Site 1

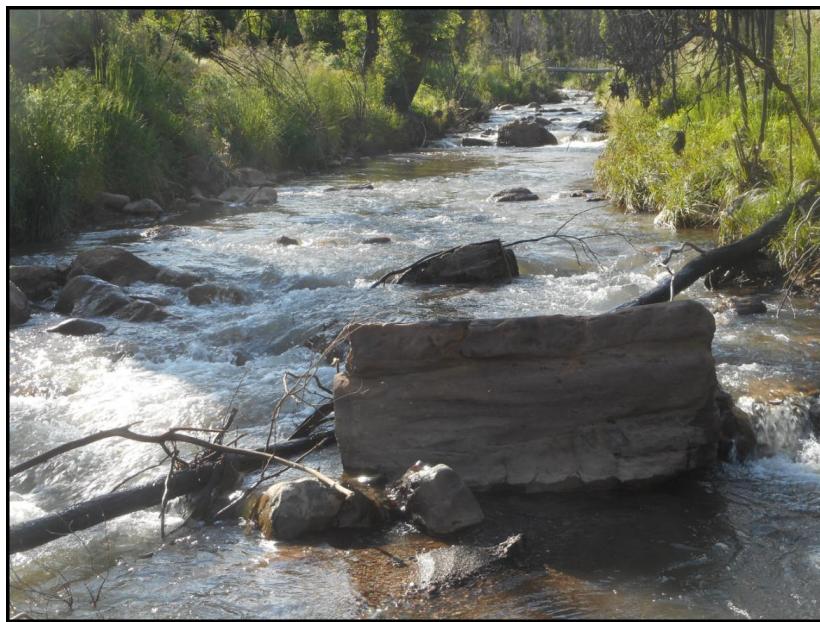
Wallaces Creek is a high angle and high energy stream (Figure 17) characterised by turbulent flows of rapids and small cascades over boulders and cobbles. The flow exhibited moderate turbidity at the time of inspection.

Figure 17 High energy turbulent flow over cobbles and boulders in the base of Wallaces Creek

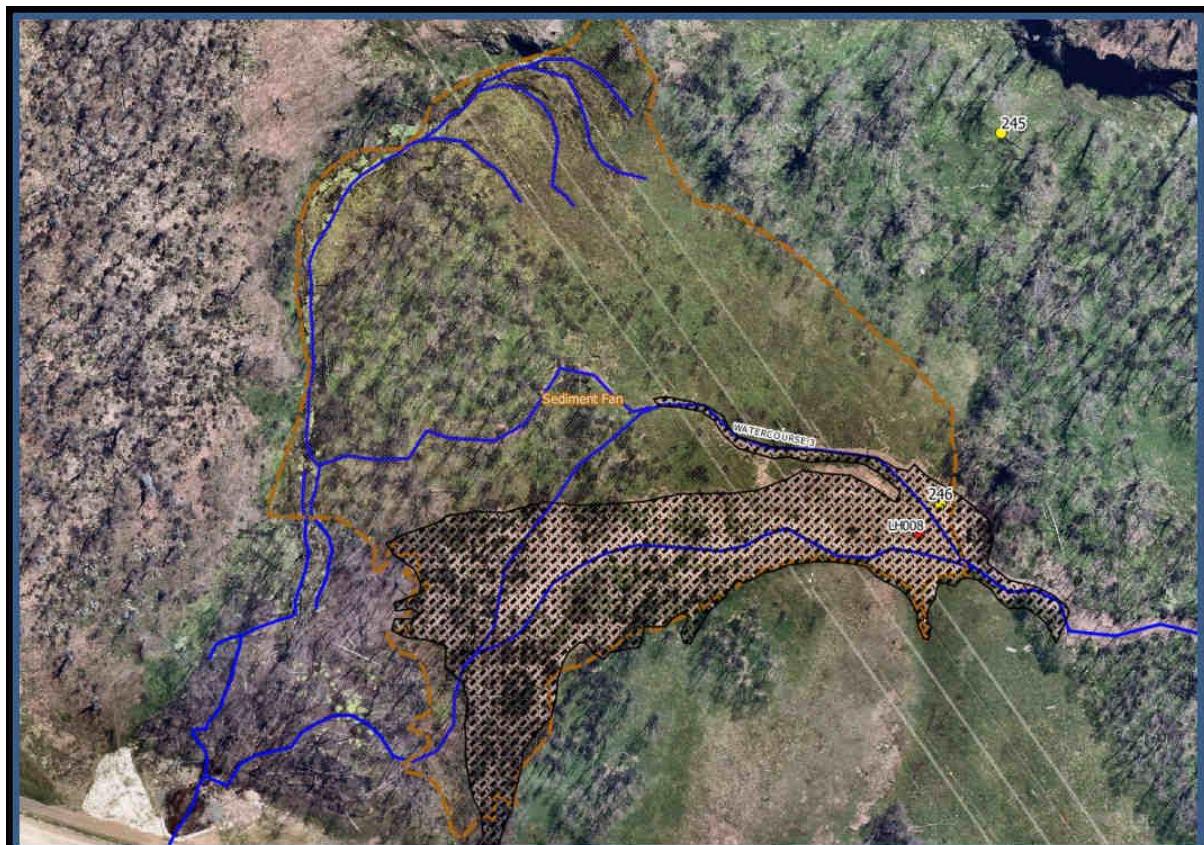
Most sediments that have been liberated from the surrounding catchment of Watercourse 3 do not reach the Yarrangobilly River. The coarser sediments are deposited as sediment fans atop the sediment in the paleo Yarrangobilly River that is underlain by coarse bedload of cobbles and boulders. As the discharge infiltrates the underlying permeable sediments it is only the dissolved load and finest suspended load that will be delivered to the Yarrangobilly River through the coarse substrate as it has a high hydraulic connectivity. There is also a dis-synchronicity between depositional processes upstream and downstream. When there is deposition upstream in Watercourse 3 there is very little, or no, sediment transferred to the downstream sink zones. Conversely, when sediment stored within the channel upstream is liberated during periods of peak discharge, this sediment is deposited as fan deposits downstream (Figure 18; See also Appendix 1).

**Figure 18 Sediment fans deposited on paleo Yarrangobilly River bedload at Watercourse 3**

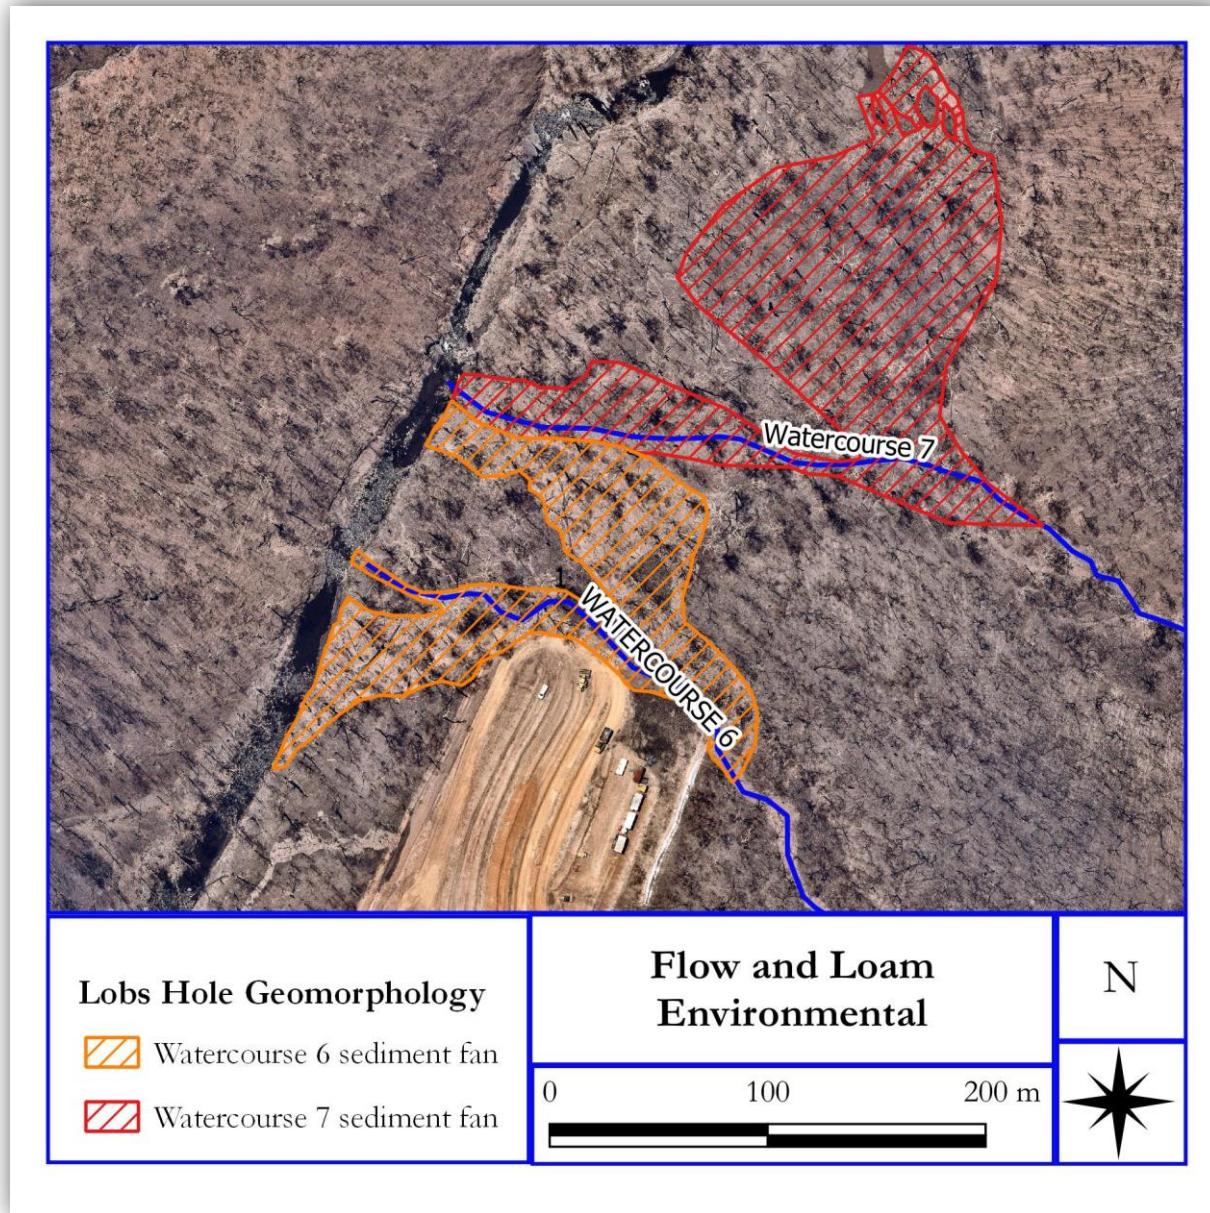
Watercourses 6 and 7 were not visited during the fieldwork component of this study. However, during desk top analysis of the aerial photography for the 26th of January it was noted that sediment fans had been deposited on the Yarrangobilly River floodplain since the fires passed through Lobs Hole (Figure 26). Watercourses 6 and 7 are of particular interest as their confluence with the Yarrangobilly River is immediately upstream of the main works area for assembling the tunnel boring machine.

Figure 26 Recent deposition of sediment fans from Watercourses 6 and 7 onto the Yarrangobilly River floodplain.
