# **Snowy 2.0 - Annual Rehabilitation Report**

**June 2024 - May 2025**

Prepared by: Ben Croome - Senior Environmental Advisor, SHL  
Date: 31 July 2025

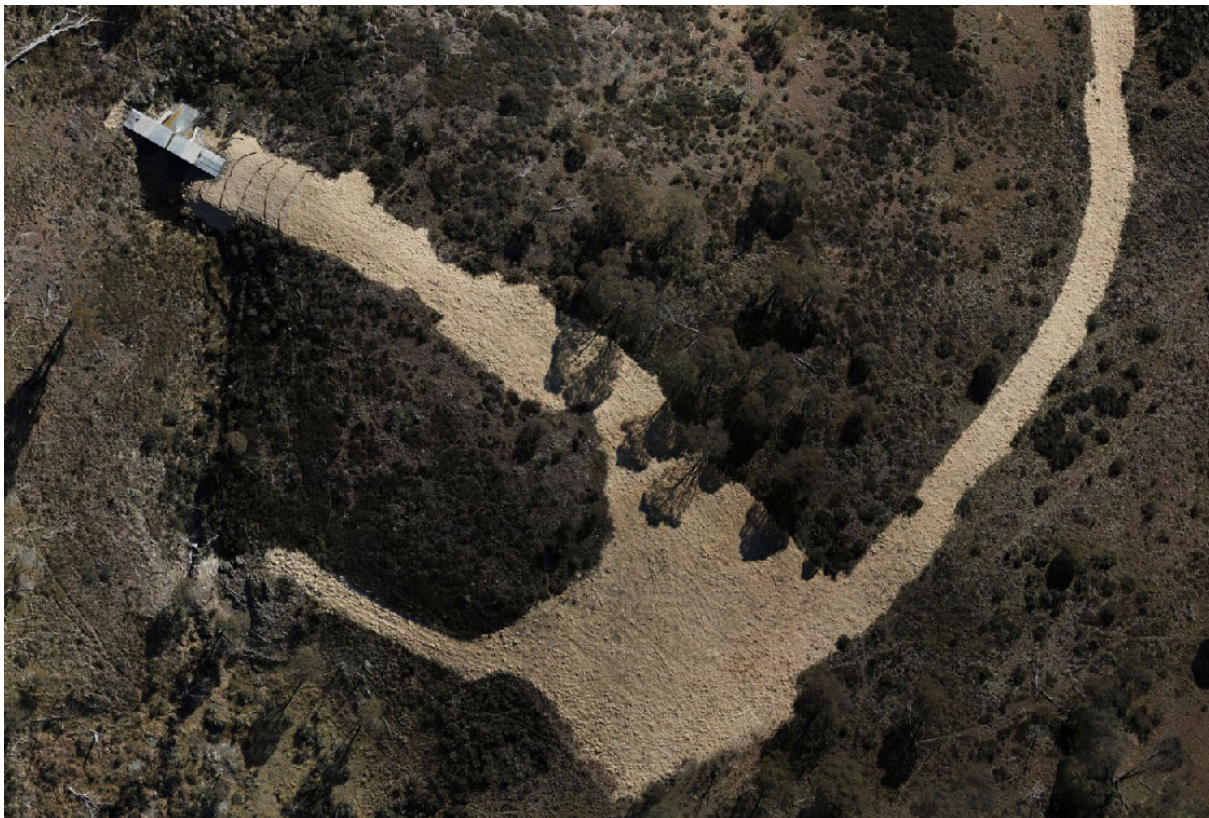
Construction of the Tantangara Creek Fish Weir was completed in April 2025 allowing for primary rehabilitation activities to be undertaken prior to winter. This included reducing the size of the passing bays, topsoil placement, seeding and mulching of disturbed areas used to facilitate construction. **Figure 3** provides an aerial view of the main work site following seeding and straw application in May.

**Figure 3** Tantangara Creek Fish Weir & Laydown - 300525

At this point no additional measures are required, works to continue to plan

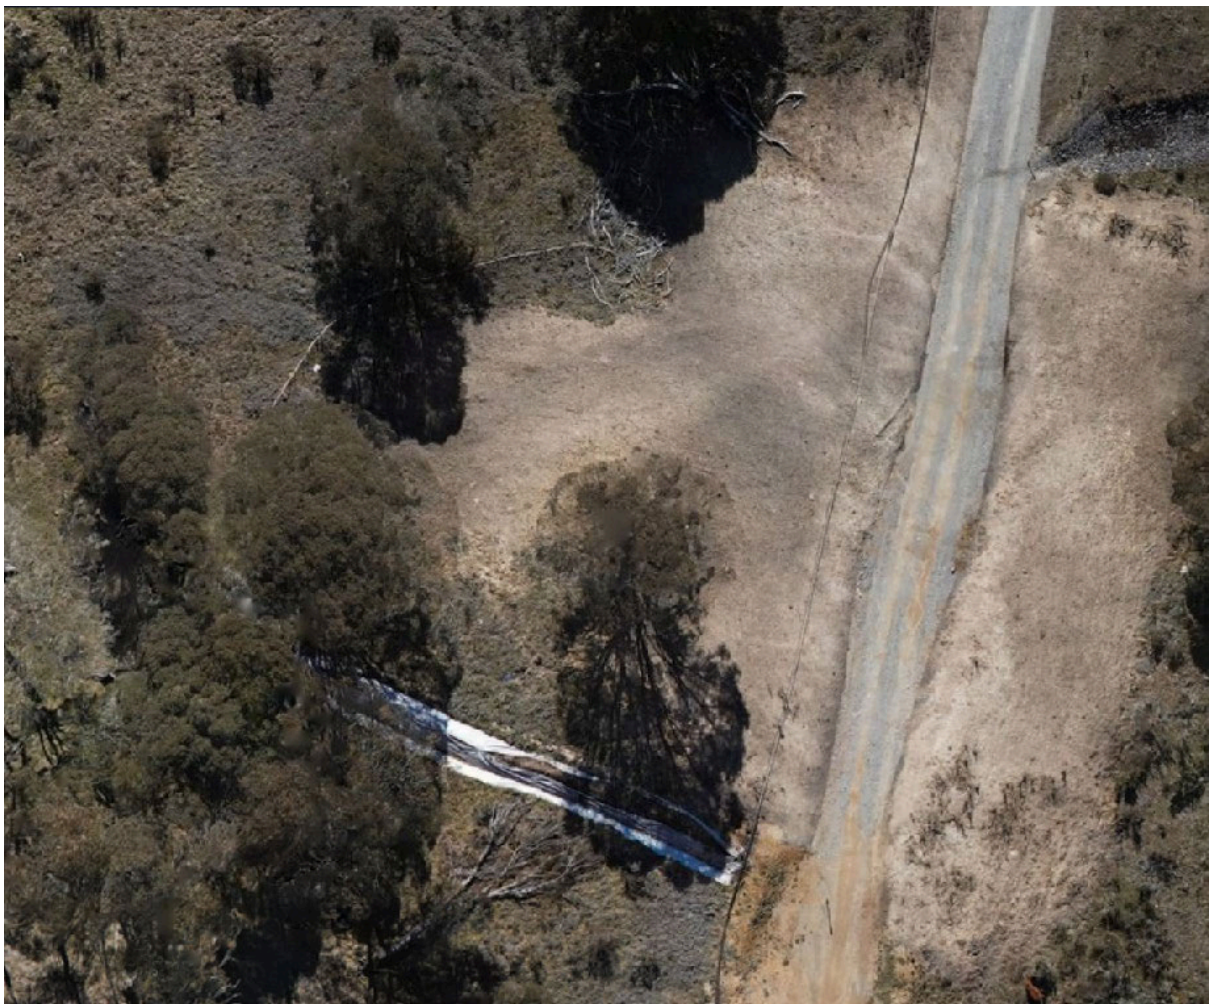
**Figure 4:** Tantangara Surface Depression after weed treatment Date - 310525

Pending success of the sweet vernal spraying and the subsequent hydromulching, application of straw mulch and fencing to be undertaken following, spraying and the planting of tubestock in Spring 2025.

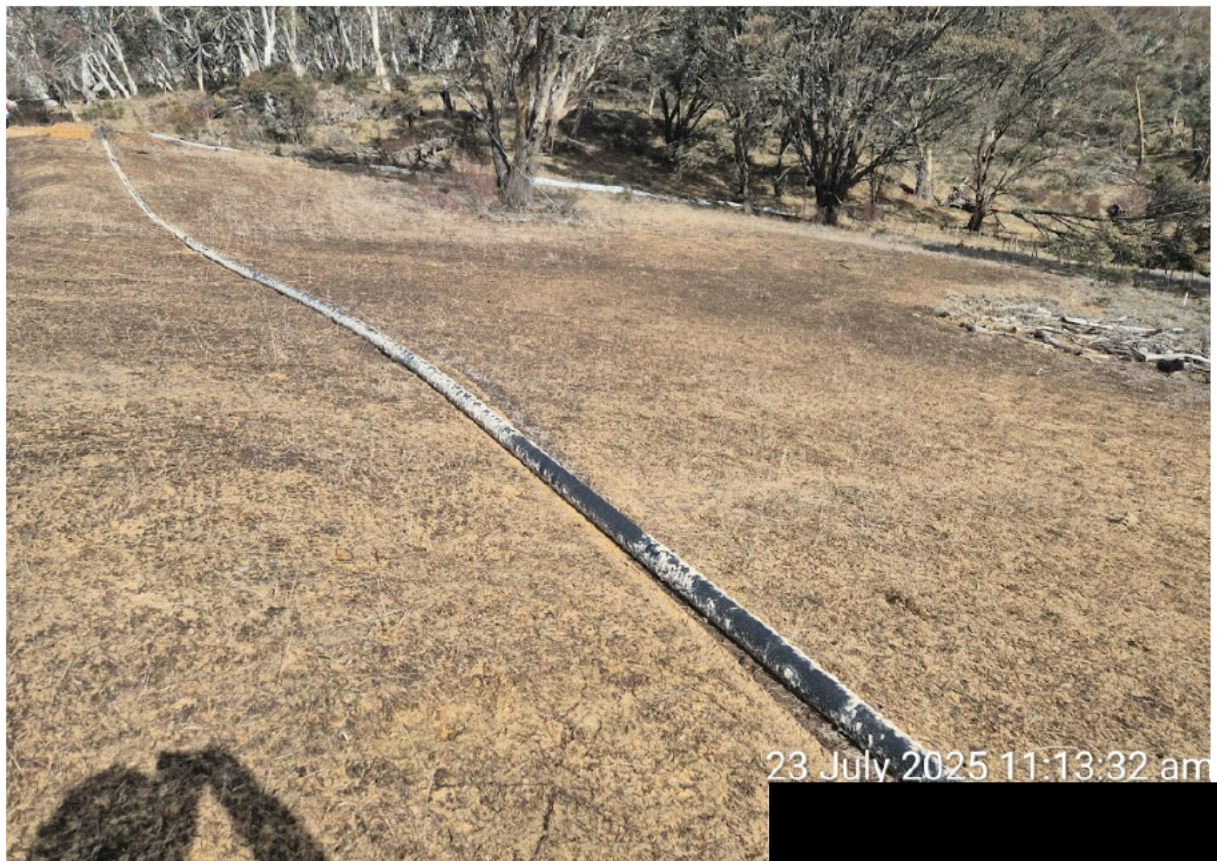
**Figure 5:** Tantangara Surface Depression following hydromulch application Date- 230725

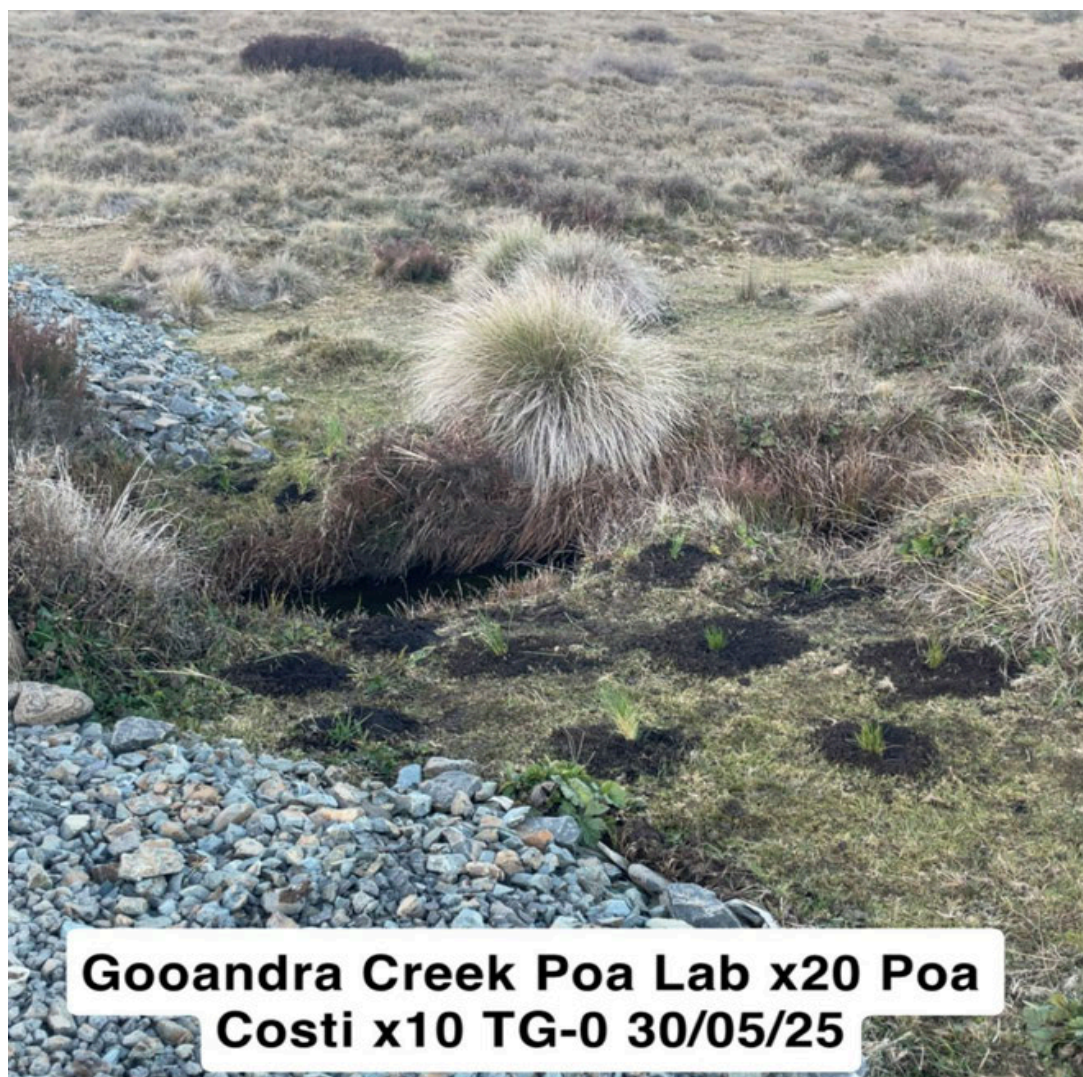
The construction of the Gooandra to Nungar Creek section of Trunk Services has been largely complete since December 2023 with minor works remaining required to complete construction. During this time Hydromulching of the finished sections of Gooandra Trail was undertaken in April 2024 and tube stock planting of poa in May ( see figure 6), unfortunately there has been limited germination and cover as a result of this treatment with cover yet to be established. Active Rehabilitation of the section between Nungar Creek and Tantangara and Tantangara Hill has yet to commence as there are still commissioning activities to be completed.

**Figure 6** Gooandra Creek tube stock planting - Gooandra trail to Nungar Creek

Straw mulching of the laydown and underbore site is required with monitoring indicating that 59% of the site is bare ground. Additional growth medium in the form of a compost blanket may be required for areas of the alignment where germination of native grasses has not occurred.

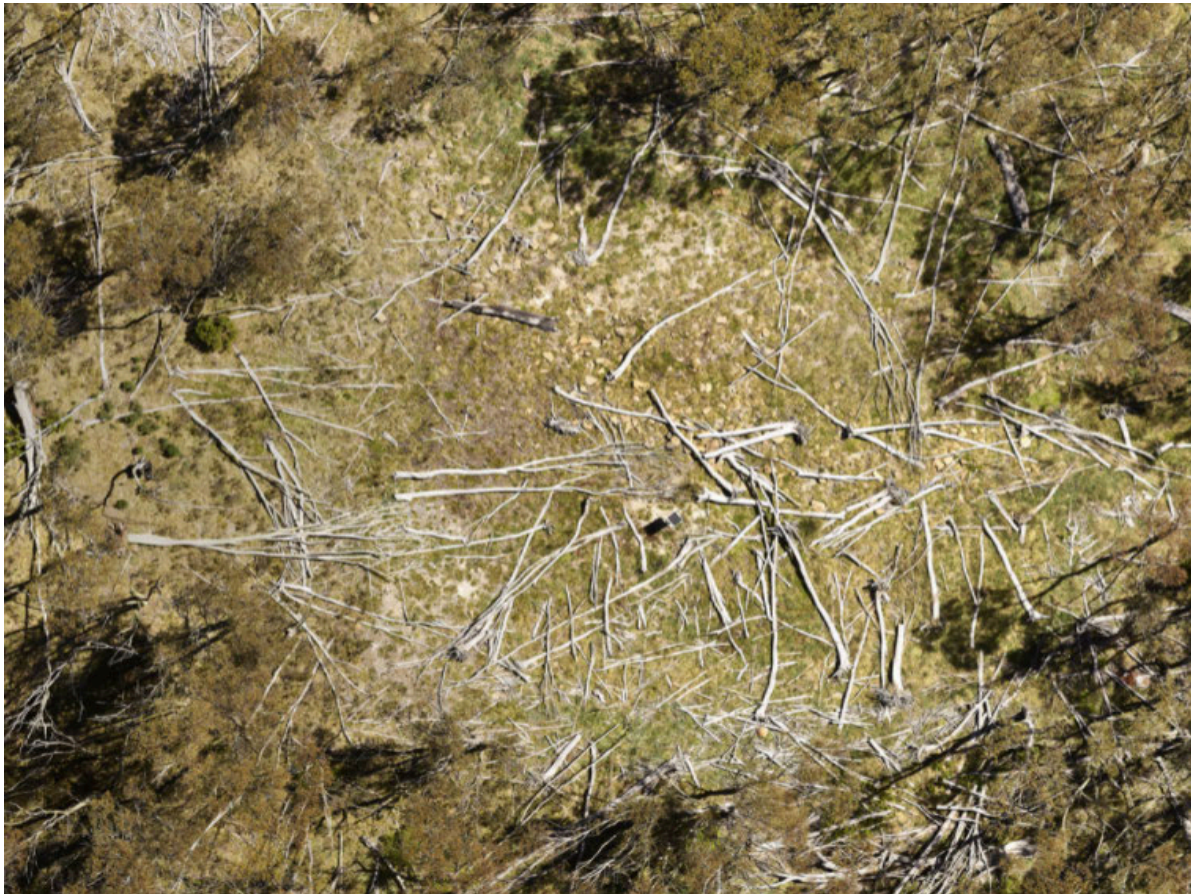
The geotech borehole drilling of 3203 was completed in Feb 2021. Both sites including the access had topsoil, straw mulch and thatch applied (see figure 7) below for example of site condition). Following the initial rehabilitation the sites have undergone weed spraying and some tubestock planting. The narrow access track has meant there has been meaningful natural recruitment in this period. Continued monitoring of bogs and fens for incisions or drying is being conducted.

Figure 7 Bore hole 3203 - Date - 121225

Weed control focus area BH3203 to 3210

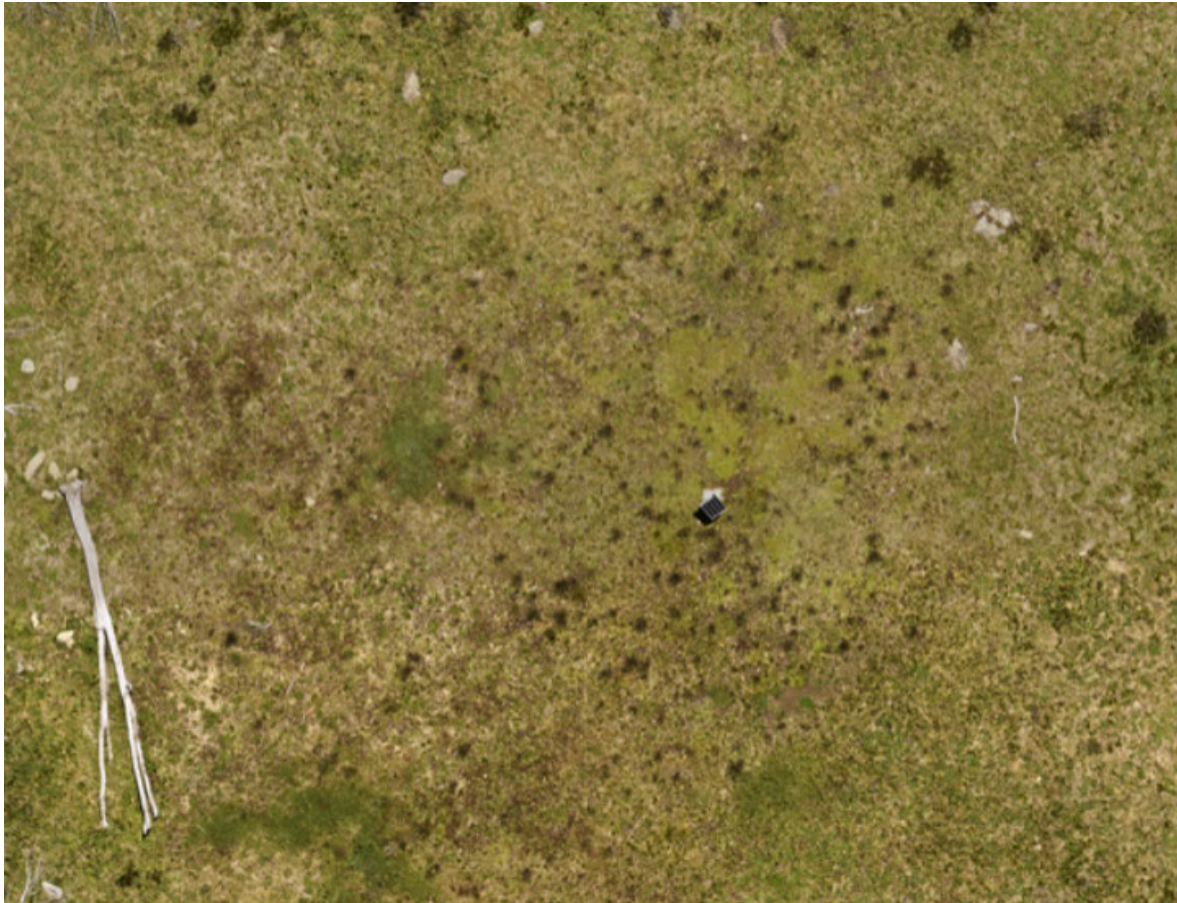
The geotech borehole drilling of 4202 & 4210 was completed in Feb 2021. Both sites including the access had topsoil, straw mulch and thatch applied. Following the initial rehabilitation the sites have undergone weed spraying and some tubestock planting. The narrow access track has meant there has been meaningful natural recruitment in this period. As figure 8 demonstrates there is good cover with little bareground.

Figure 8 Bore hole 4202 - Date - 121225

Weed control focus area Wallace creek trail to Eucumbene

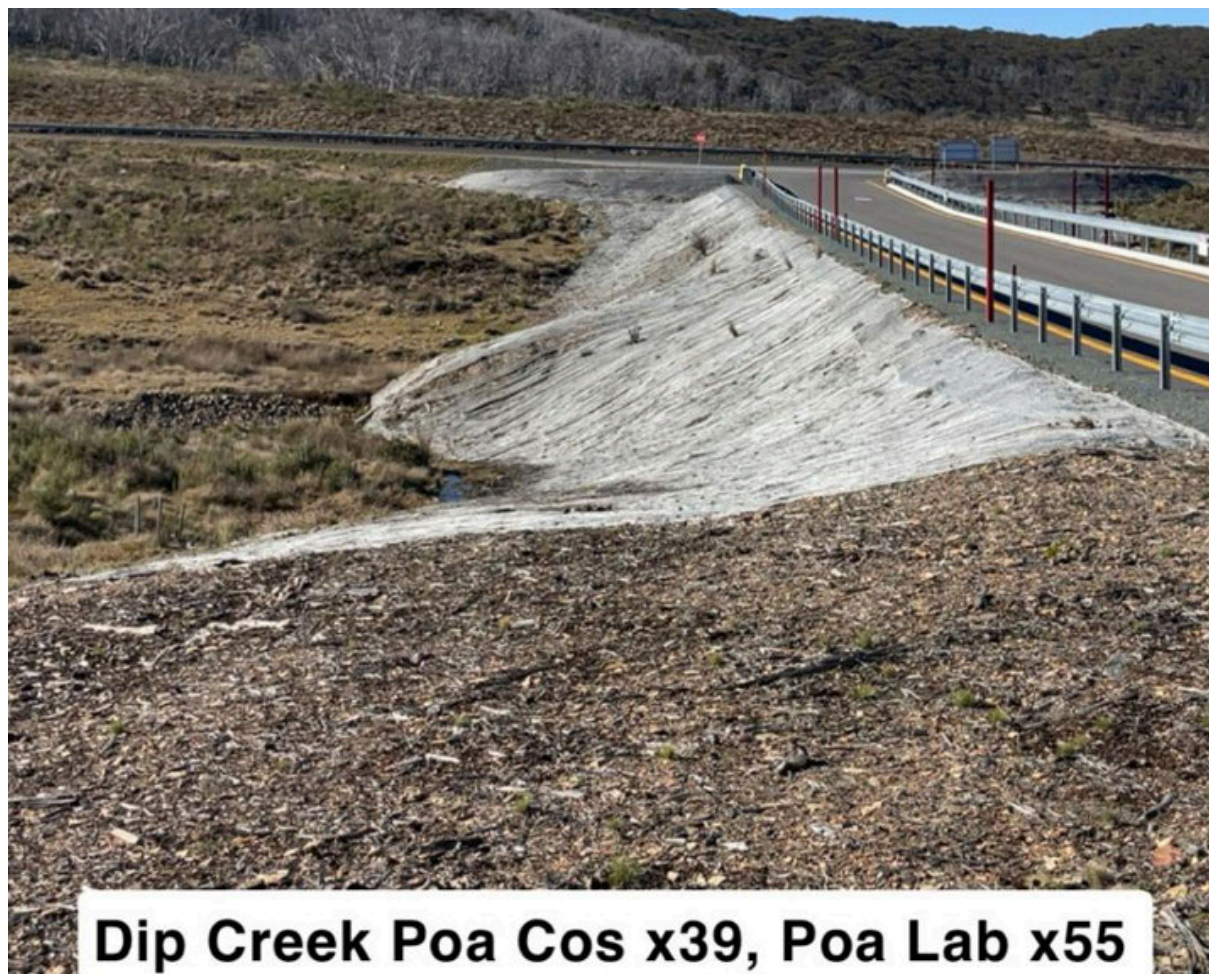
Figure 9 - Dip Creek

Marica main access road verge has been reinstated with topsoil and mulch, it was then hydromulched in March 2024 using native seed and the sediment basins at Eucumbene and Dip Creek removed. Jute mesh was also applied to the batters for interim stabilisation at the waterways. Initial tube stock planting has also been undertaken as seen in figure 9.

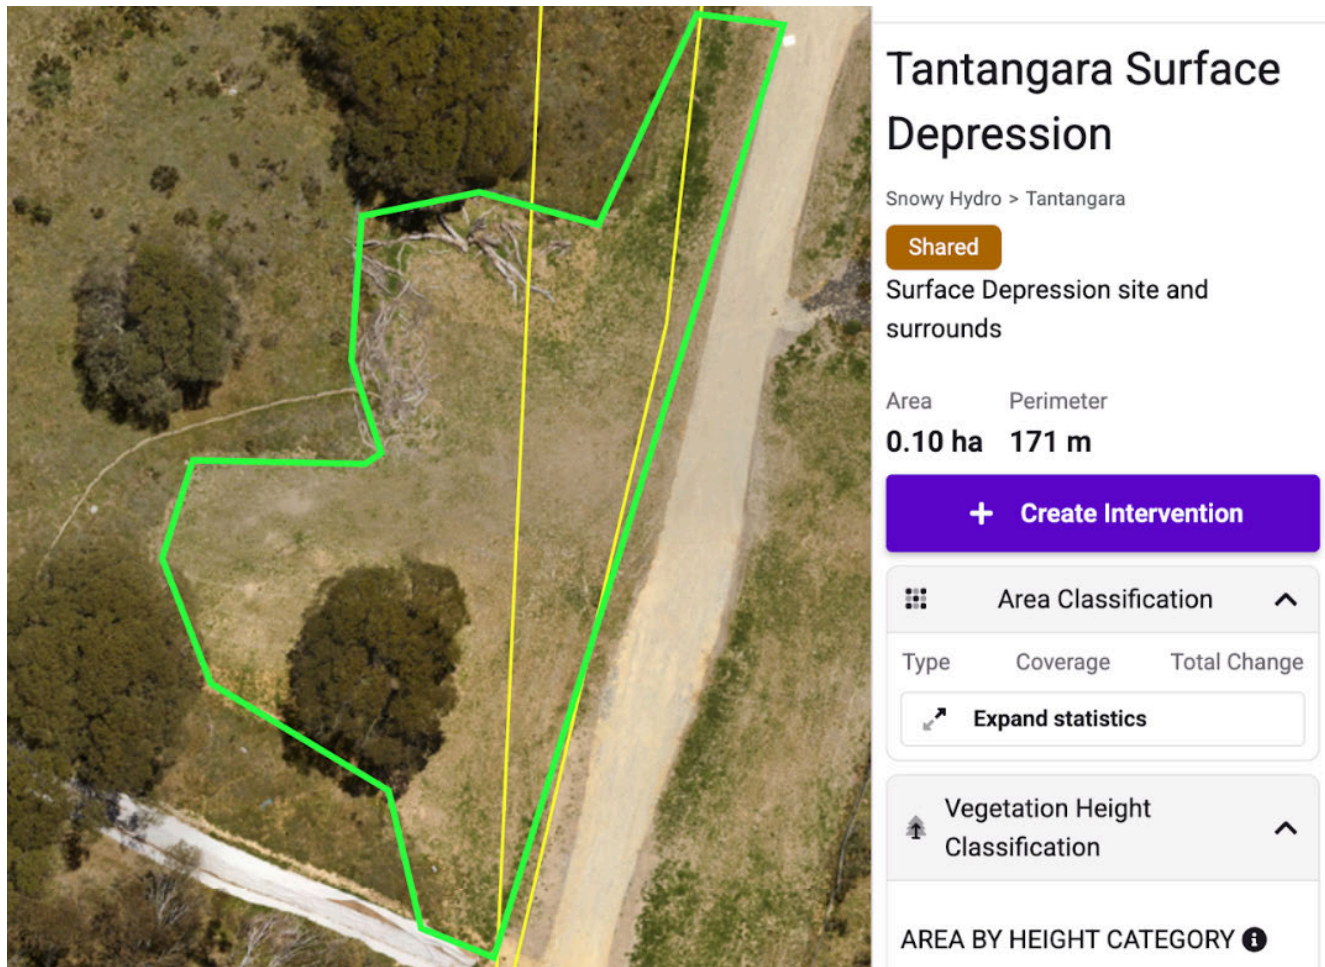
Below figure 11 details the Jan 2024 survey boundary shown in yellow. Green is the December survey boundary. This accounts for the dramatic increase in almost all indicators.

**Figure 11** Tantangara surface depression survey boundary overlay

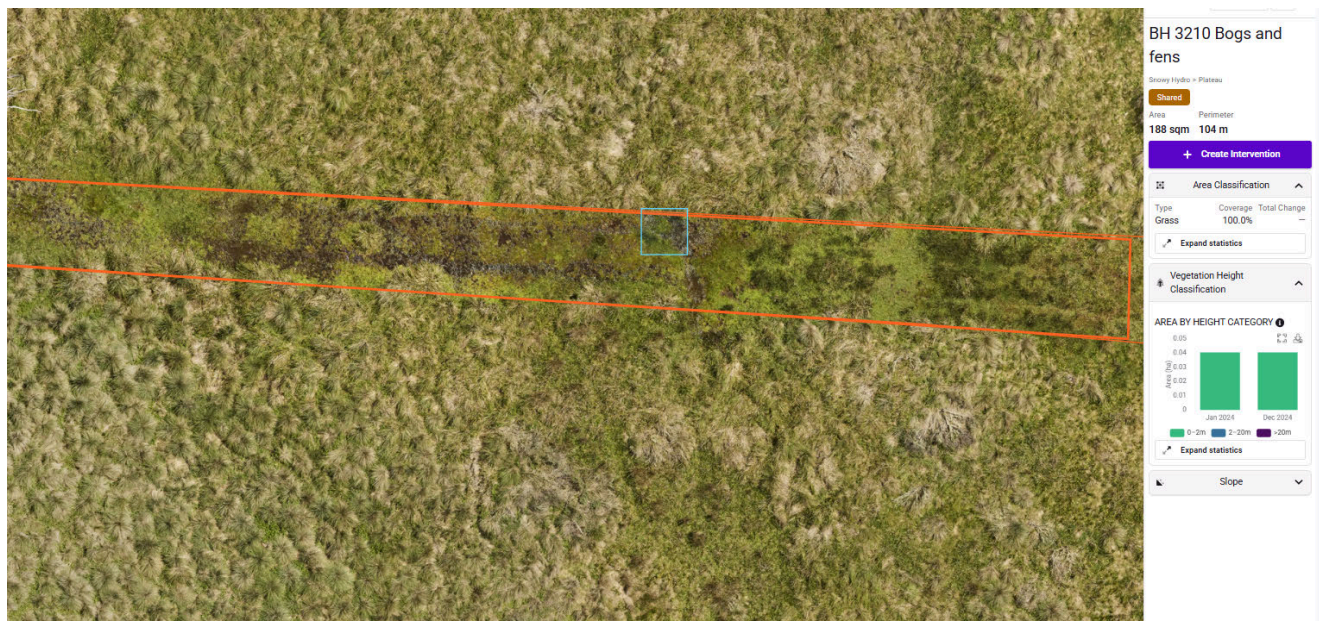
**Figure38:** BH 3210 access - Bogs and Fens image showing no incisions
