EPL 21266 – BI-ANNUAL MONITORING REPORT DECEMBER 2022 – MAY 2023

S2-FGJV-ENV-REP-0078

This document provides a summary of surface- and ground-water quality and associated information for monitoring conducted as part the Snowy 2.0 project, across monitoring locations pertaining to Environmental Protection Licence (EPL) 21266.

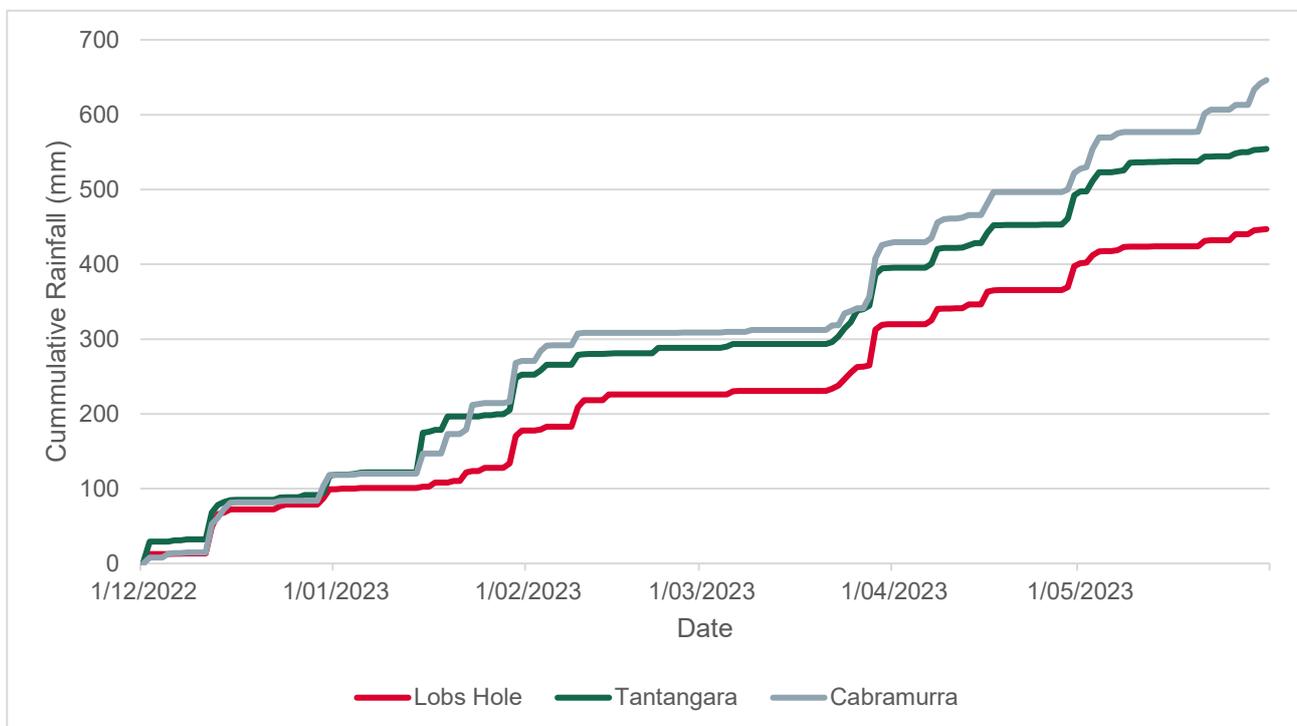
Figure 2-1: Cumulative Rainfall across Lobs Hole, Tantangara and Cabramurra

The cumulative rainfall between December 2022 and May 2023 is presented in **Figure 2-1**.

At each of the three rainfall recording sites (Tantangara, Lobs Hole, and Cabramurra), the highest volume of rain that fell in a single day are as follows:

- 48.2 mm at Lobs Hole – 29/03/2023
- 52.4 mm at Cabramurra (Marica) – 30/01/2023
- 53.0 mm at Tantangara – 15/01/2023

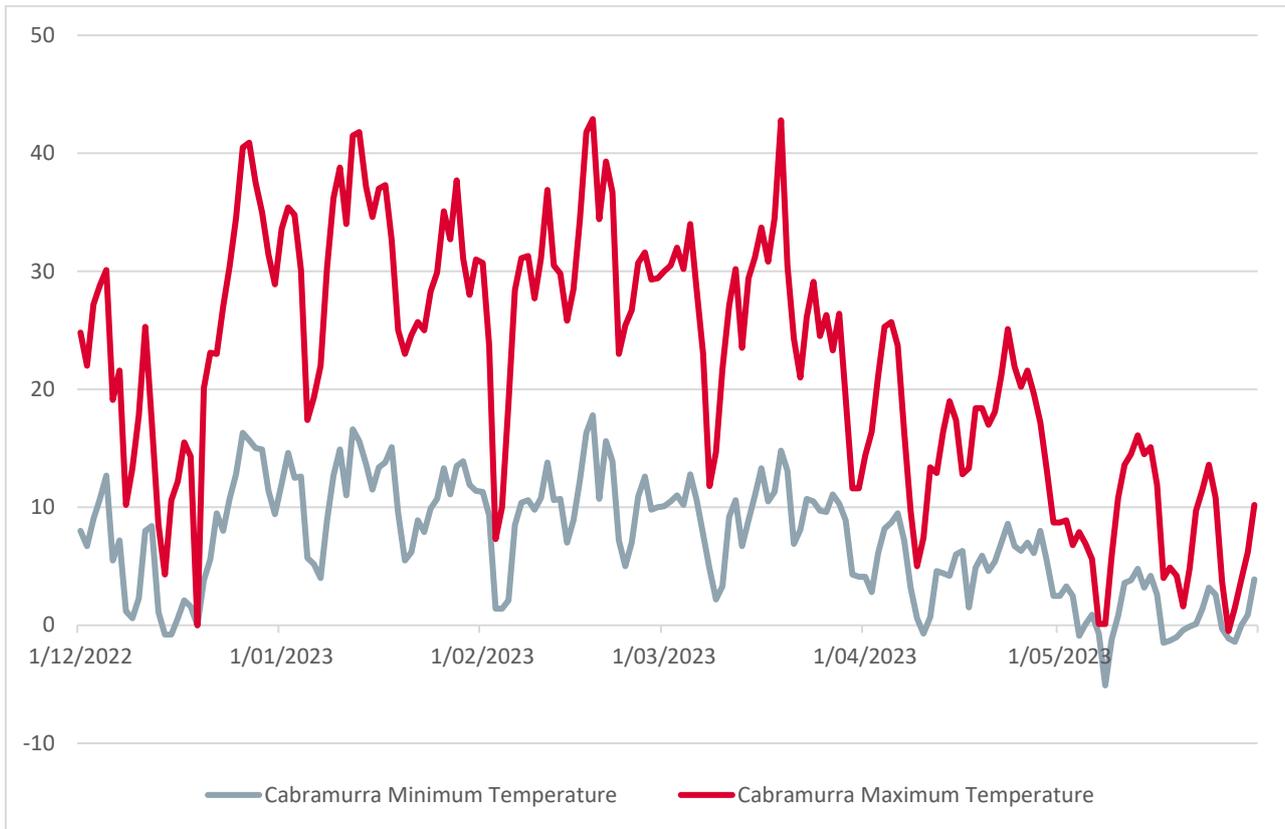
Figure 2-2: Cabramurra (Marica) - Minimum and Maximum Temperatures

Figure 2-1 to Figure 2-4 show temperature maximum and minimums across the project at Lobs Hole and Cabramurra weather stations.

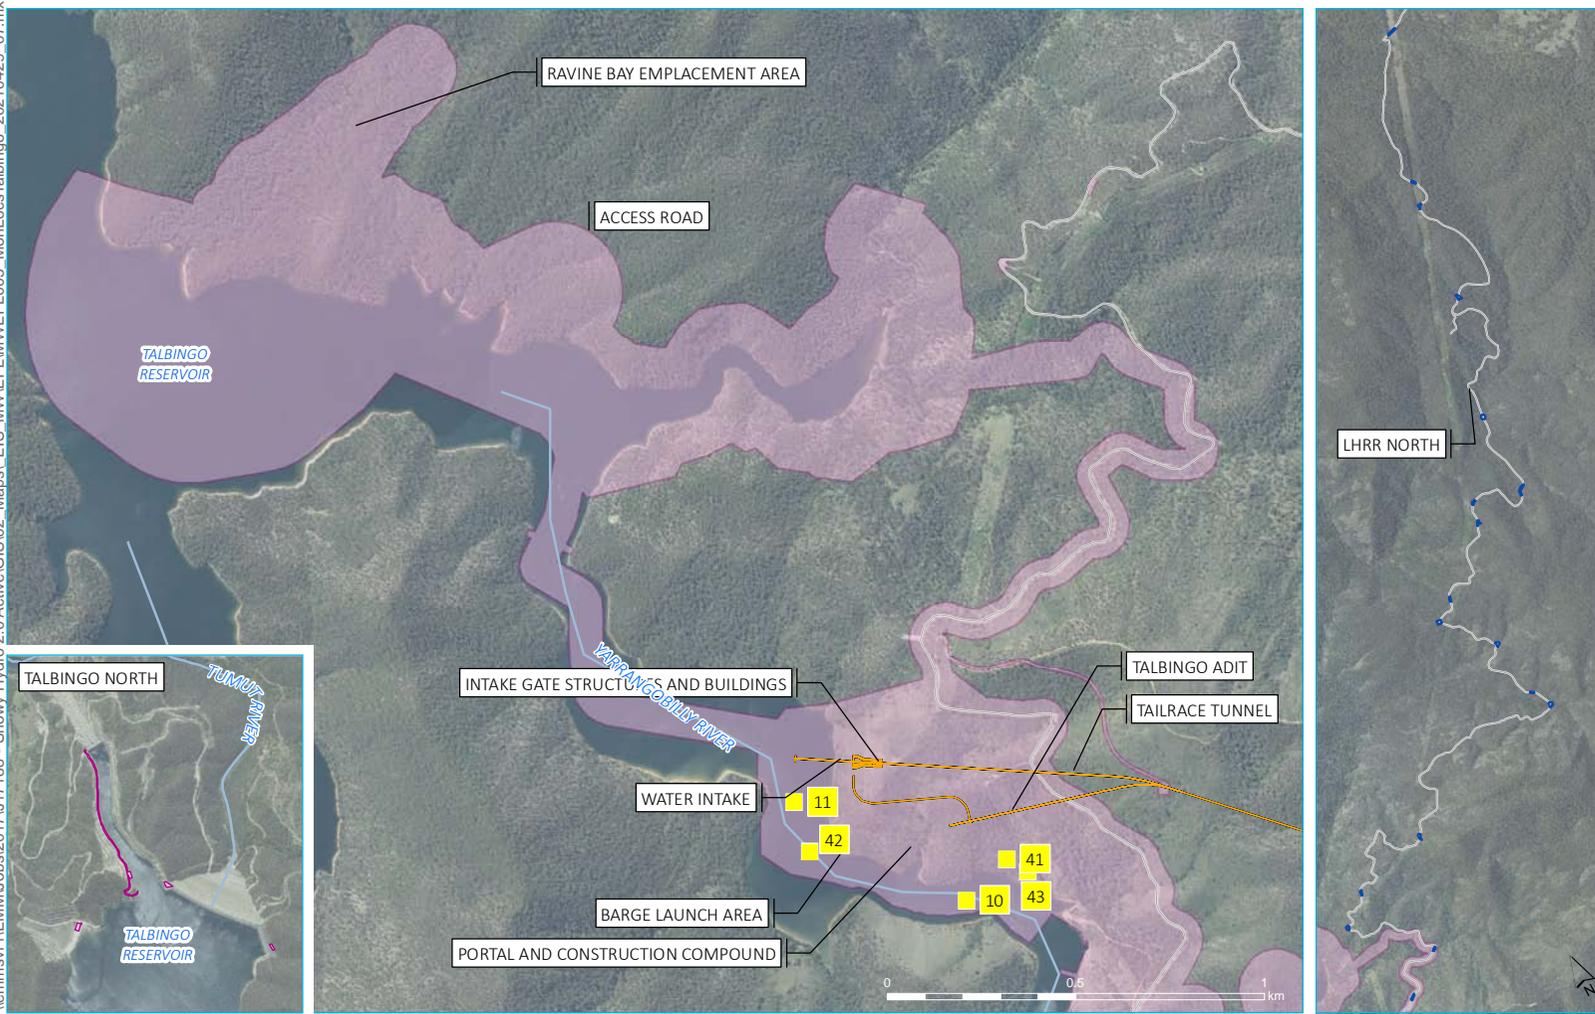
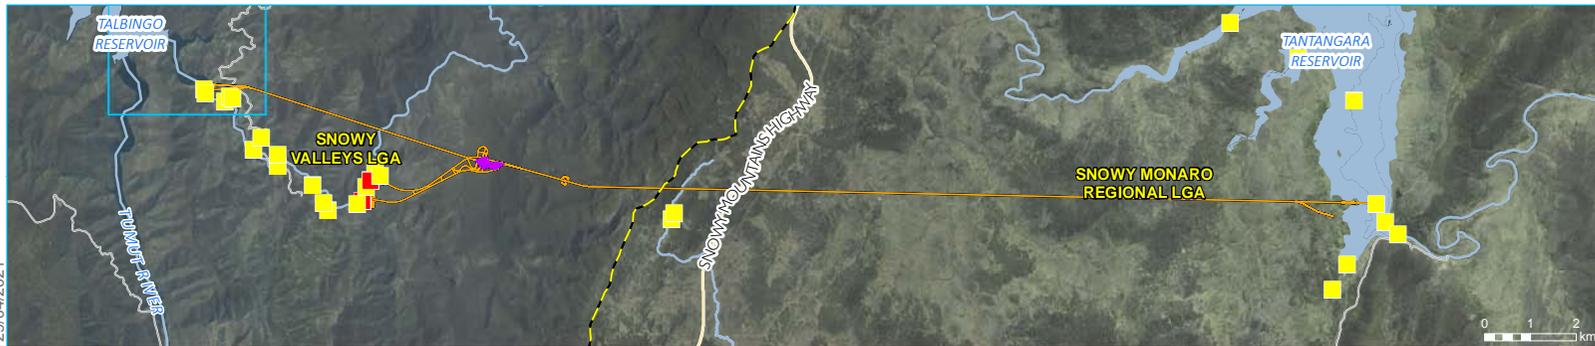
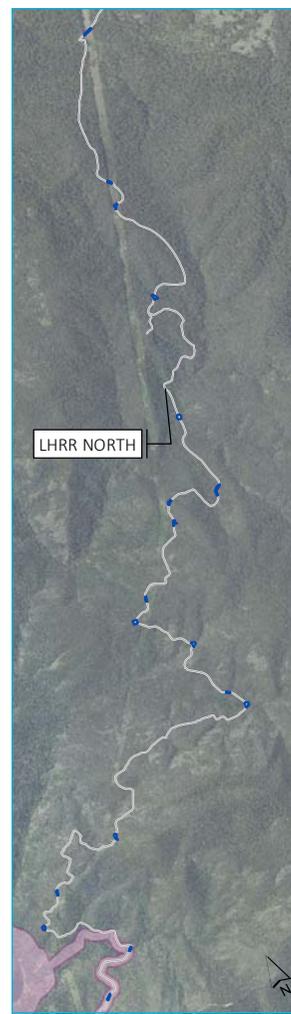
- KEY**
- EPL monitoring point
 - Groundwater
 - Surface water
 - Existing environment
 - Main road
 - Local road
 - Watercourse
 - Waterbodies
 - Local government area boundary
 -
 - Snowy 2.0 Main Works operational elements
 - Tunnels, portals, intakes, shafts
 - Power station
 - Licence Premise

The disturbance area is an estimation of the area required for construction works based on the current level of project design. Detailed design is still required to be completed, therefore it is expected that the precise location of the disturbance area may move within the broader construction envelope and consequently there will be some further refinements to the disturbance area.

Section 2, Condition P1.2 of EPL 21266 identifies the points required for monitoring, these points are presented on **Figures 1.1 – 1.5** of **Appendix A** and listed in **Table 1.1** below.

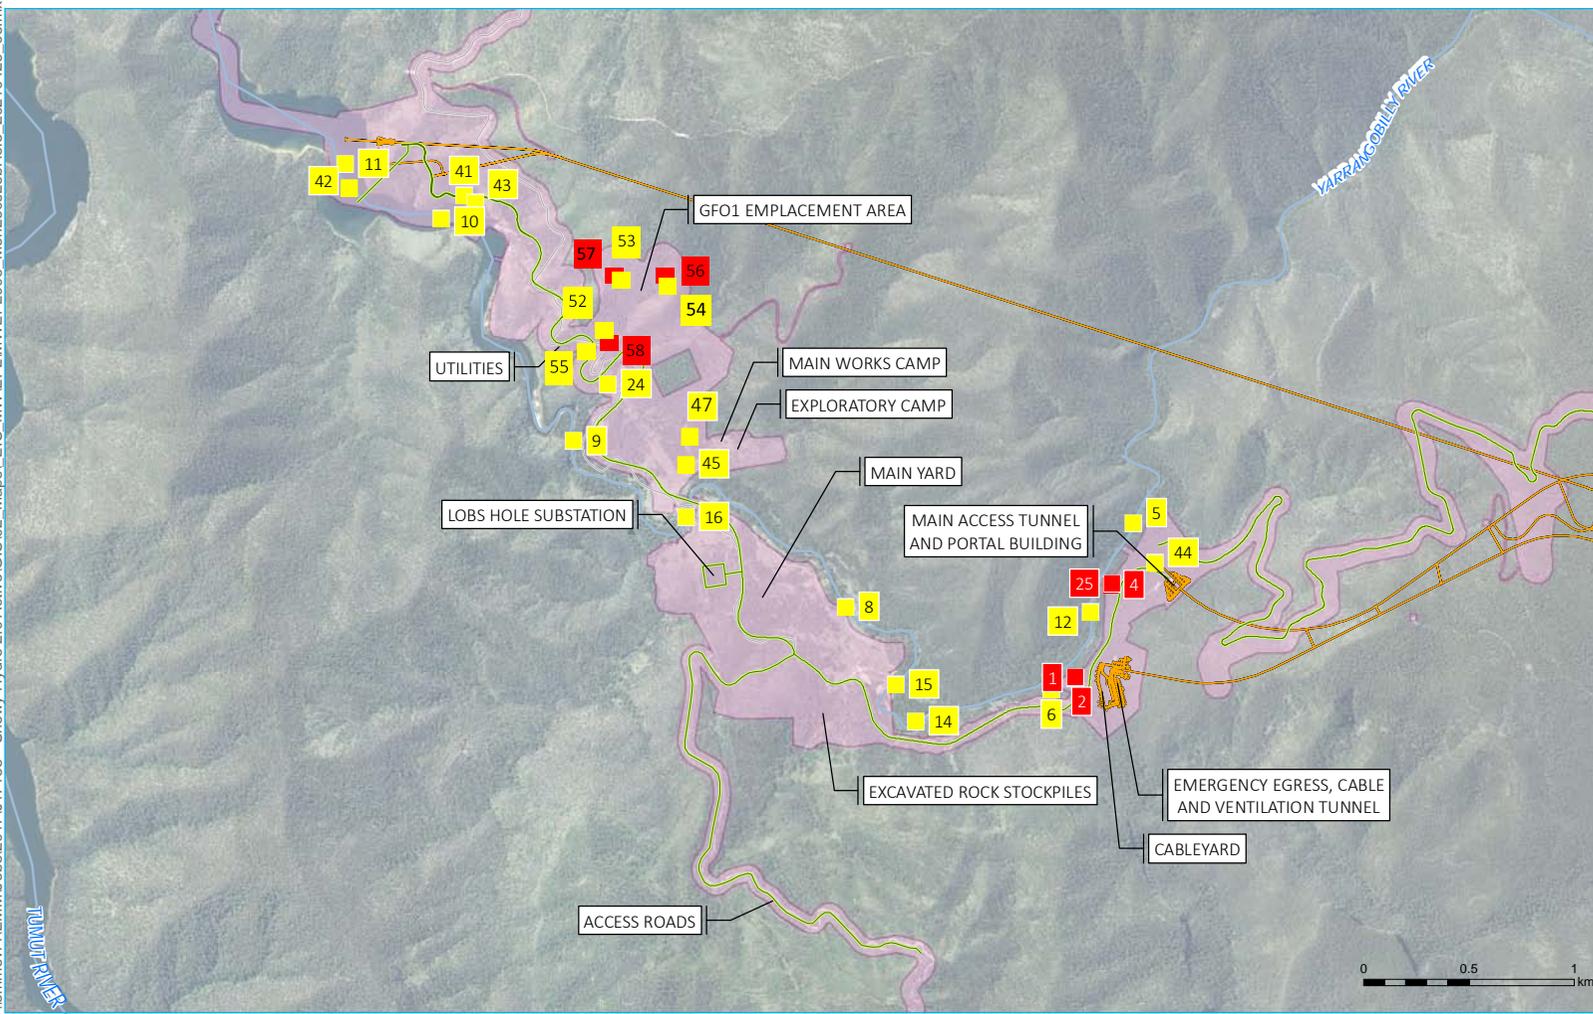
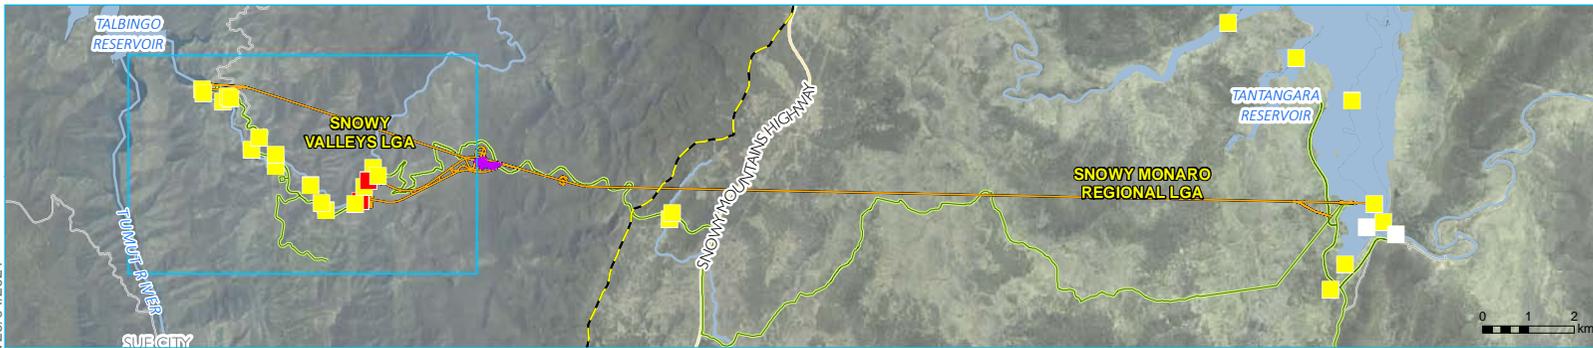
- KEY**
- EPL monitoring point
 - Groundwater
 - Surface water
 - Existing environment
 - Main road
 - Local road
 - Watercourse
 - Waterbodies
 - Local government area boundary
 - Snowy 2.0 Main Works operational elements
 - Tunnels, portals, intakes, shafts
 - Power station
 - Utilities
 - Licence Premise

The disturbance area is an estimation of the area required for construction works based on the current level of project design. Detailed design is still required to be completed, therefore it is expected that the precise location of the disturbance area may move within the broader construction envelope and consequently there will be some further refinements to the disturbance area.

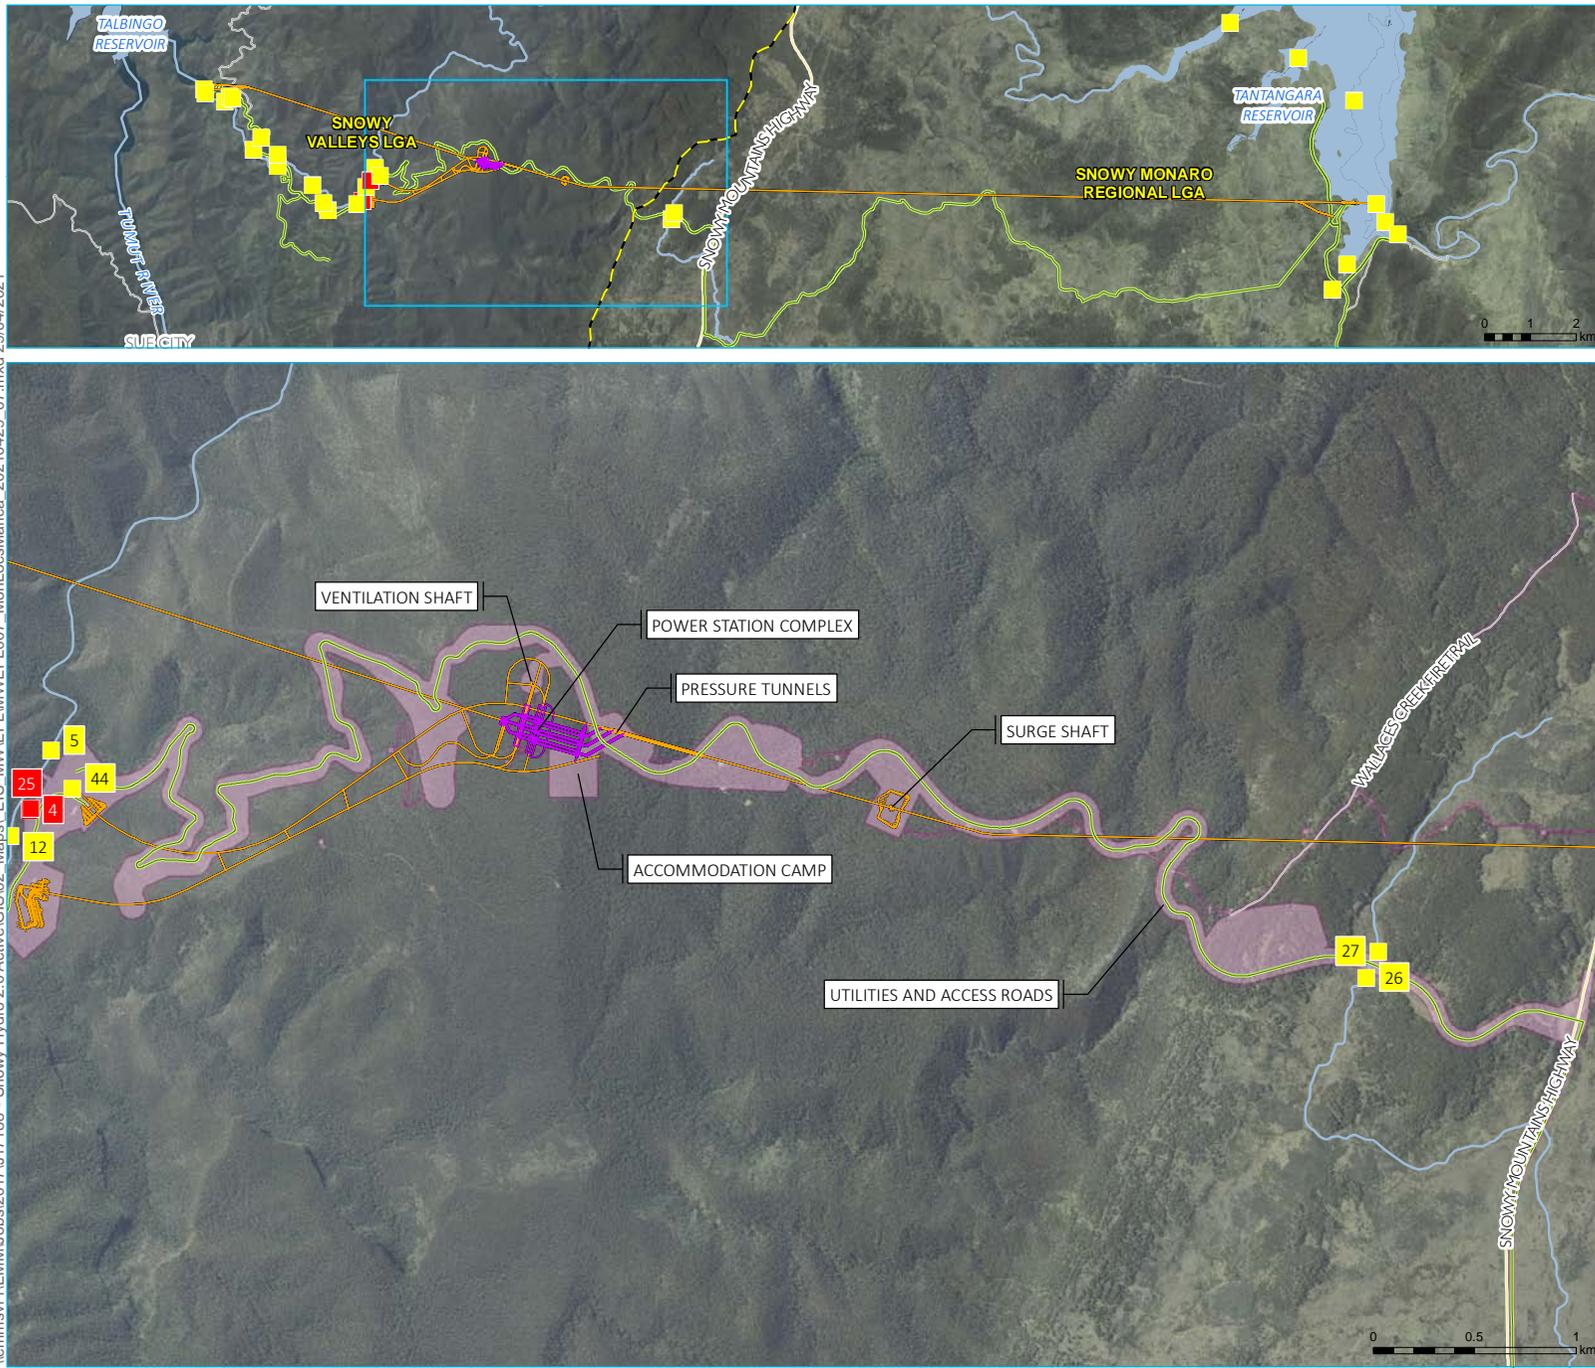
- KEY**
- EPL monitoring point
 - Groundwater
 - Surface water
 - Existing environment
 - Main road
 - Local road
 - Watercourse
 - Waterbodies
 - Local government area boundary
 - Snowy 2.0 Main Works operational elements
 - Tunnels, portals, intakes, shafts
 - Power station
 - Utilities
 - Licence Premise

The disturbance area is an estimation of the area required for construction works based on the current level of project design. Detailed design is still required to be completed, therefore it is expected that the precise location of the disturbance area may move within the broader construction envelope and consequently there will be some further refinements to the disturbance area.

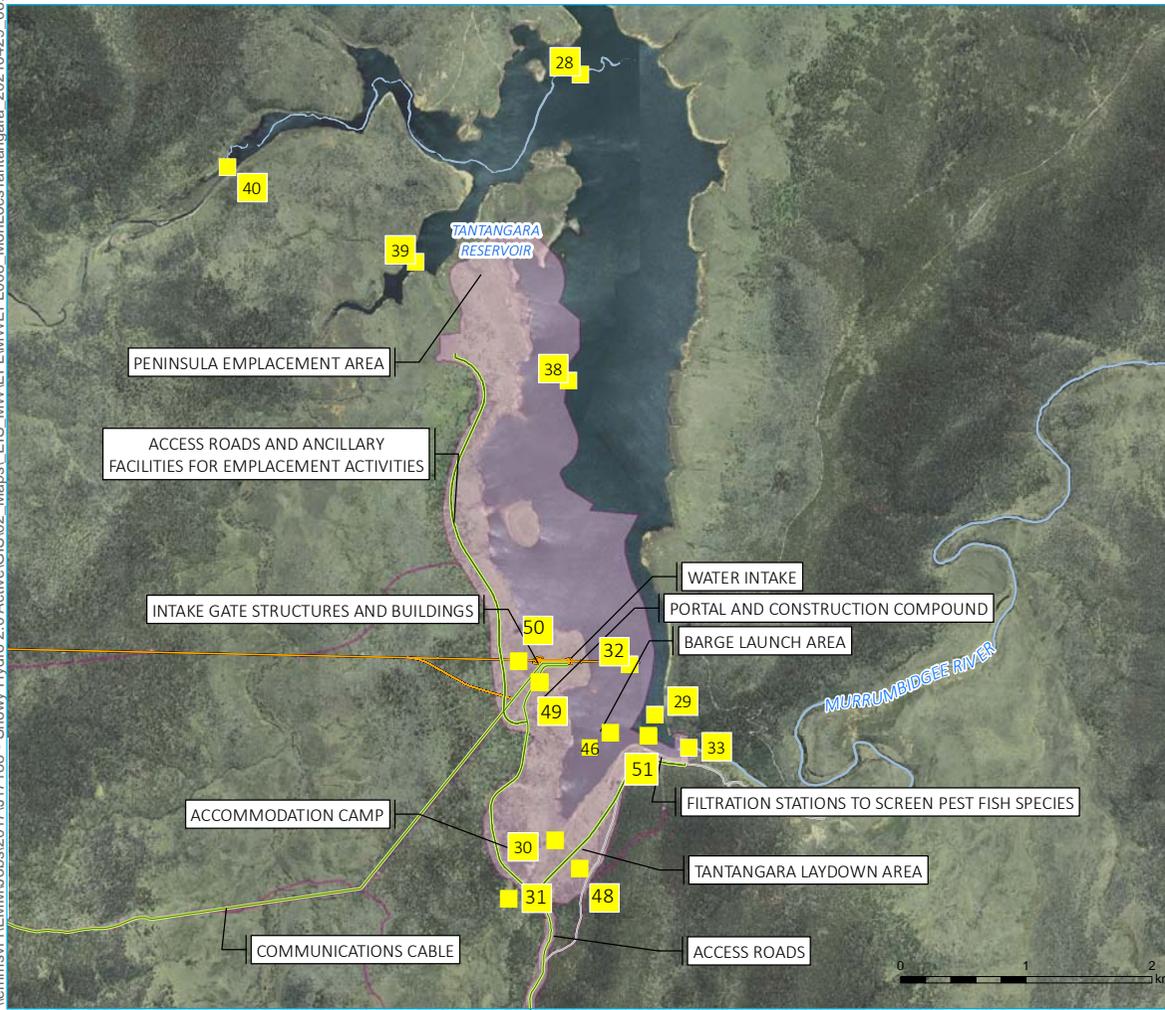
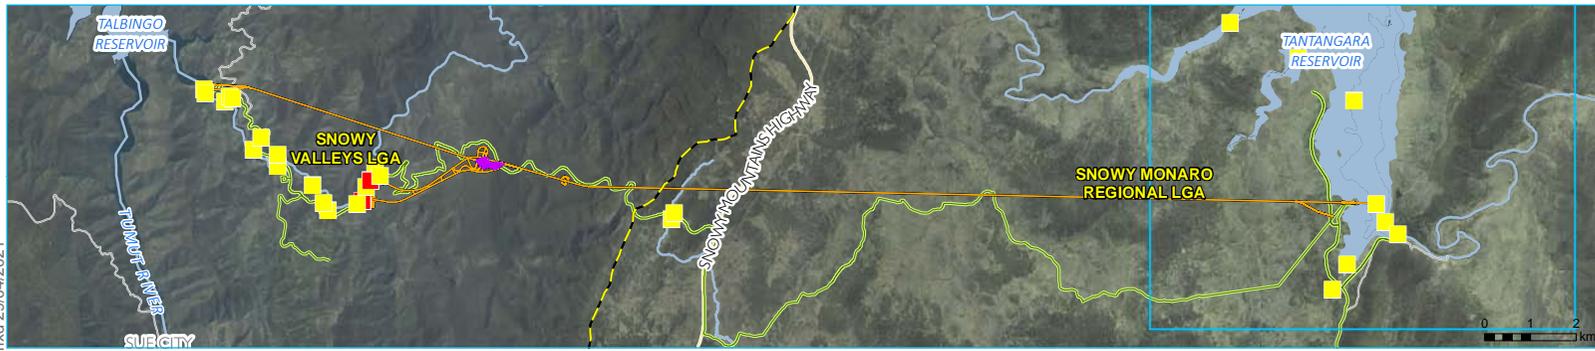
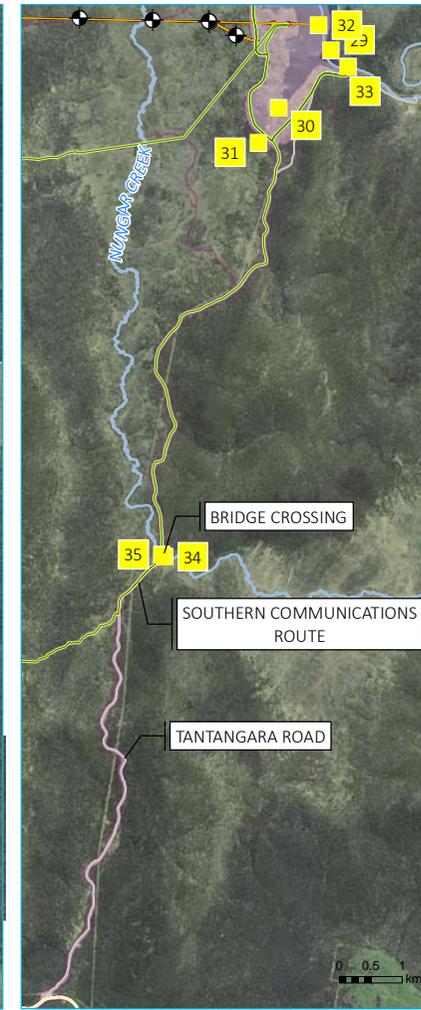
- KEY**
- EPL monitoring point
 - Groundwater
 - Surface water
 - Existing environment
 - Main road
 - Local road
 - Watercourse
 - Waterbodies
 - Local government area boundary
 - Snowy 2.0 Main Works operational elements
 - Tunnels, portals, intakes, shafts
 - Power station
 - Utilities
 - Licence Premise

The disturbance area is an estimation of the area required for construction works based on the current level of project design. Detailed design is still required to be completed, therefore it is expected that the precise location of the disturbance area may move within the broader construction envelope and consequently there will be some further refinements to the disturbance area.

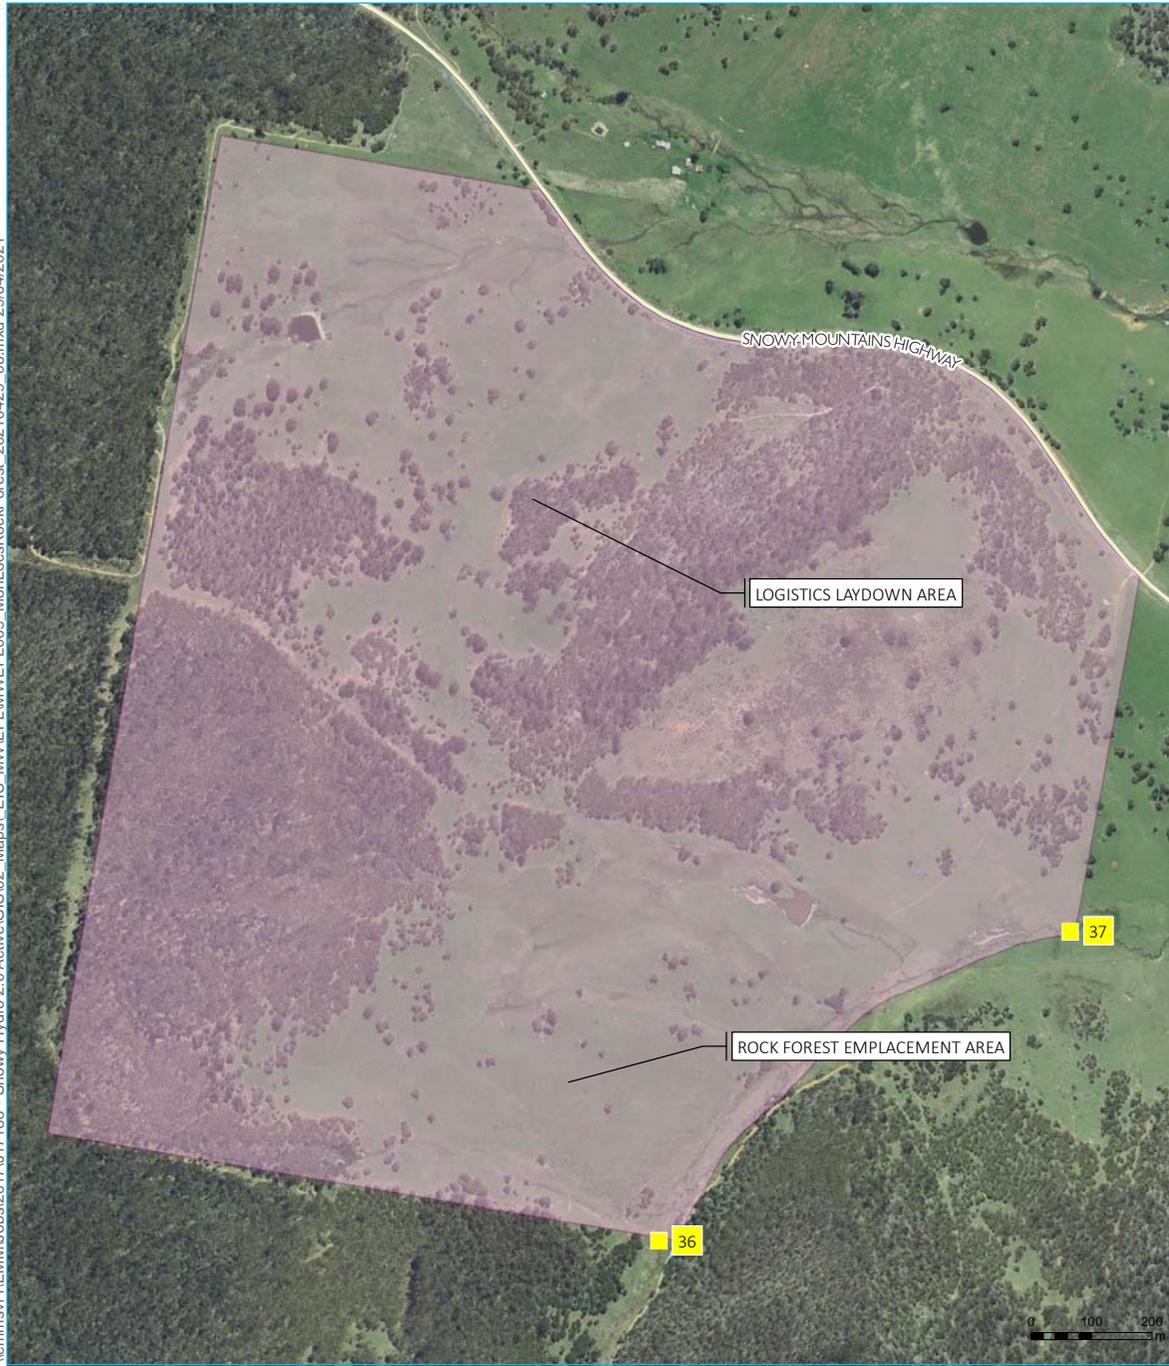
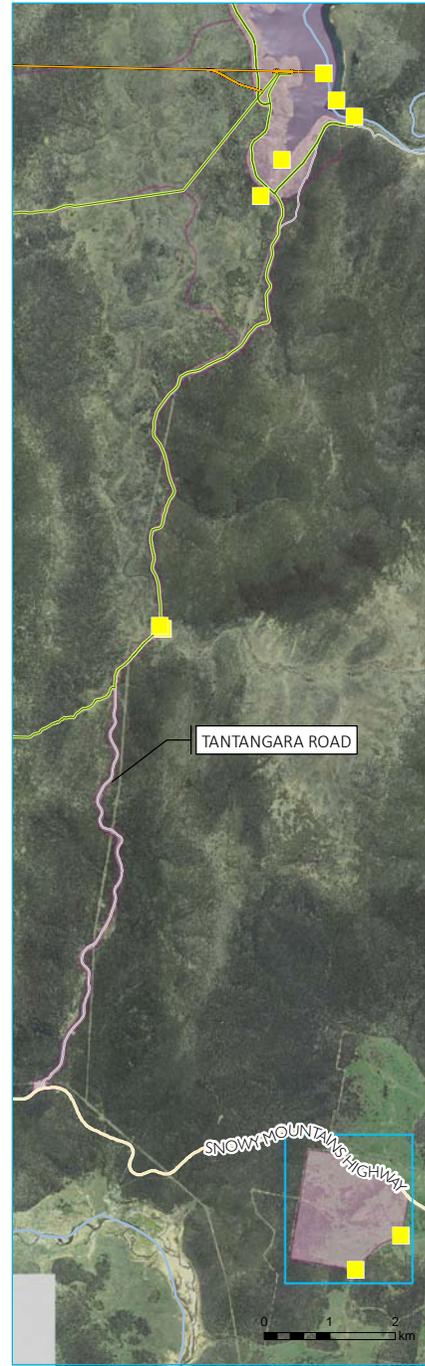
- KEY**
- EPL monitoring point
 - Surface water
 - Existing environment
 - Main road
 - Local road
 - Watercourse
 - Snowy 2.0 Main Works operational elements
 - Tunnels, portals, intakes, shafts
 - Utilities
 - Licence Premise

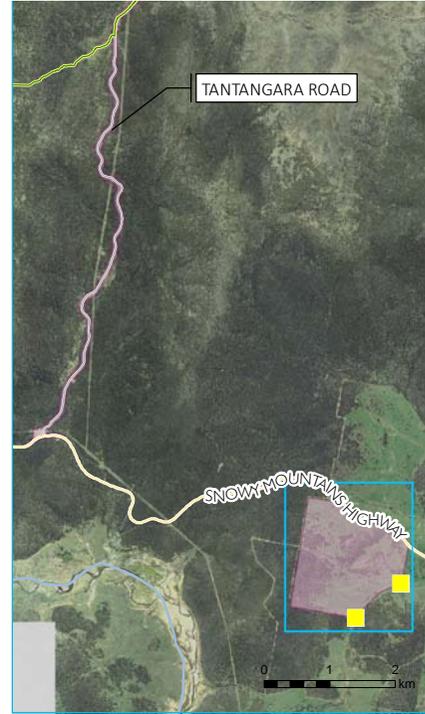
The disturbance area is an estimation of the area required for construction works based on the current level of project design. Detailed design is still required to be completed, therefore it is expected that the precise location of the disturbance area may move within the broader construction envelope and consequently there will be some further refinements to the disturbance area.
 Note that the Approved Exploratory Works disturbance area (SSI 9208) will also be a disturbance area for Main Works, even following surrender of the Exploratory Works Approval. The cumulative disturbance area for the Main Works and approved Exploratory Works is therefore presented in this figure.
