Snowy 2.0 – Plateau – Trunk Services Rehabilitation Plan

Subject: Snowy 2.0 - Main Works – Plateau Rehabilitation Plan

| Title | Snowy 2.0 – Plateau Rehabilitation Plan | |
| Document Number | S2-SHL-ENV-PLN-0005 Rev 4 | |

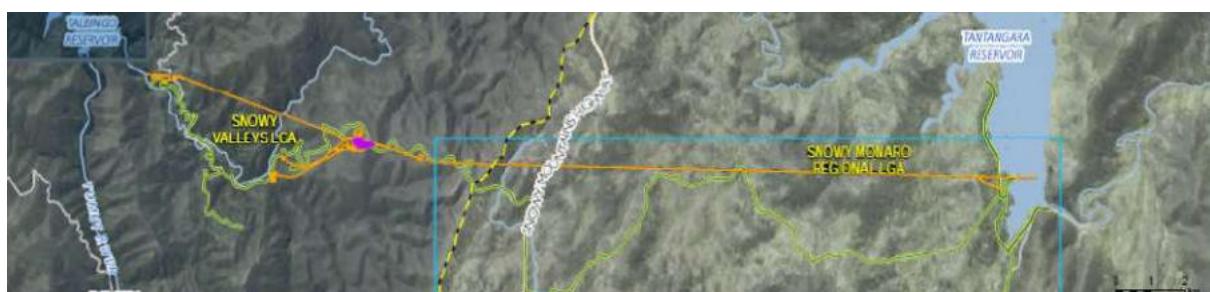
Figure 1: Region location

The Plateau portion of the project is located between the Marica entrance and Tantangara, including the trenched area parallel to Snowy Mountain Highway (SMH), and then along Gooandra, Bullocks Hill, Nungar Creek and Tantangara Dam Firetails to Tantangara Reservoir. Trunk services are power and communication cables which run underground between Tantangara and Talbingo storages. The general location is shown in Figure 1.

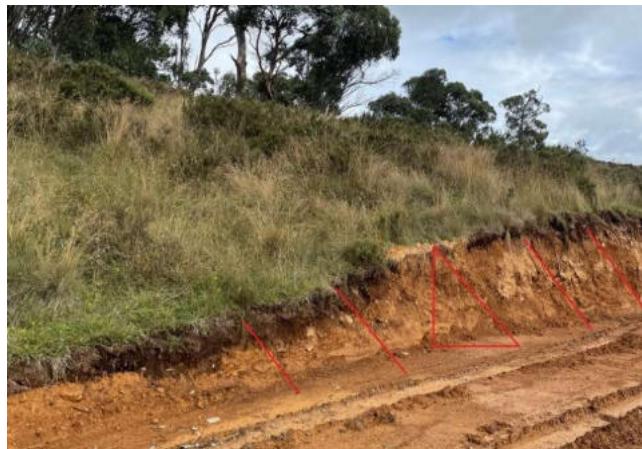
Figure 3: Proposed Batter reinstatement (as indicated by red)

No major landform reshaping is required on most of the alignment, only reinstatement of the original surface levels. Where site cuts have been made for the purpose of creating a level surface for construction, reinstatement of the batter has been undertaken for cuts over 0.5m at a gradient no steeper than 1v:2H (50%) (see Figure 3 for example and Appendix C & D for locations).

Compaction of the sites has and will be addressed by 'crazy' ripping to ~200mm depth. Fill material (for reinstatement of batter cuts) has and will continue to be sourced from removal of pads and temporary culverts on the SMH section of the services corridor. The outer layer has and will continue to be topsoiled with topsoil retained during the original construction works, with hydromulch containing native seed applied to provide cover and initial stabilisation.

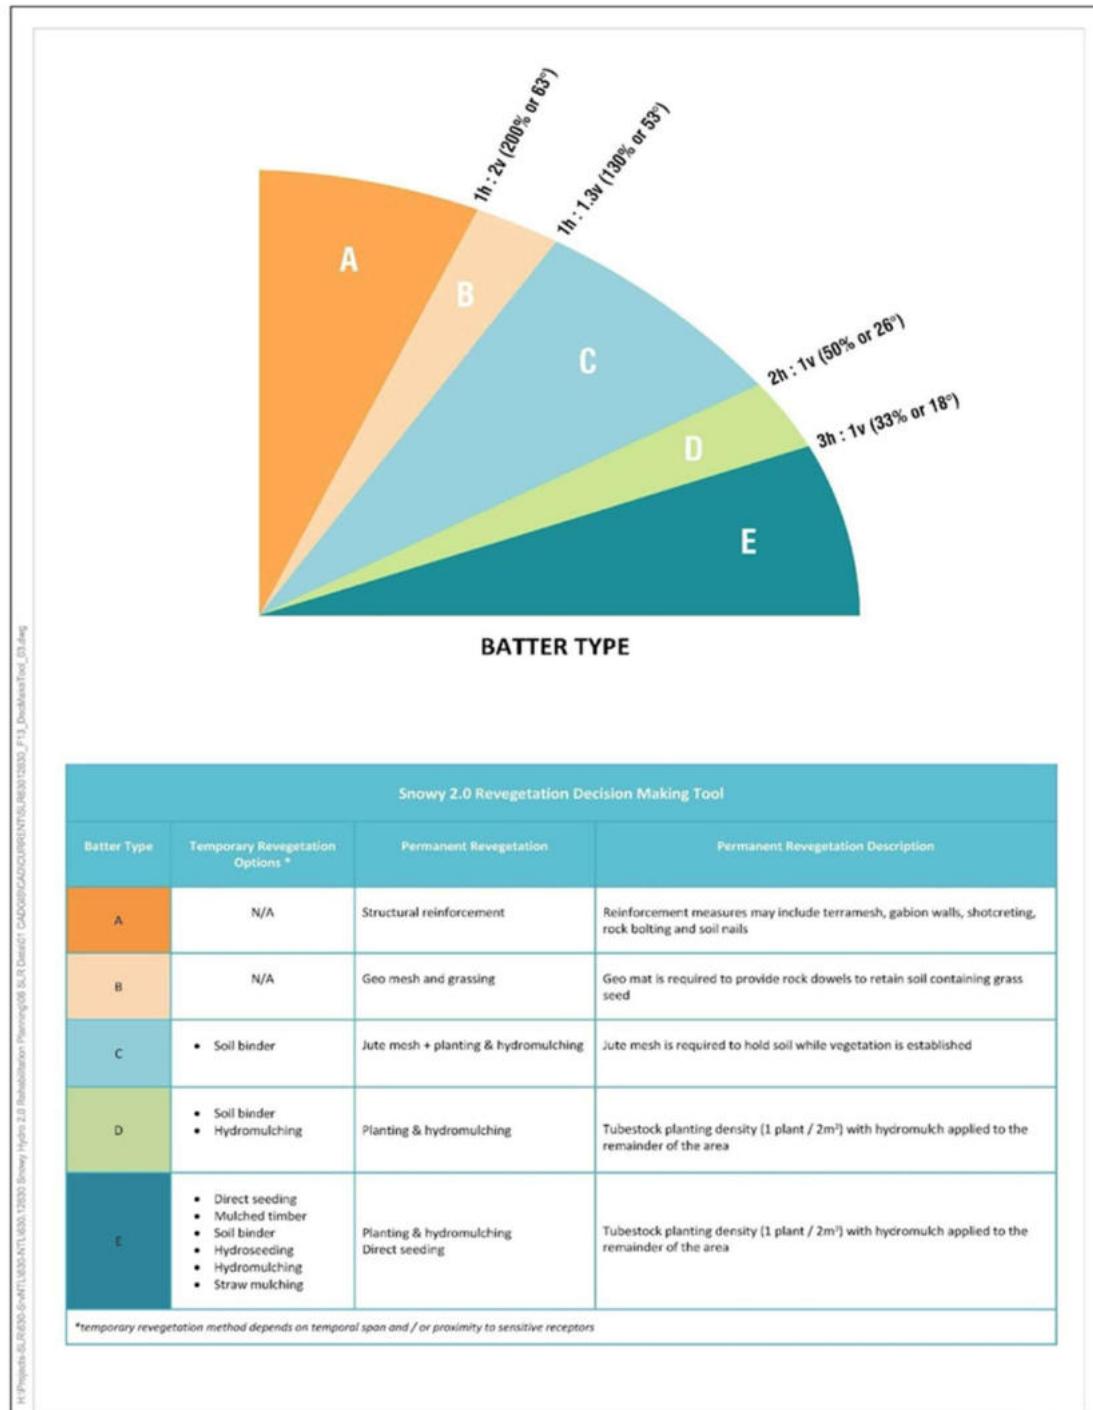
Figure 4: Revegetation Decision Making Tool

Below Figure 4 demonstrates the revegetation decision making process for determining stabilisation techniques, materials, and vegetation depending on the gradient of the area to be rehabilitated.

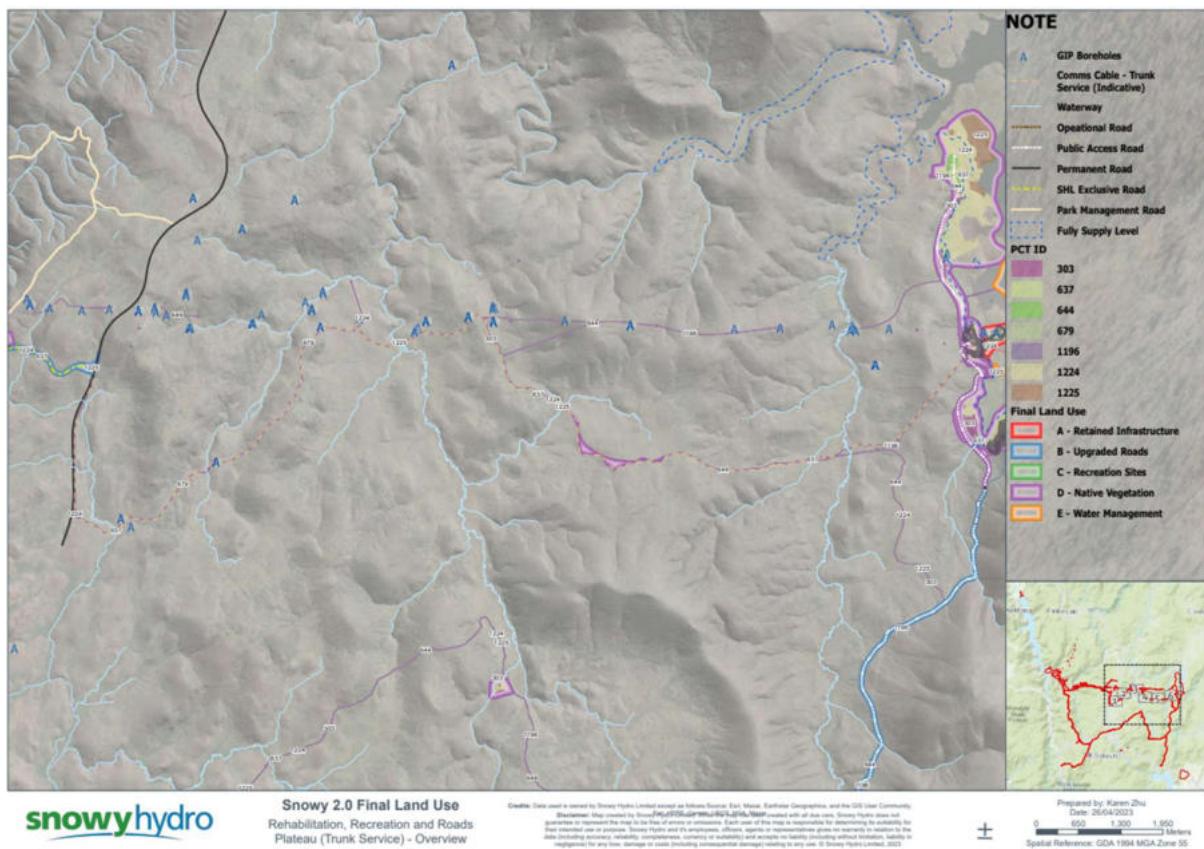
Figure 5: Final land use mapping for Plateau

It is envisaged that the future use of this site is a combination of native vegetation, access road and underground permanent infrastructure. See Figure 5 for detail.

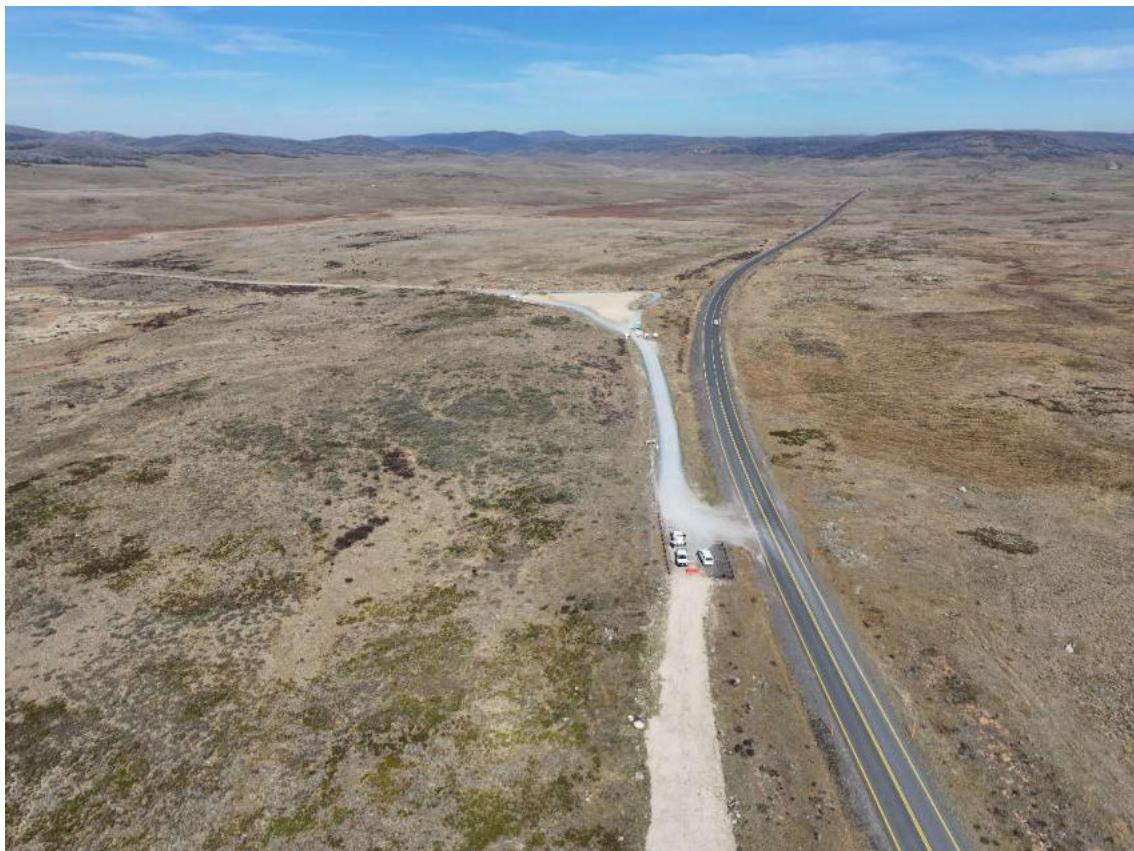
Chainage 1800 – 2300 (Gooandra Trail site entrance laydown) (SMH section) (L1)

Earthworks status – complete – topsoil applied

Gradient - less than 3.5%

Cover – complete - hydromulched with native seed (see Section 4.2 Table 3 and Section 5.2 Table 4)

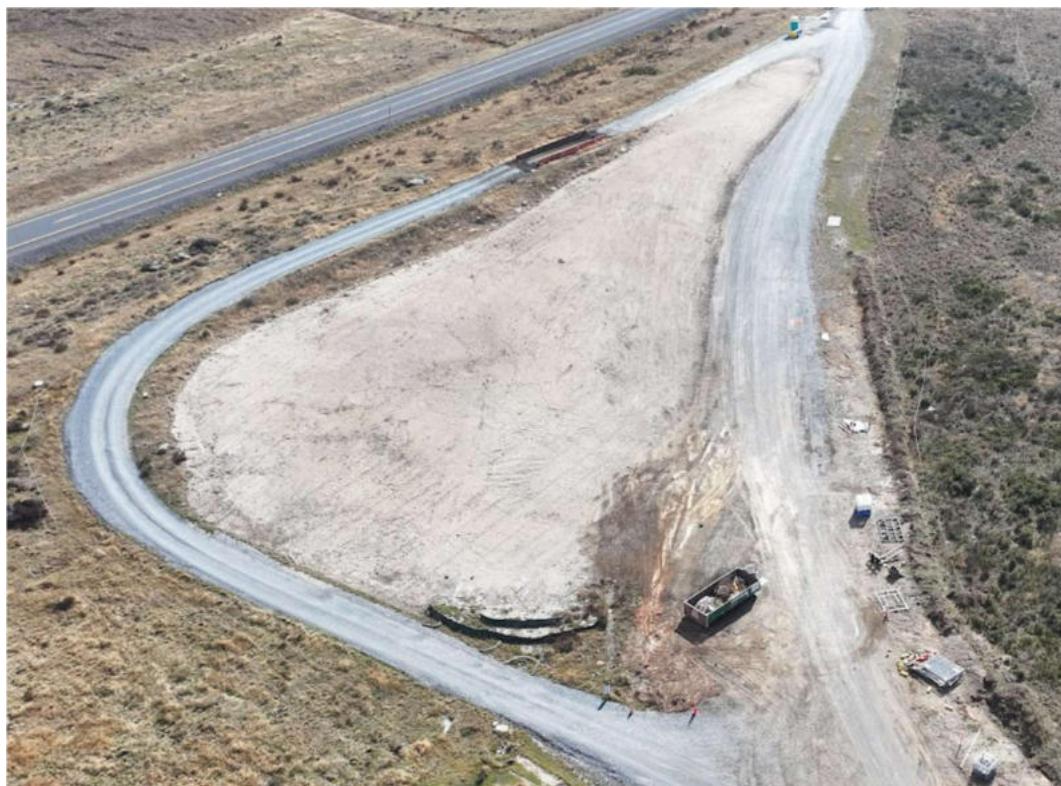
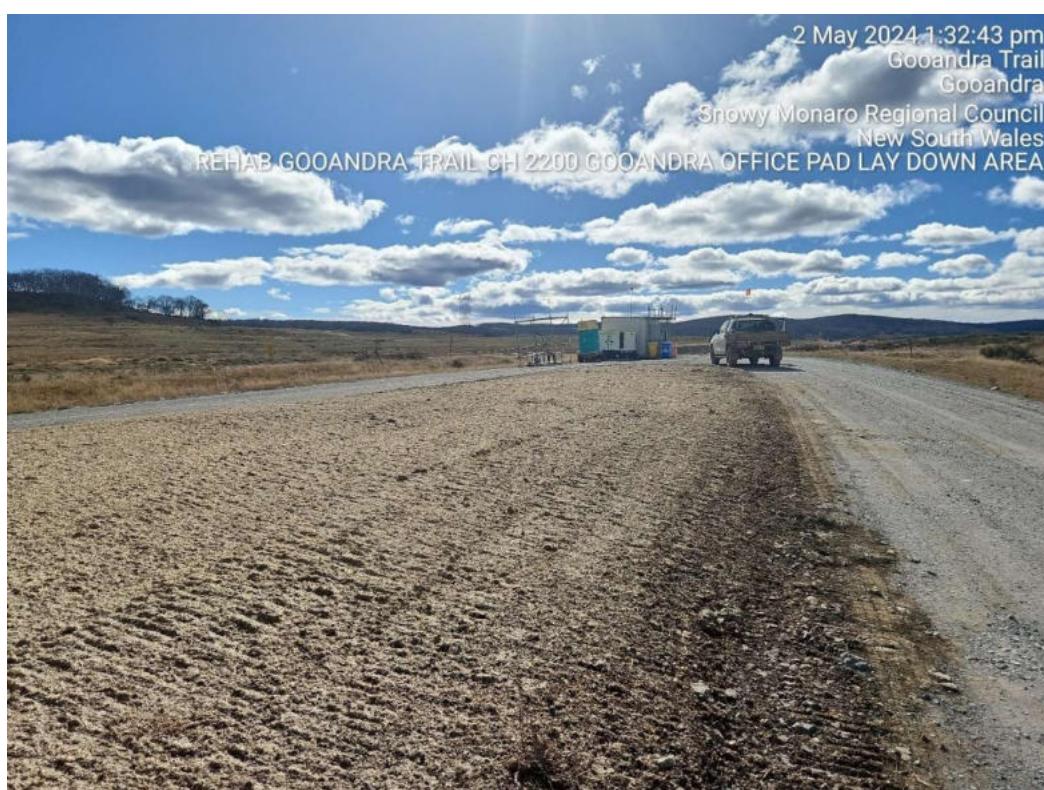
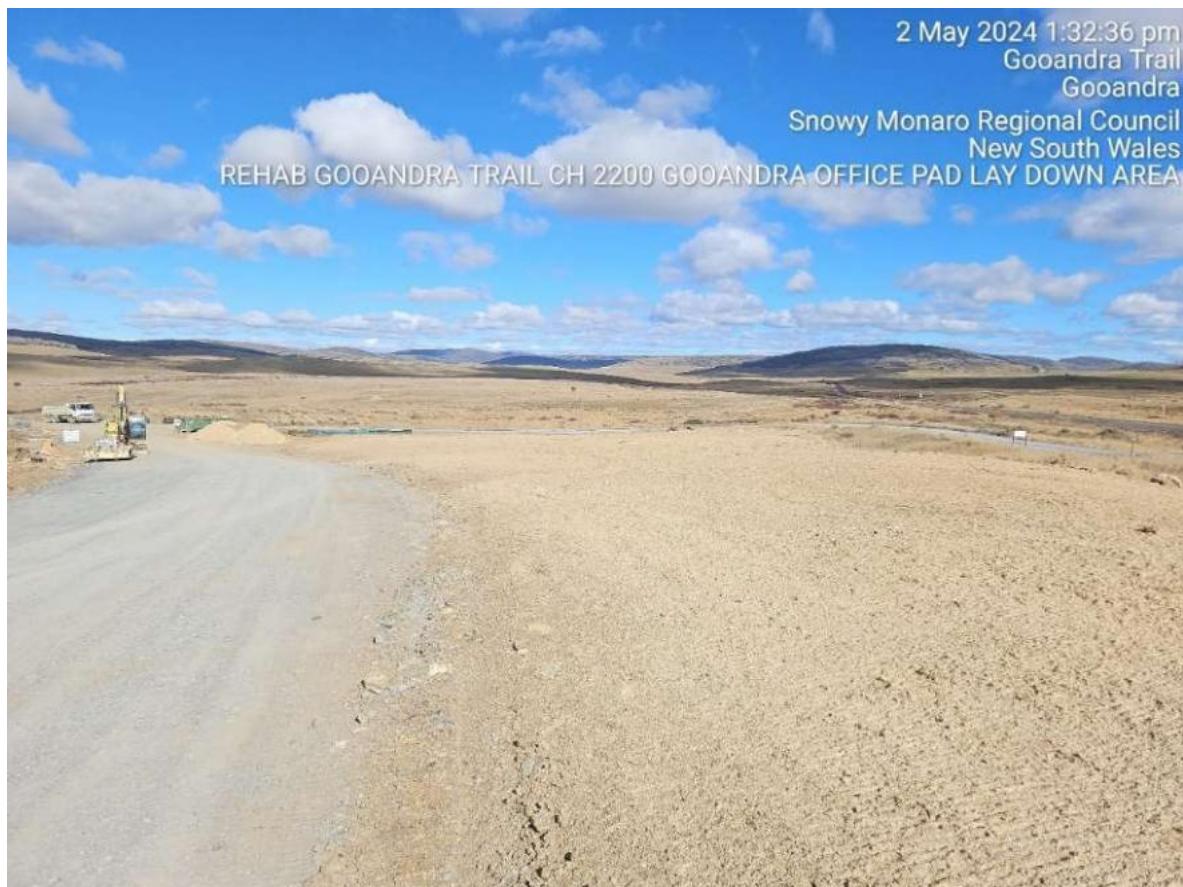
Chainage 2000-2300 — Site entrance laydown (L1)

Area – 7,285m2 - (area of track to remaining to rehabilitated – 1,200m2)

Earthworks status – 90% (removal of highlighted section of track to be undertaken and demobilisation of wheel wash at the completion of works. Other miscellaneous materials to be removed and windrowed topsoil applied.

Gradient - less than 2%

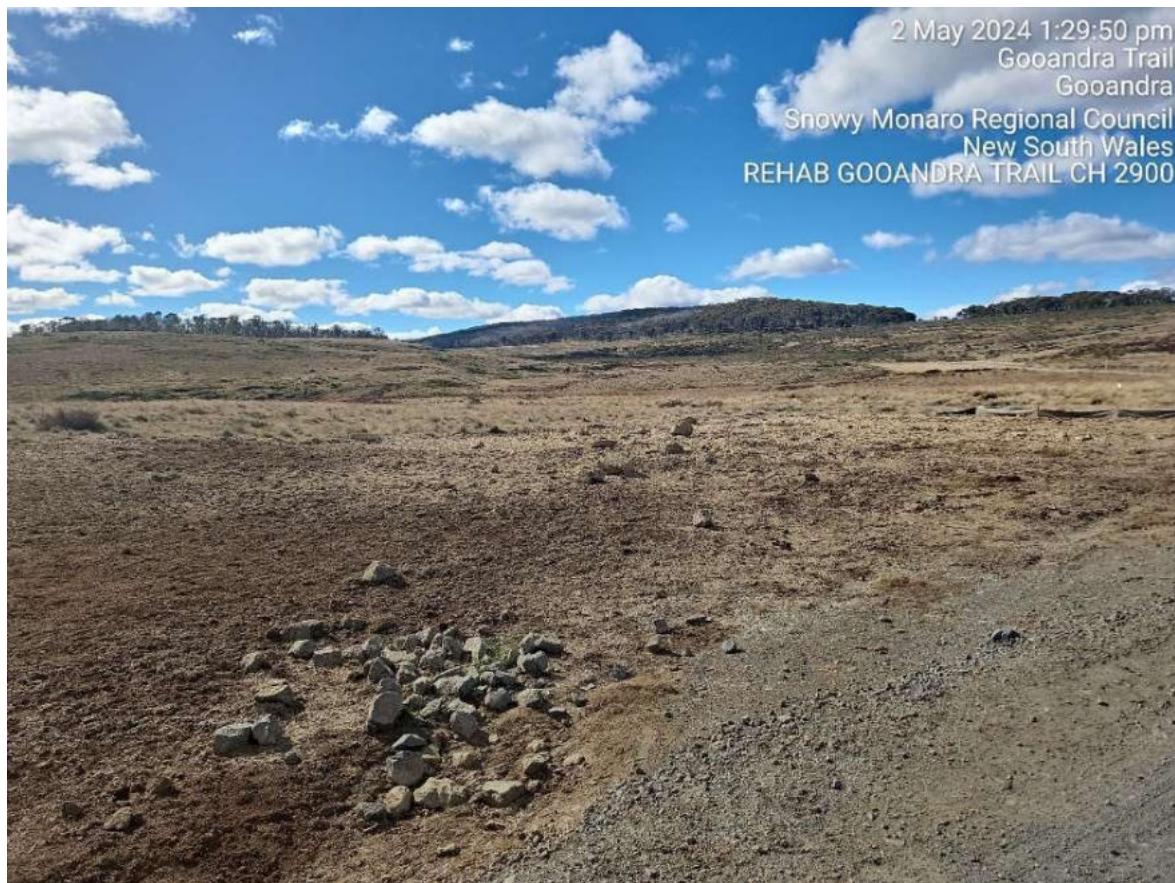
Eucumbene laydowns Chainage 2800— Laydown (L2)

Area – 575m2

Earthworks status – complete – topsoil applied

Gradient - less than 3.5%

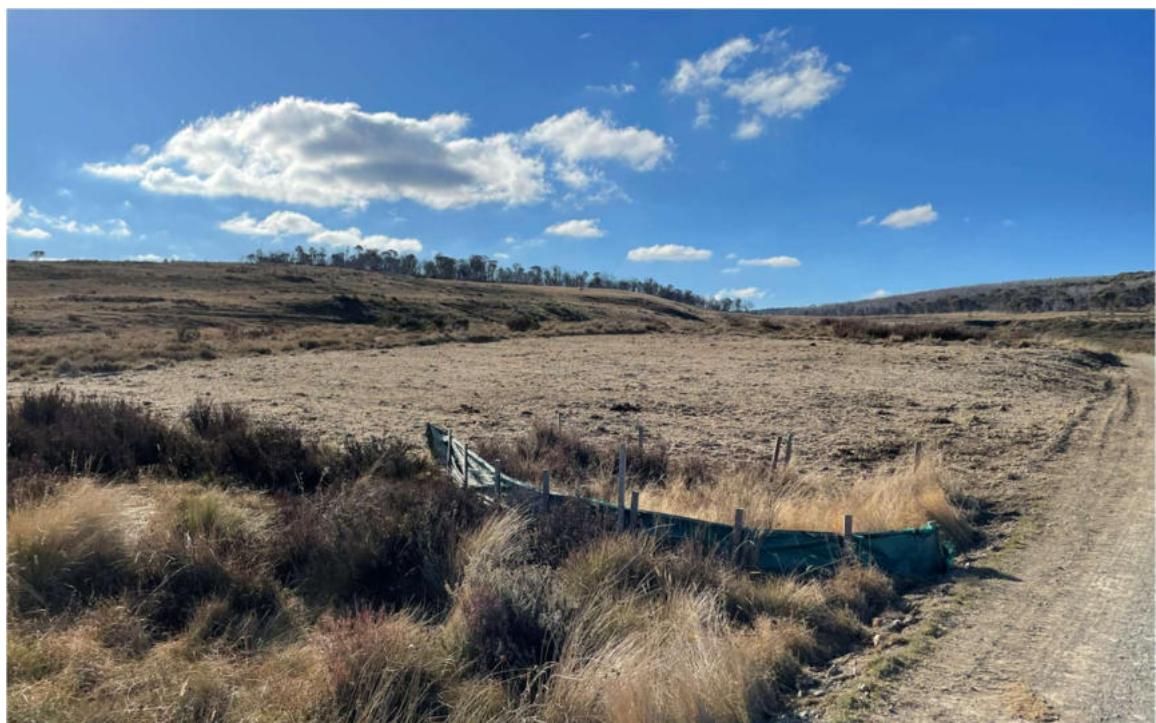
Eucumbene laydowns Chainage 3000 — laydown (L3)

Area – 496 m²

Earthworks status – complete – topsoil applied

Gradient - less than 7.5%

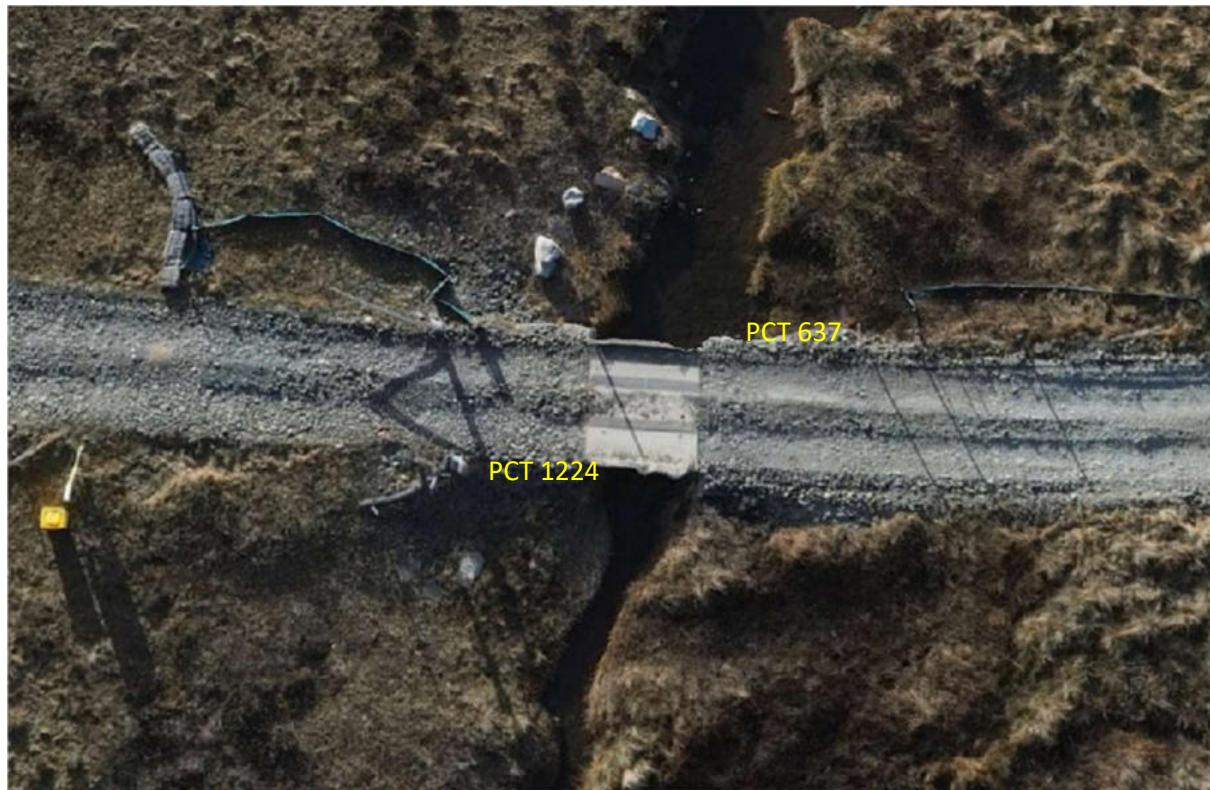
Eucumbene River PCT 637 (Alpine bogs and fens)/1224 (>40m2)

This site will be sown and planted with primary species on the batters and in the disturbed areas of waterway zone. All species selected for the first pass of rehabilitation are considered primary species for this PCT. This site will be monitored, and additional planting and sowing will be done with secondary species as part of the rehabilitation and maintenance program. This site will use a mix of primary species from PCT's 637 and 1224 in the rehabilitation.

Alpine bogs and fens will be rehabilitated using techniques described in *The Australian Alps Rehabilitation Manual 2006* and guided on ground by a suitable Alpine rehabilitation specialist.

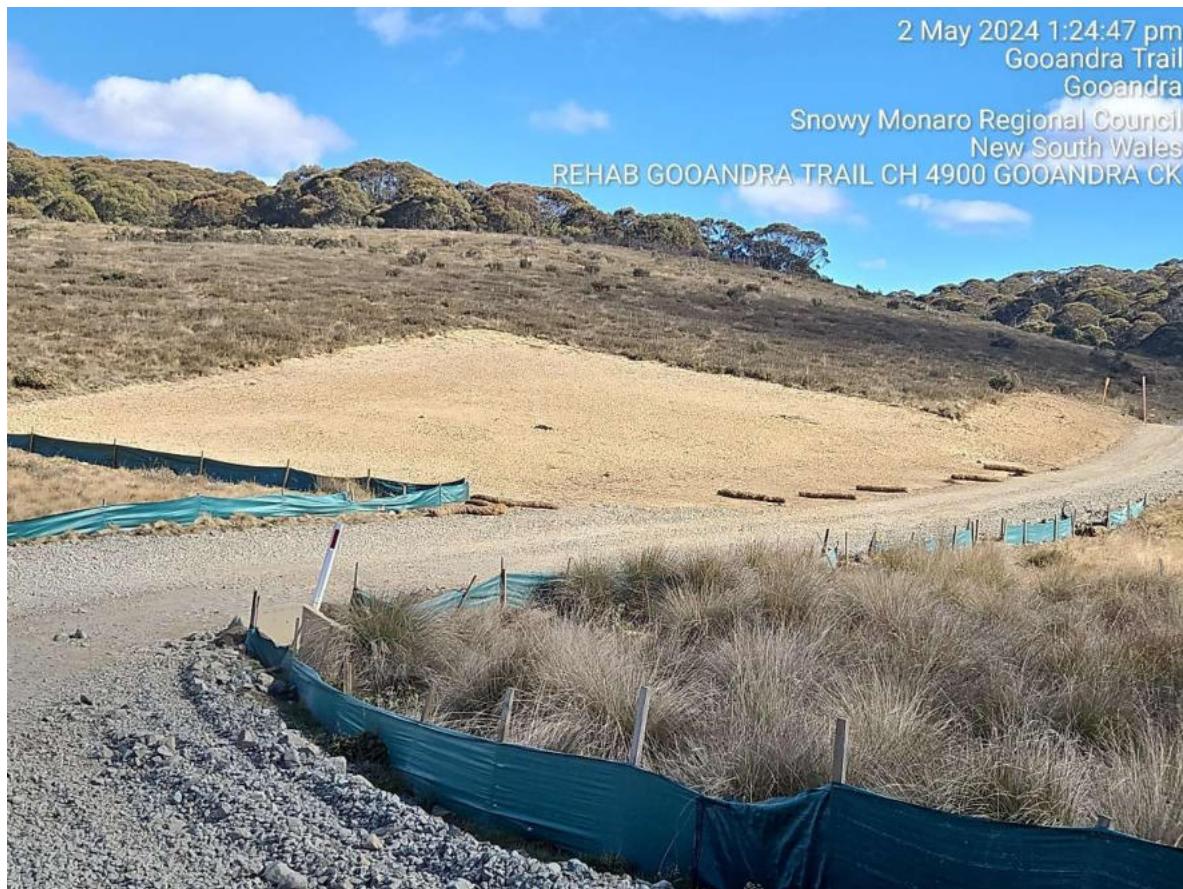
Gooandra Creek laydowns Chainage 4700 — laydown (L4)

Area – 660 m²

Earthworks status – complete - topsoil applied

Gradient - less than 16%

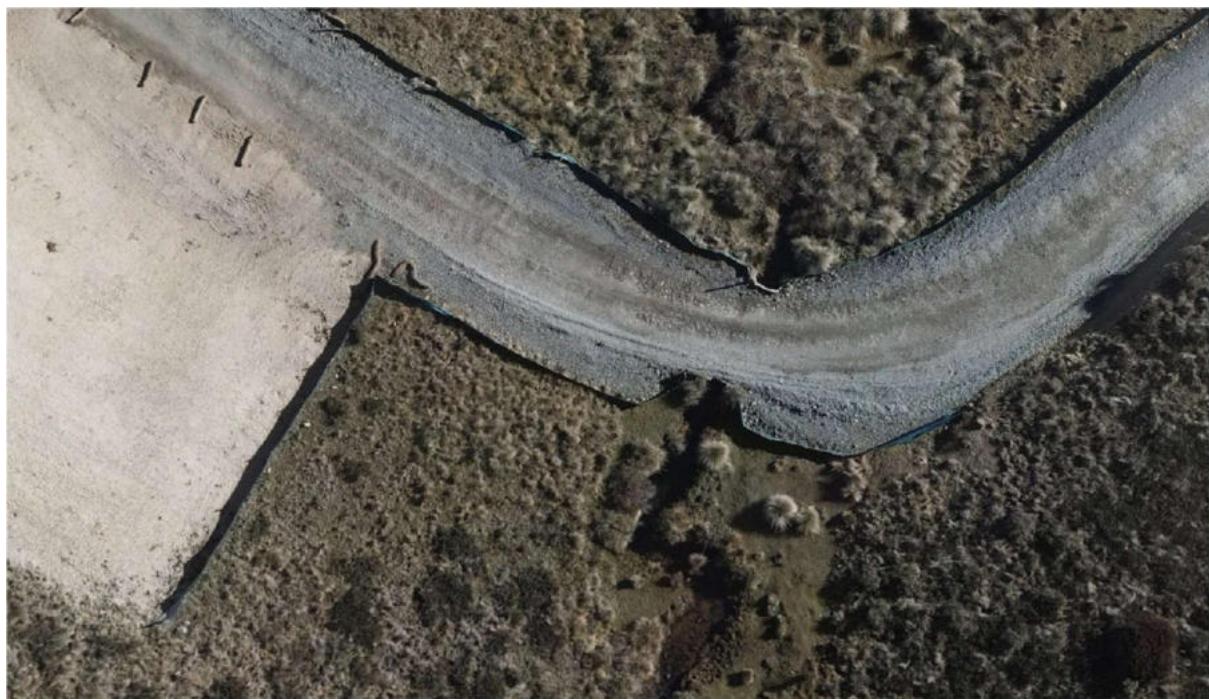
Gooandra Creek – PCT 1225 (>40m2)

This site will be sown and planted with primary species on the batters and in the disturbed areas of waterway zone. All species selected for the first pass of rehabilitation are considered primary species for this PCT. These sites will be monitored, and additional planting and sowing will be done with secondary species as part of the rehabilitation and maintenance program.

The table below outlines the primary species to be planted around the waterway as tubestock. Trees are to be planted approximately 3 metres apart with shrubs planted 1-2 metres apart

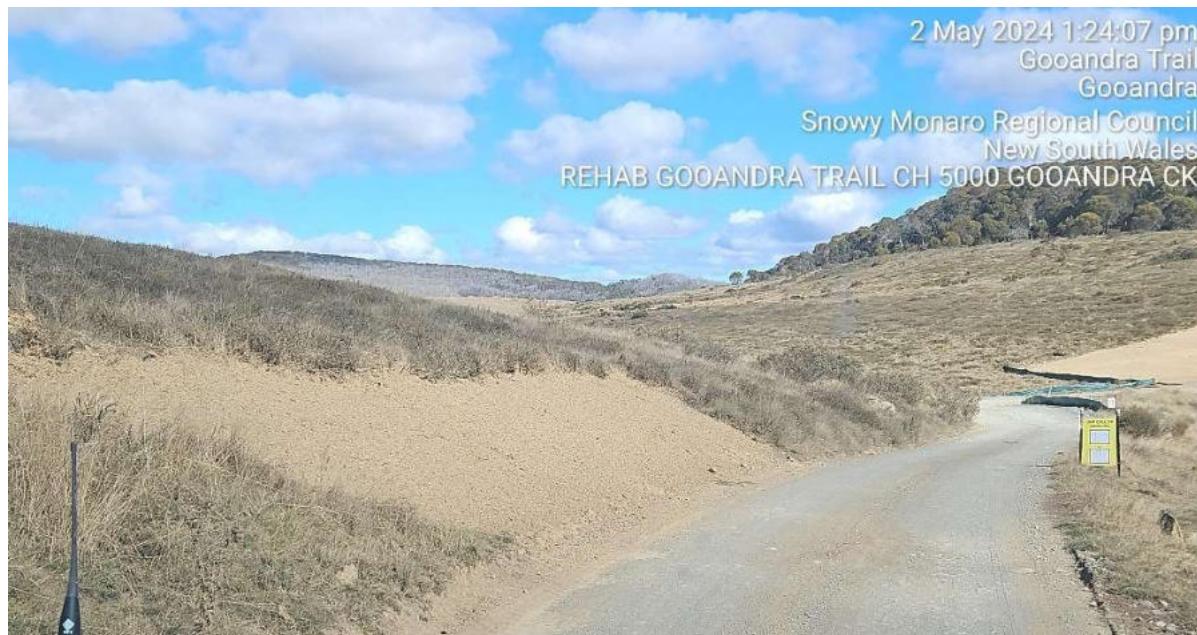
Chainage 4900 — Cut/Fill batter (CFB 1)

Area – 62 m²

Earthworks status – complete - topsoil applied

Gradient - less than 38%

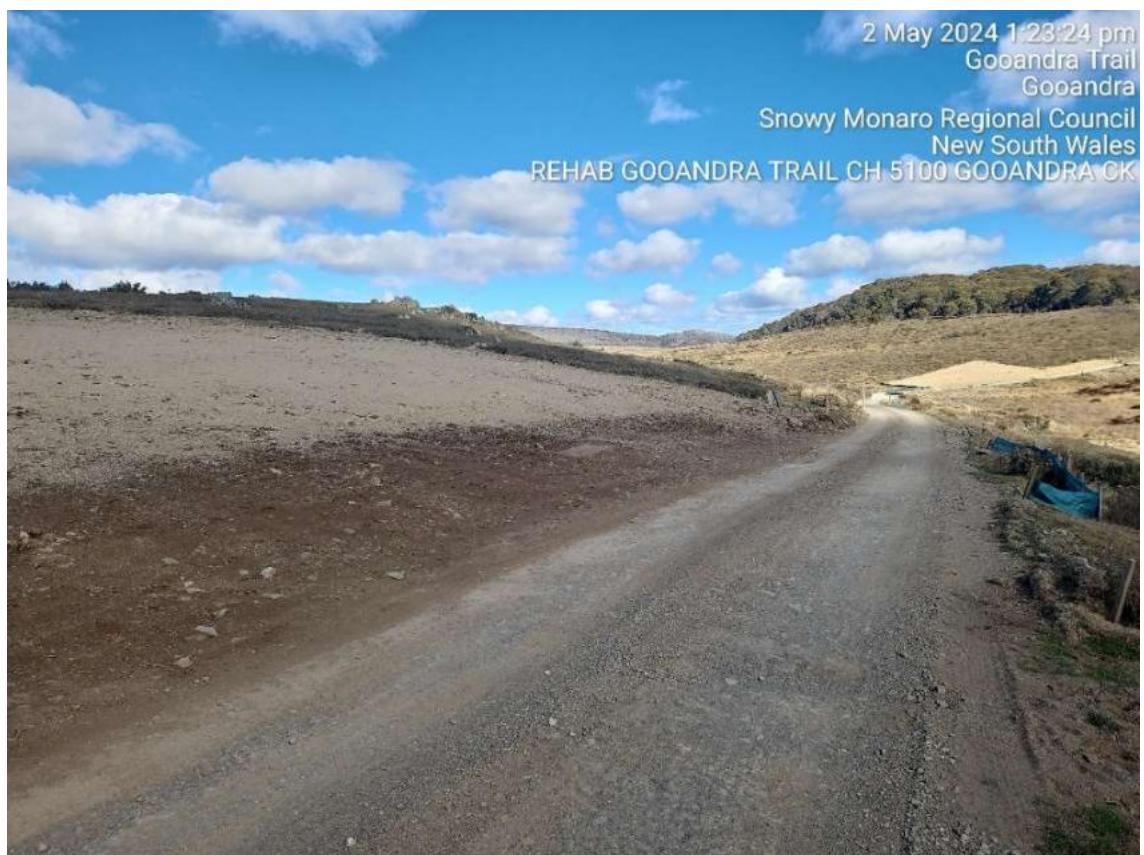
Gooandra Creek laydowns Chainage 5000 — laydown (L5)

Area – 660 m²

Earthworks status – 90% complete - topsoil applied

Gradient - less than 17%

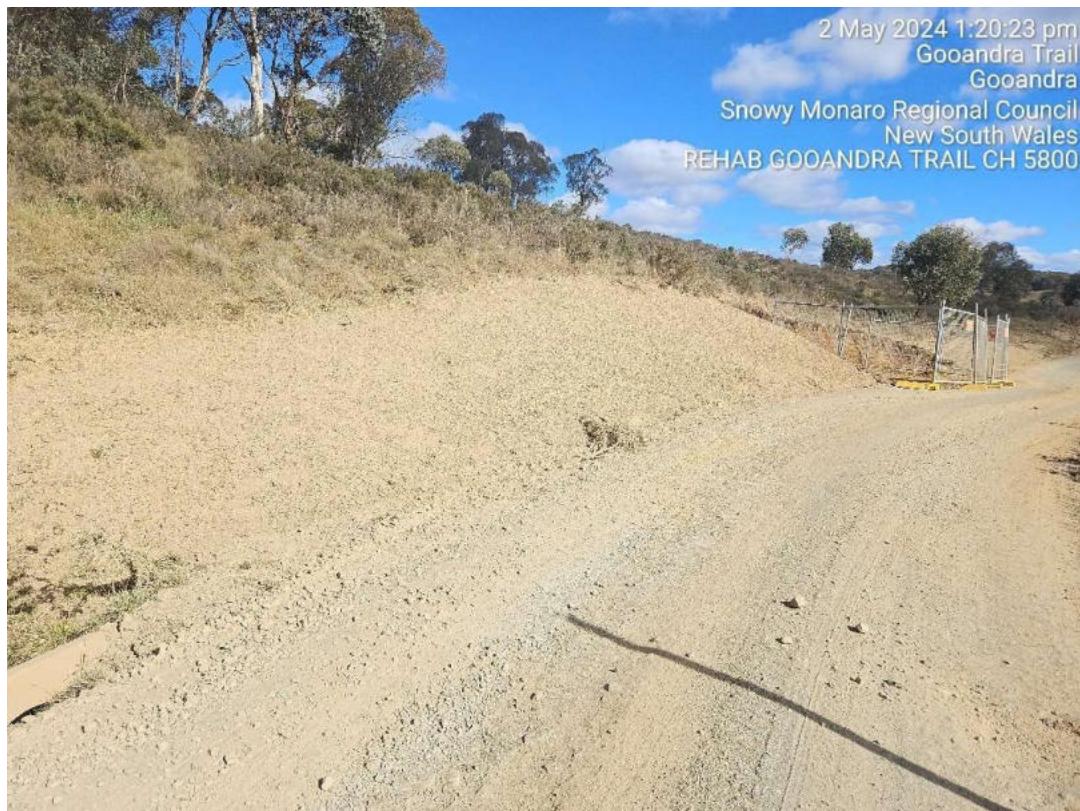
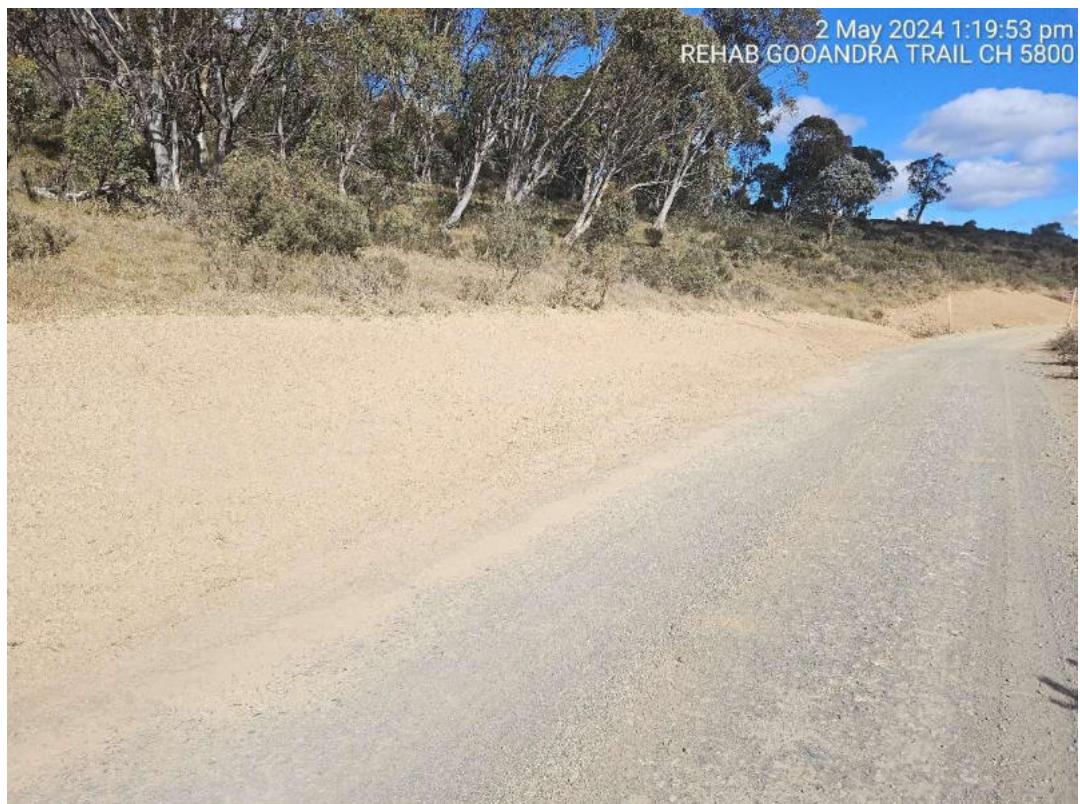
Chainage 5700 – 5900 — Cut/Fill batter (CFB 2) & (CFB 3)

Area – 450 m2

Earthworks status – 95% complete - topsoil applied

Gradient - less than 30%

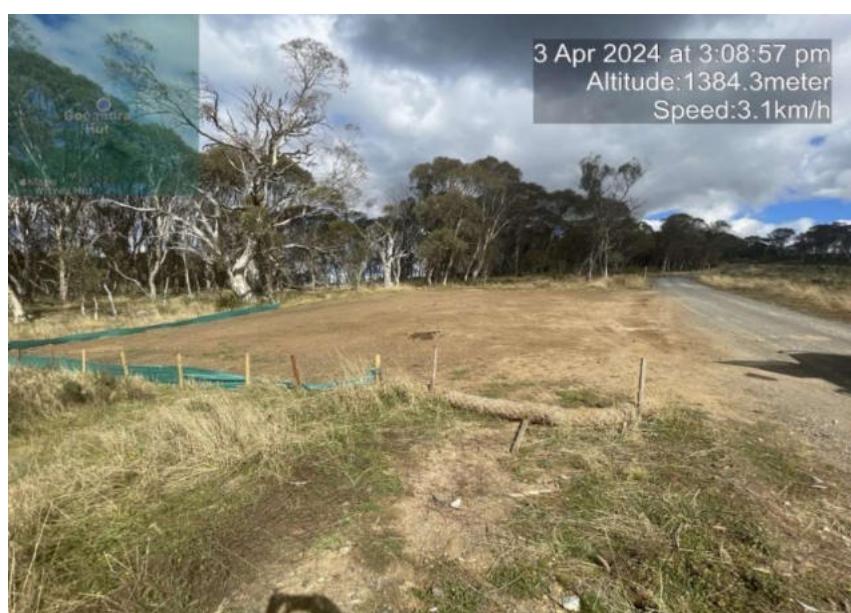
Chainage 7000—Laydown (L6)

Area – 460m²

Earthworks status – complete – topsoil applied

Gradient - less than 10%

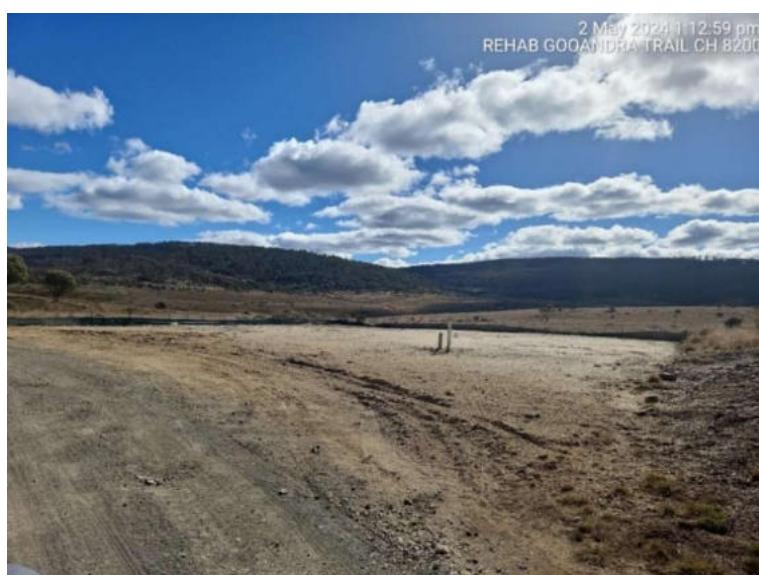
Chainage 8000—Laydown (L7)

Area – 482m²

Earthworks Status - Complete topsoil applied

Gradient - less than 2%

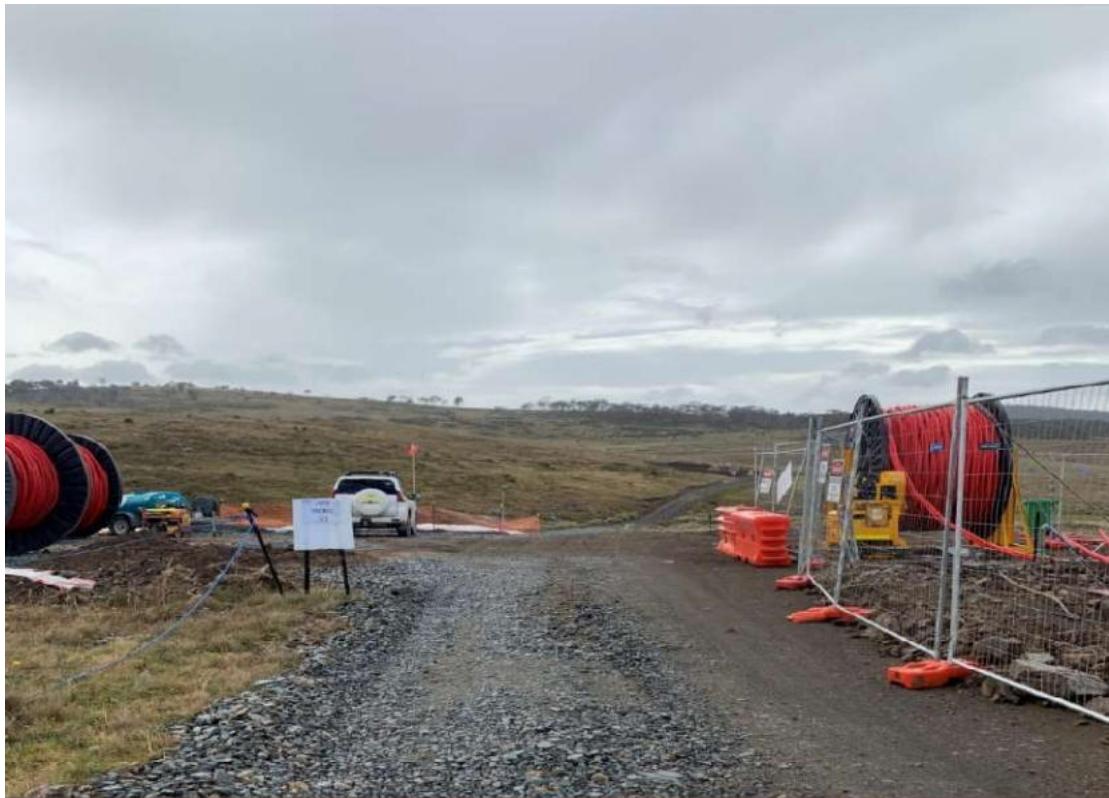
Tantangara Creek laydowns 9200 – (L8)

Area 498 m²

Earthworks status – not complete (site still in use for remaining testing and Tantangara Creek culvert installation work) – culvert installation scheduled for Summer 2024/2025

Gradient – less than 16%

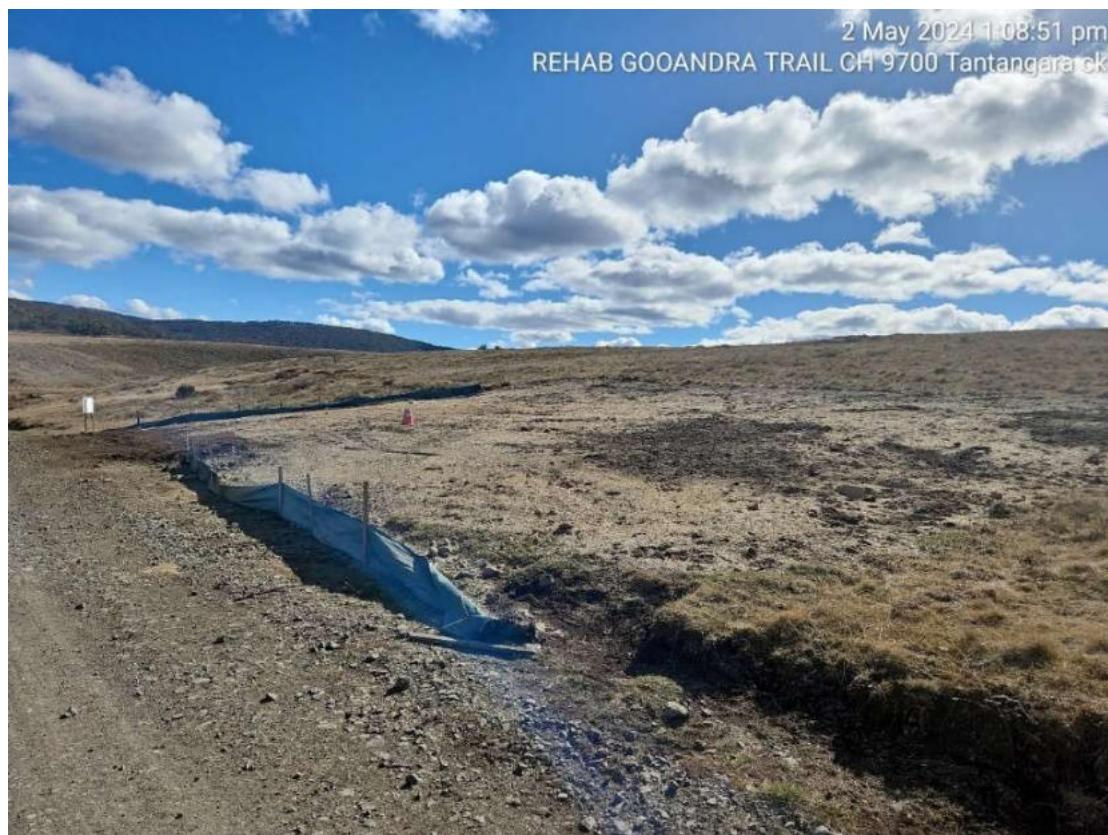
Tantangara Creek laydowns 9400 – (L9)

Area 535 m²

Earthworks status – complete – topsoil applied

Gradient – less than 16%

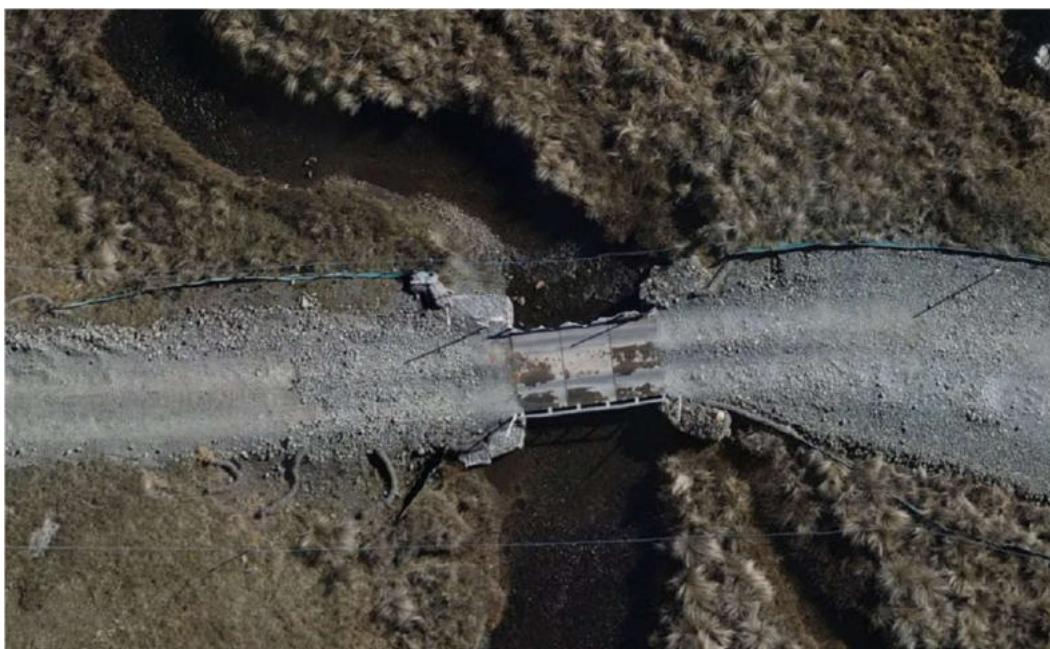
**Plateau – Tantangara Creek – PCT 1225 (>40m2)**

This site will be sown and planted with primary species on the batters and in the disturbed areas of waterway zone. All species selected for the first pass of rehabilitation are considered primary species for this PCT. These sites will be monitored, and additional planting and sowing will be done with secondary species as part of the rehabilitation and maintenance program.

The table below outlines the primary species to be planted around the waterway as tubestock. Trees are to be planted approximately 3 metres apart with shrubs planted 1-2 metres apart.

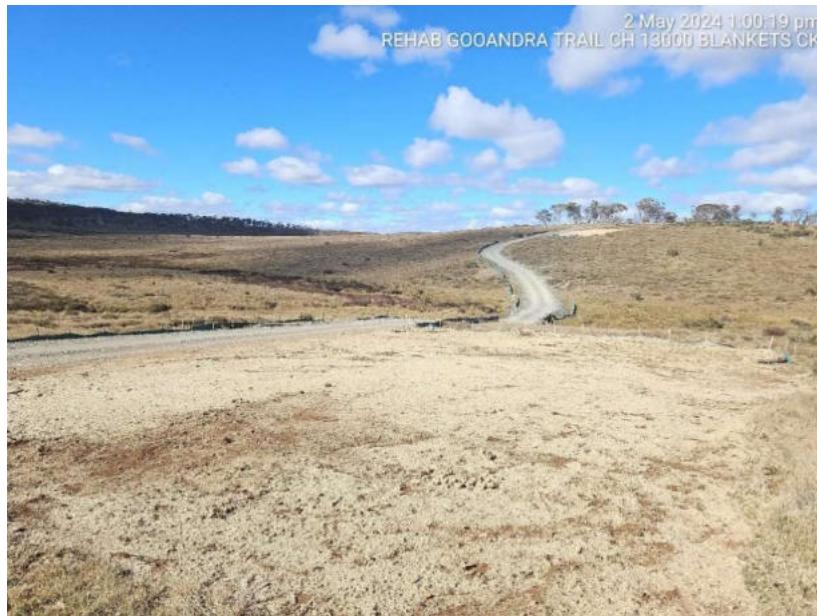
Blankets Creek laydown Chainage 12800—laydown (L10)

Area – 448 m²

Earthworks status – complete – topsoil applied

Gradient - 12%

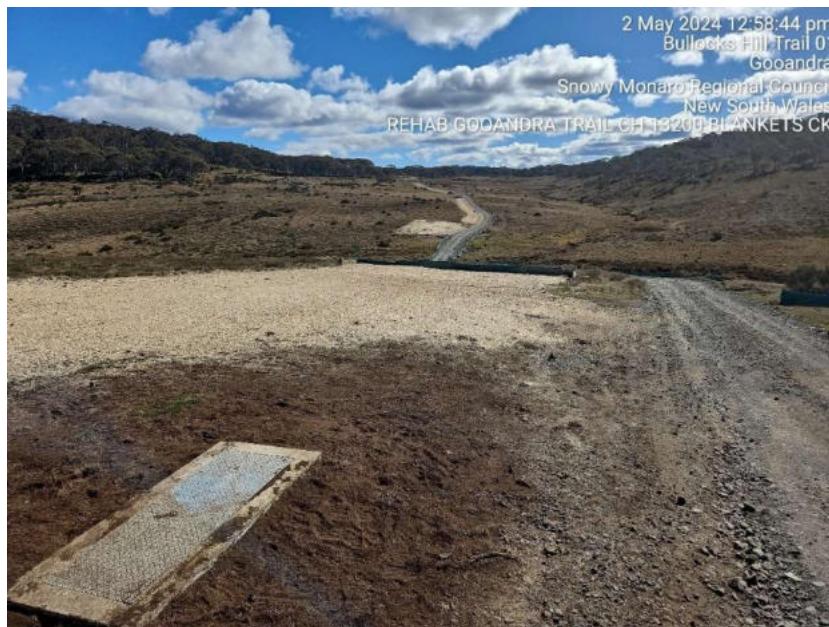
Blankets Creek laydown Chainage 13000—laydown (L11)

Area – 408 m²

Earthworks status – complete – topsoil applied

Gradient - 12%

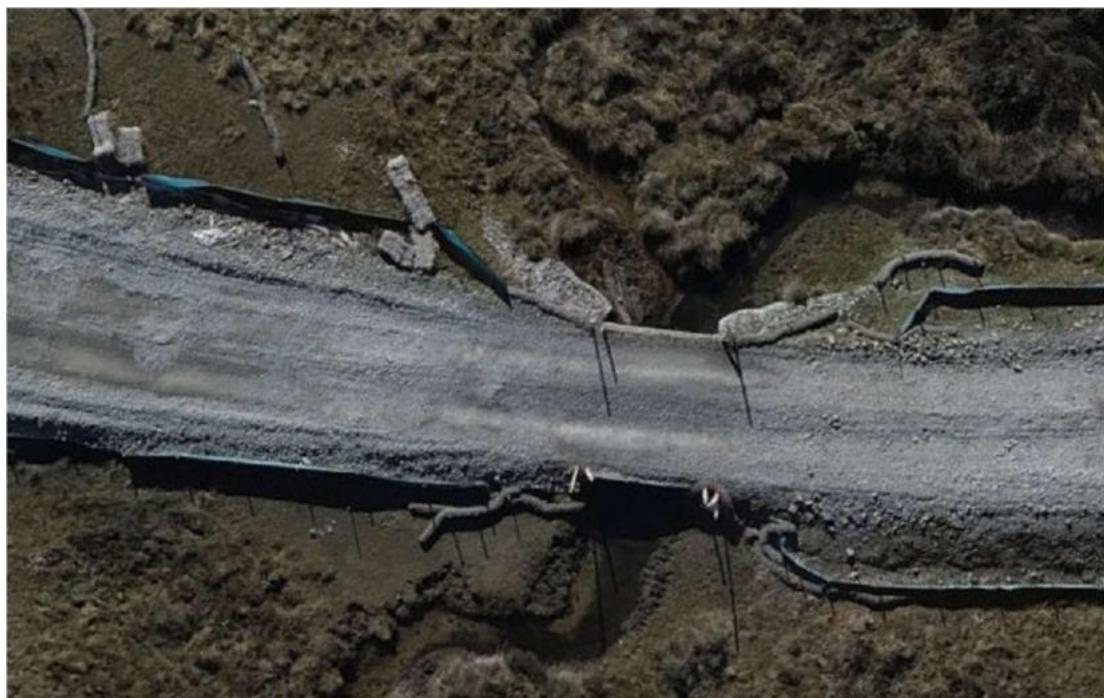
Blankets Creek – PCT 1224 (>40m2)

This site will be sown and planted with primary species on the batters and in the disturbed areas of waterway zone. All species selected for the first pass of rehabilitation are considered primary species for this PCT. These sites will be monitored, and additional planting and sowing will be done with secondary species as part of the rehabilitation and maintenance program.

The table below outlines the primary species to be planted around the waterway as tubestock. Trees are to be planted approximately 3 metres apart with shrubs planted 1-2 metres apart.

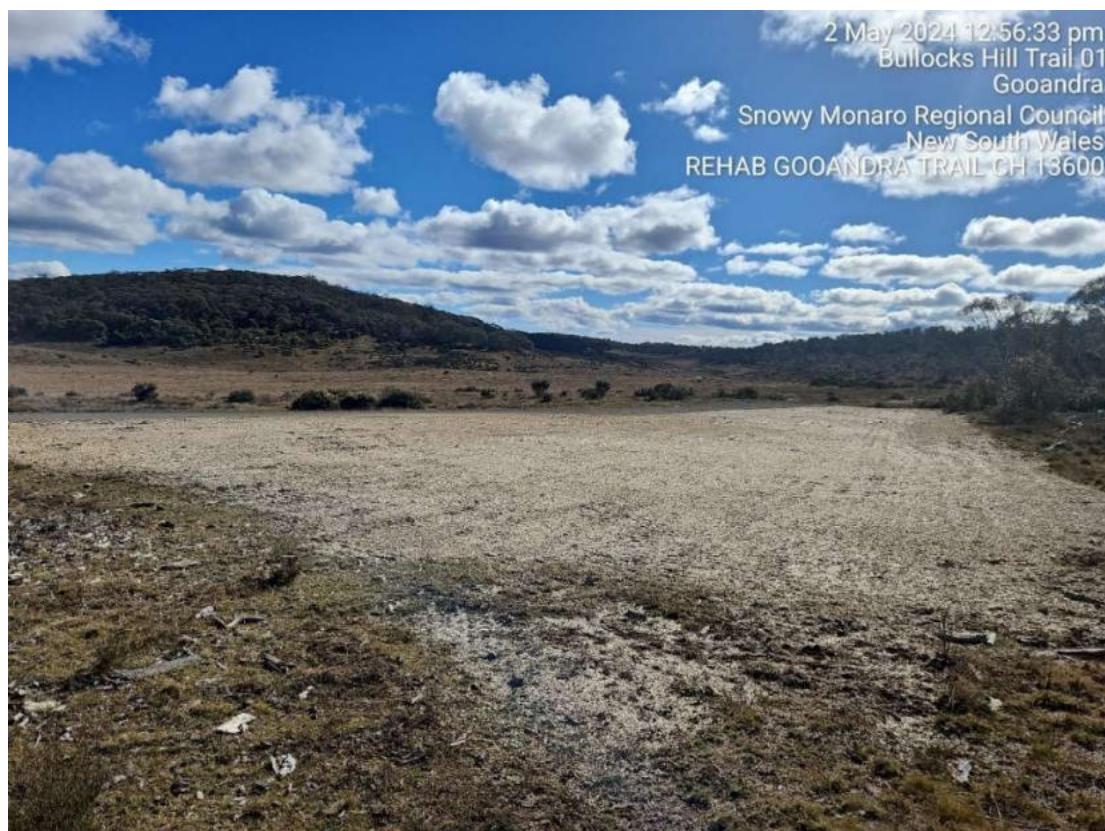
Chainage 13600 — laydown (L12)

Area – 21,227m²

Earthworks status – complete – topsoil applied

Gradient - 12%
