Snowy 2.0 – Plateau – Trunk Services Rehabilitation Plan

Subject: Snowy 2.0 - Main Works – Plateau Rehabilitation Plan

| Title | Snowy 2.0 – Plateau Rehabilitation Plan | |
| Document Number | S2-SHL-ENV-PLN-0005 Rev 4 | |

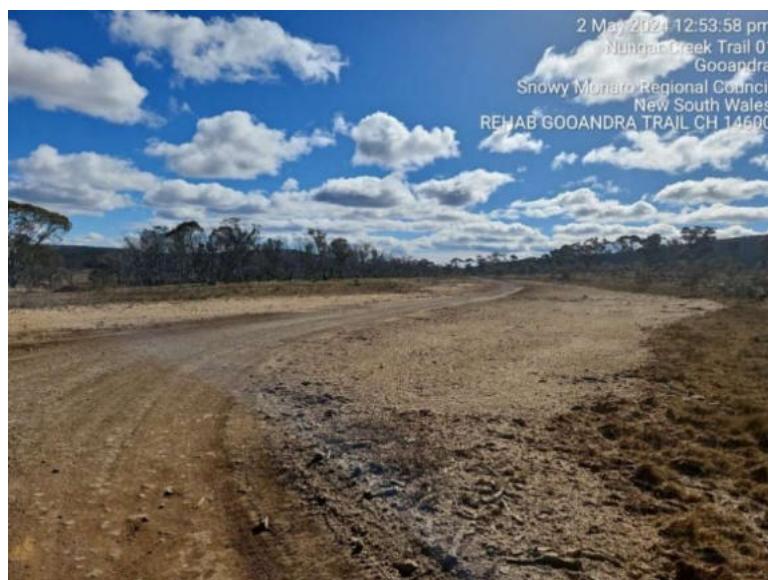
Chainage 14000 — laydown (L13)

Area – 3000 m²

Earthworks status – complete – topsoil applied

Gradient - 3.7%

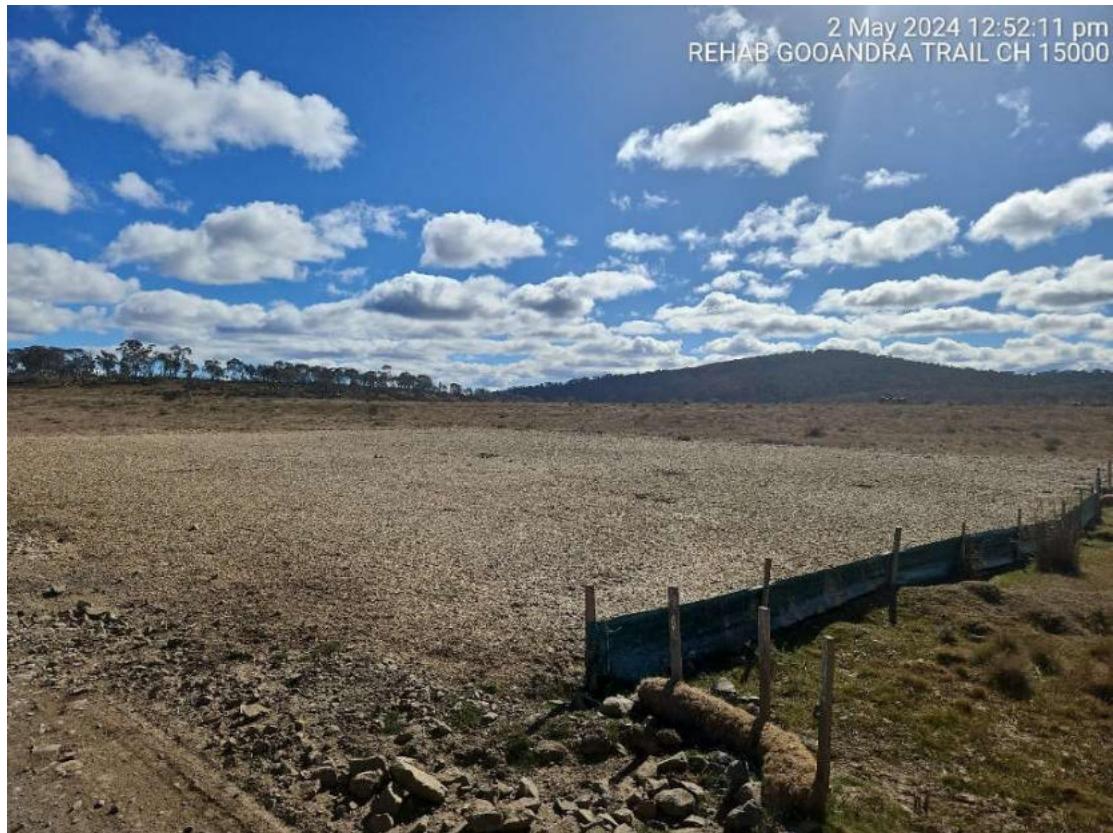
Chainage 14600 - laydown (L14)

Area –768 m²

Earthworks status – complete – topsoil applied

Gradient - 2.1%

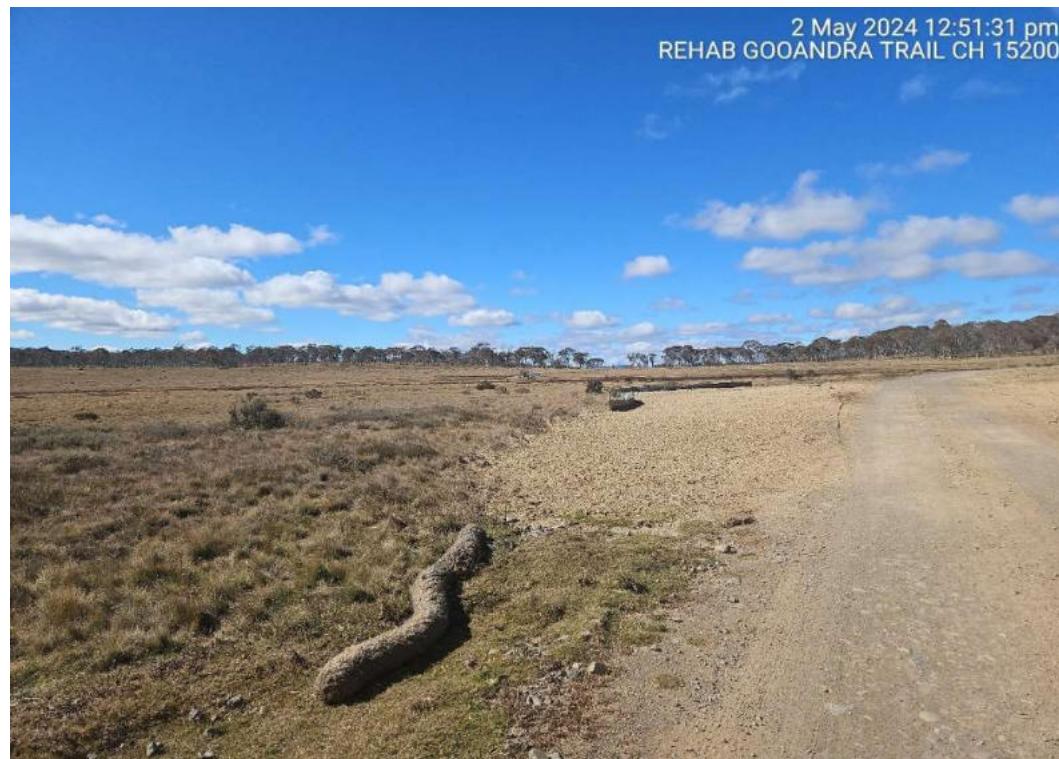
Chainage 14850 — laydown (L15)

Area —858 m²

Earthworks status — complete — topsoil applied

Gradient - 5.1%

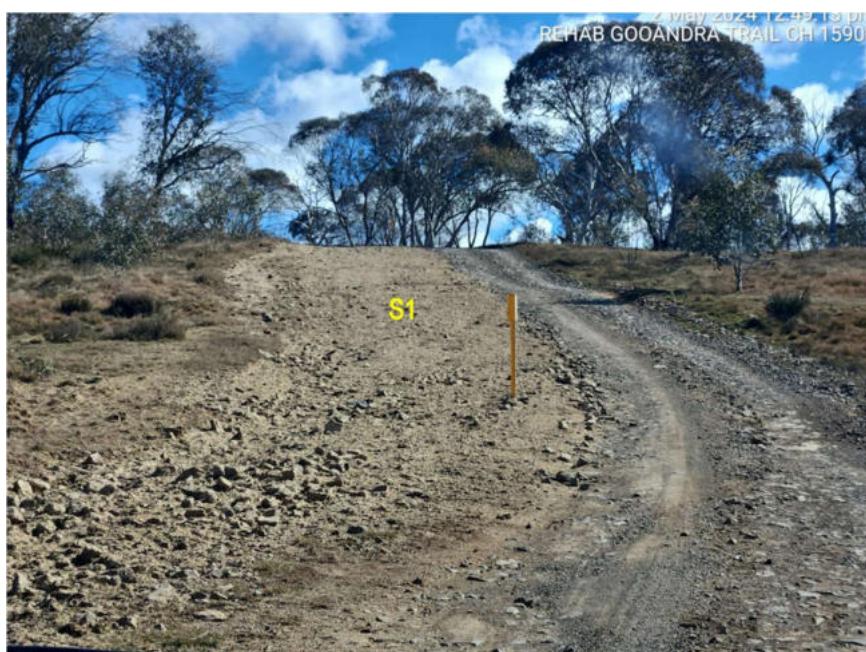
Chainage 16700 - 16850 (S1)

Area – 450 m²

Earthworks status – complete – topsoil applied

Gradient – 10%

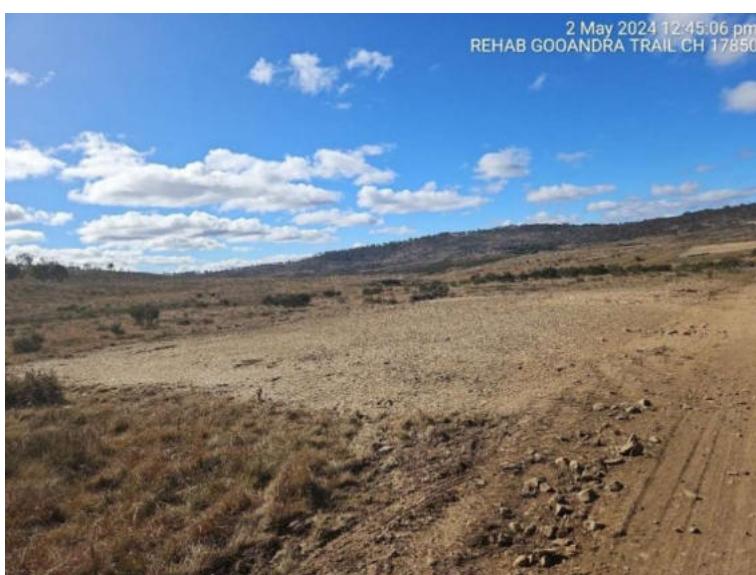
Chainage 17400 - laydown (L16)

Area – 537m²

Earthworks status – complete – topsoil applied

Gradient – 2.5%

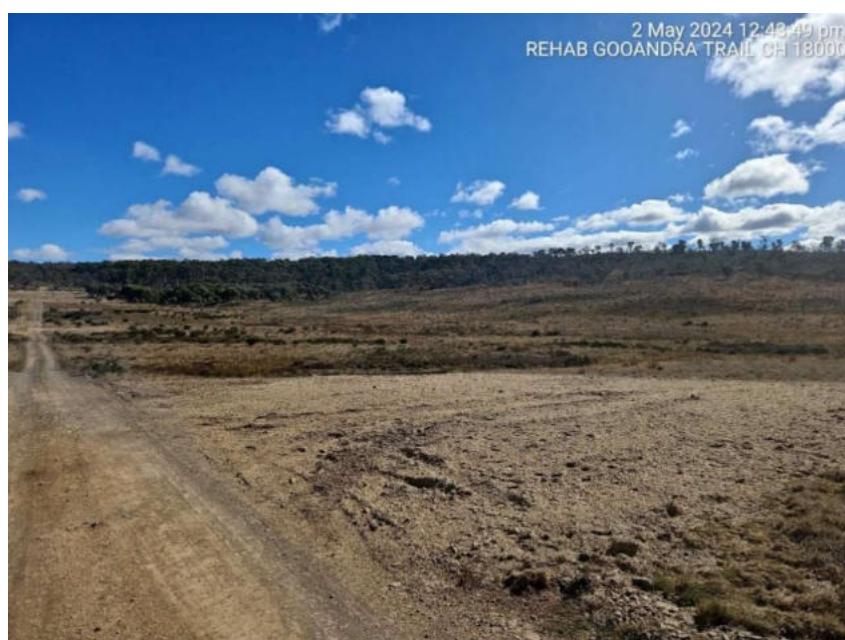
Chainage 17600 - laydown (L17)

Area - 520 m²

Earthworks status - complete

Gradient – 3%

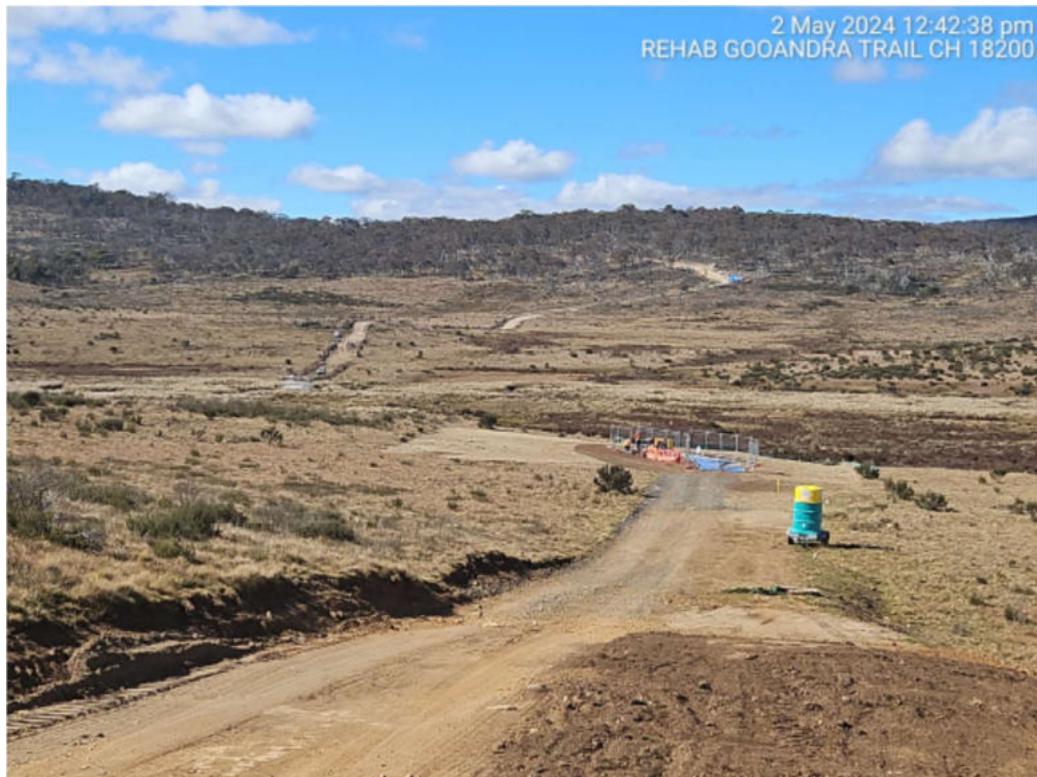
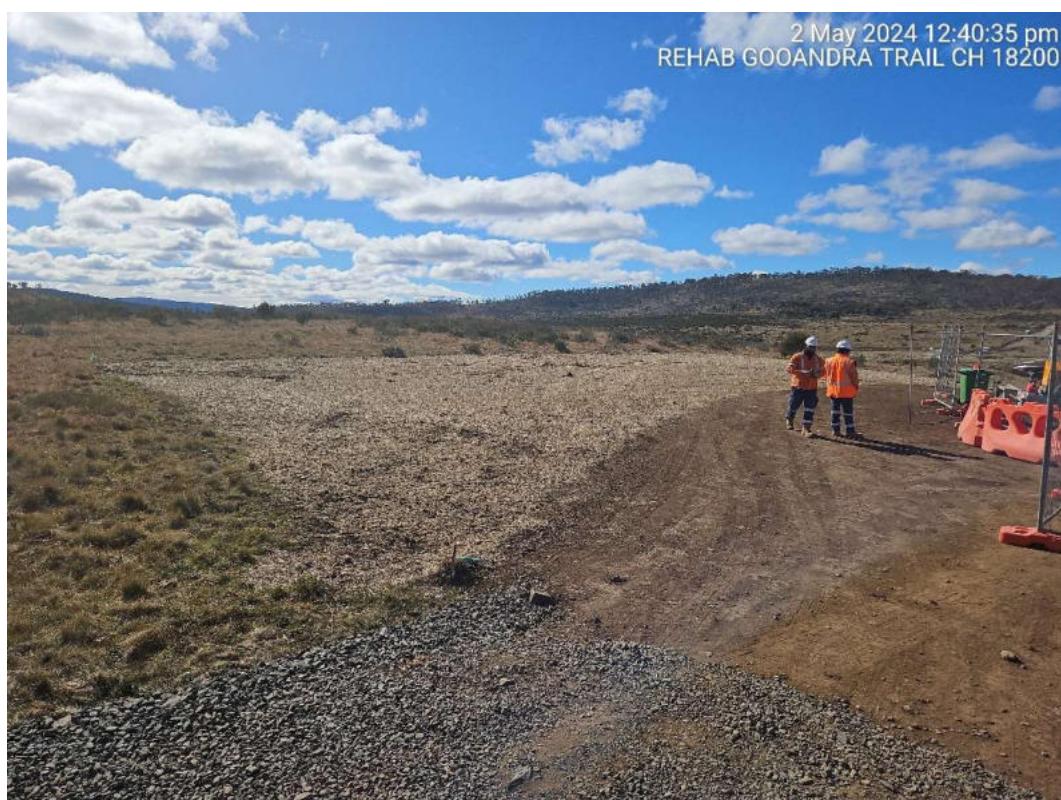
Nungar Creek laydown Chainage 17850 — laydown (L18)

Area – 996 m2

Earthworks Status – partially complete

Gradient – 5%

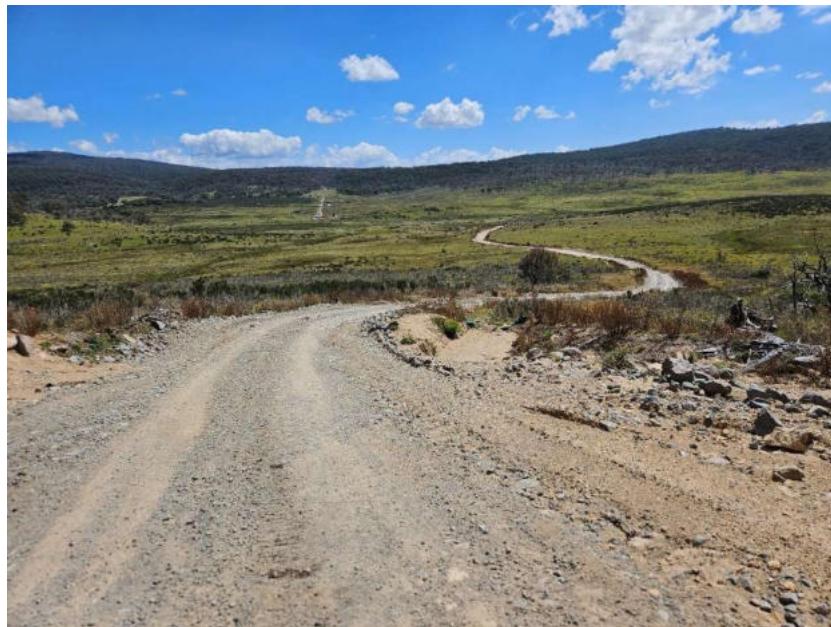
Nungar Creek laydown Chainage 18200 – 18700 — Nungar creek to Tantangara dam fire trail laydown section (TT1) Tantangara section

Area – 4602 m²

Photo taken facing west towards Nungar Creek

Earthworks Status - partially complete – geofabric to be removed

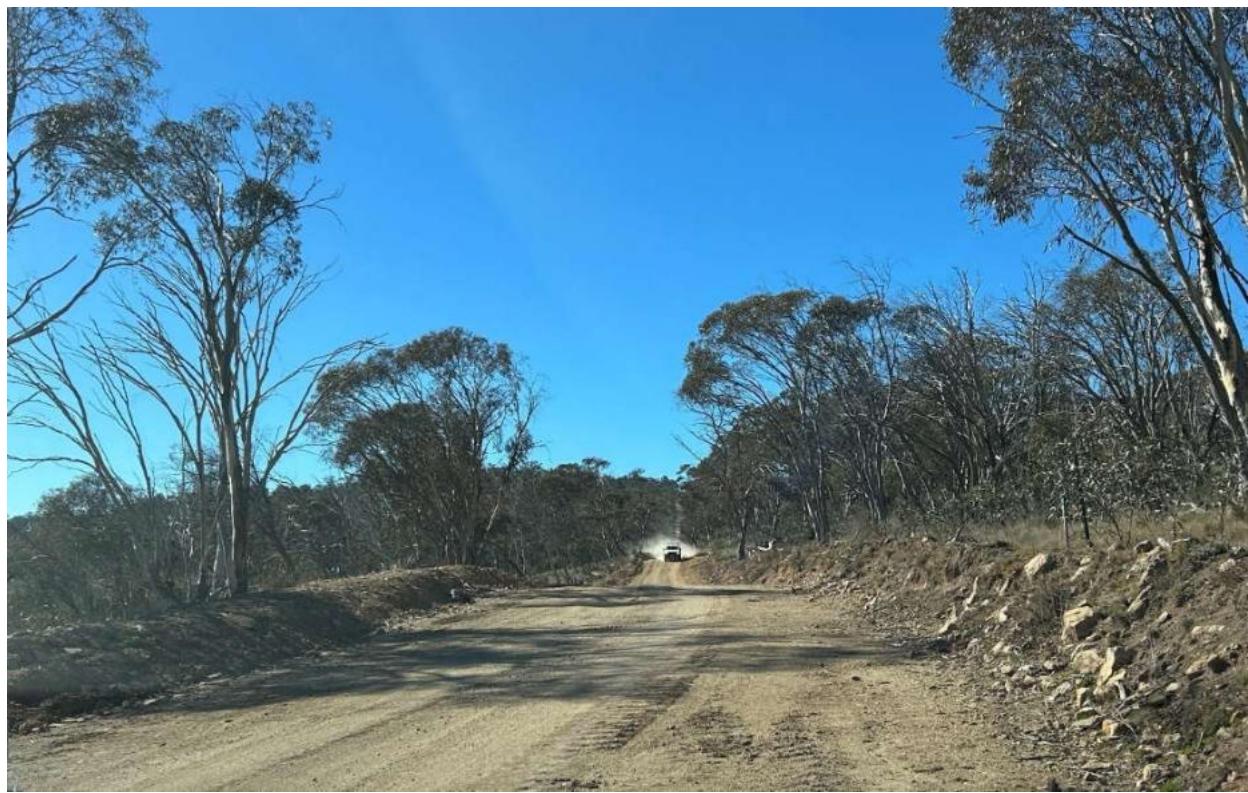
Chainage 18700 – 19700 (Southwestern side of Tantangara Hill down to Tantangara dam fire trail)
4WD access required for ongoing maintenance (TT2)

Area - 1.5 ha

Facing North towards Tantangara Hill

Earthworks status – incomplete - track to be ripped prior to topsoil respread at depth it was stripped, and cover applied (surface roughness maintained), roll overs and scour protection to be retained to break up slope to result in a low level 4WD track (wheel tracks with vegetative cover) to allow for inspection pit access, rehabilitation activities and ongoing weed control

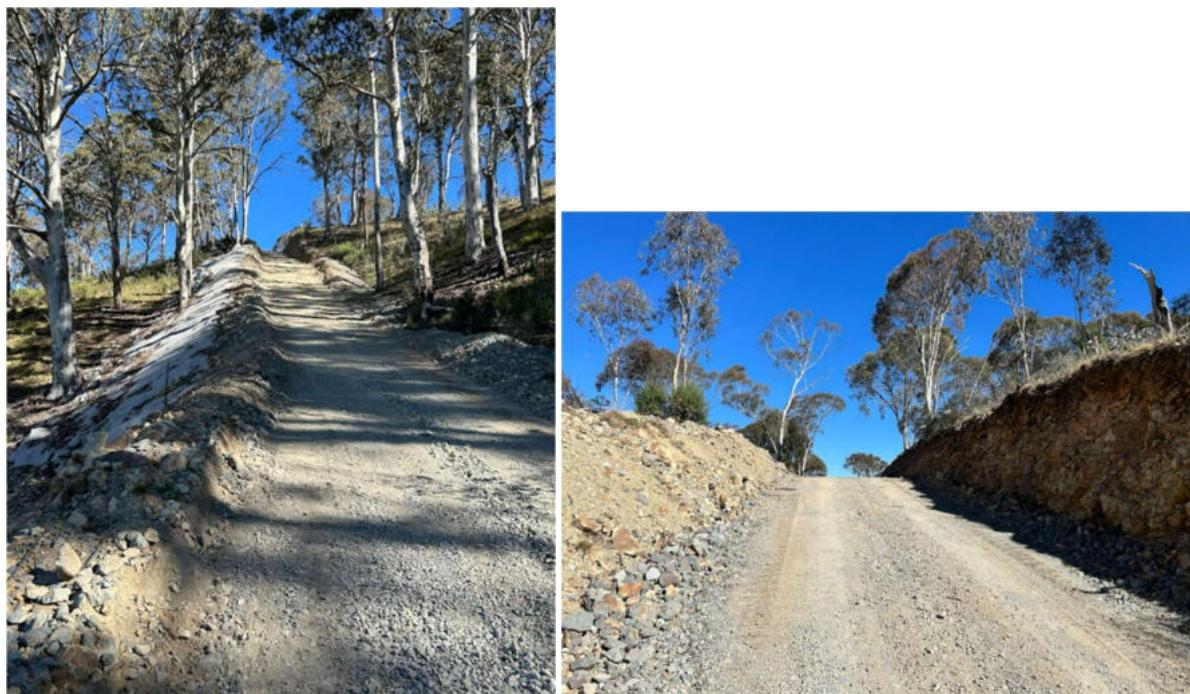
Chainage 19700 – 20000 (Tantangara Hill – Steep section - top of hill to first inspection pit at base of hill) closed to traffic (TT3)

Area 800m2

Earthworks Status – incomplete

Key principals of rehabilitation of the Tantangara Hill slope –

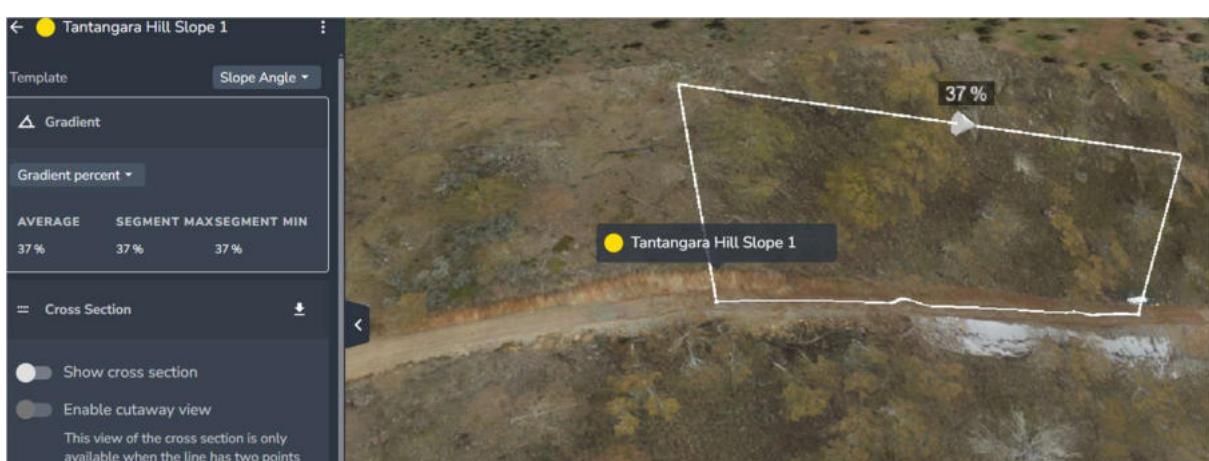
Gradient – 37%

Earthworks

- Site won material (subsoil & bunds) to be used to reduced depth of cutting
- Earthworks design to developed in consultation with NPWS to address steep batters and drainage
- Elements such as creation of slope breaks no more 5 metres apart to control surface water flow / undulation using subsoil / topsoil to be incorporated in design
- Application of topsoil ~100 mm (surface roughness maintained)
- ESCP to be updated for rehabilitation work

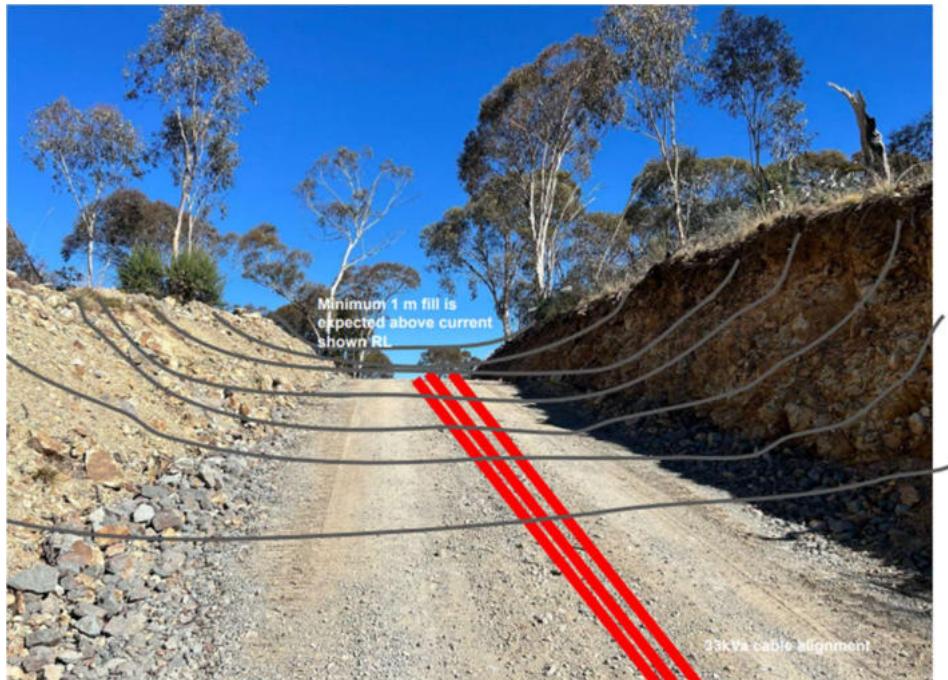
Reduce the existing batter profile grade as much as possible. This will typically give a "U" shaped finish as roughly illustrated.

We will need to do this for the entire corridor of the Tantangara hill (top to bottom)

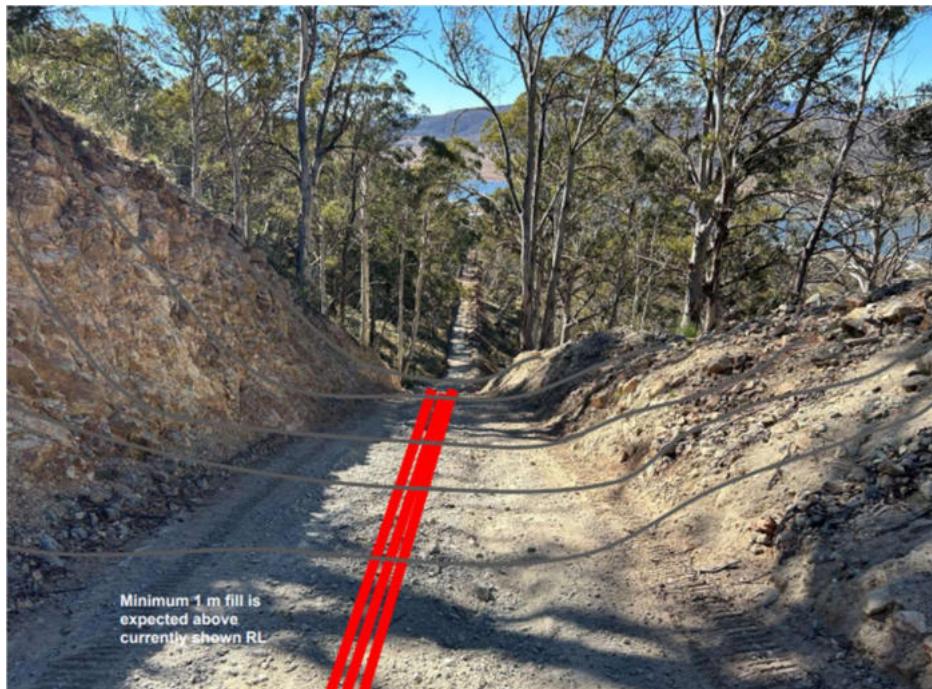
Reduce the existing batter profile grade as much as possible. This will typically give a "U" shaped finish as roughly illustrated.

We will need to do this for the entire corridor of the Tantangara hill (top to bottom)

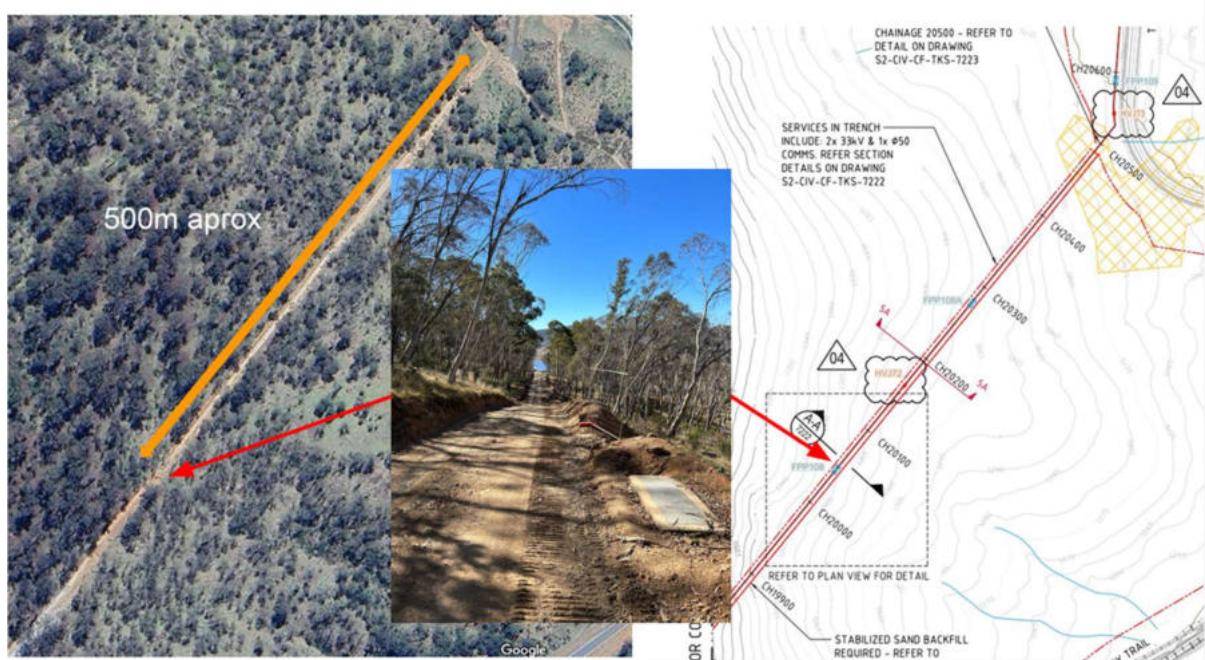
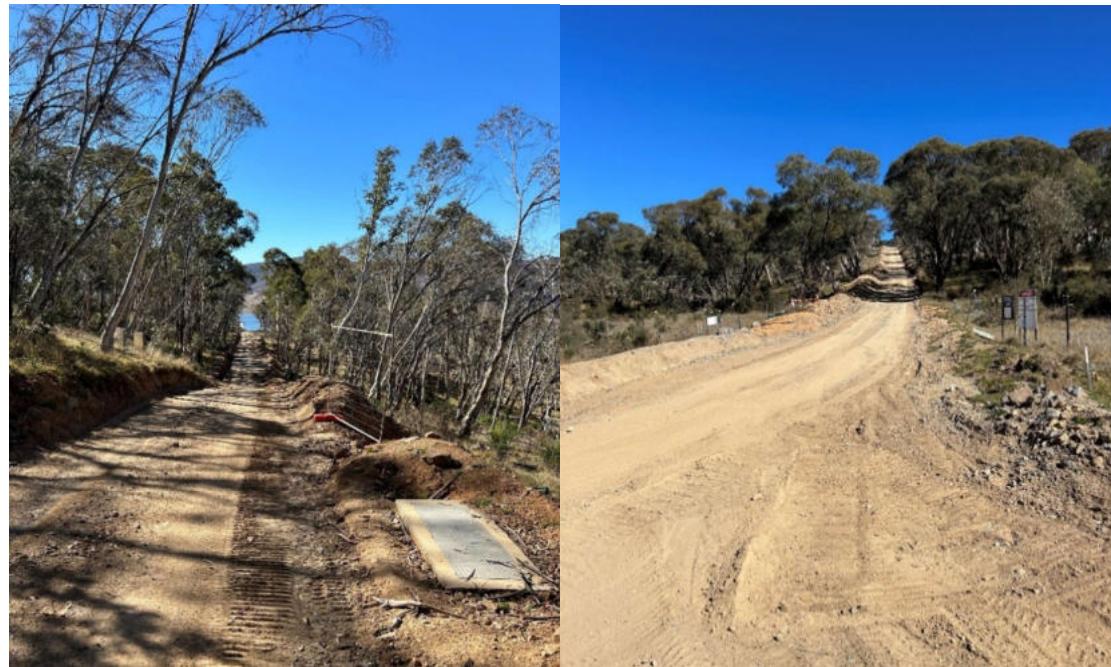
Chainage 20000 - 20500(Tantangara Hill) (TT4) 4WD access required for maintenance

Area- 5000 m2

Upper section

Lower section
