snowy2.0

EPL 21266 – BI-ANNUAL MONITORING REPORT JUNE 2022 – NOVEMBER 2022

S2-FGJV-ENV-REP-0070

This document provides a summary of surface- and ground-water quality and associated information for monitoring conducted as part the Snowy 2.0 project, across monitoring locations pertaining to Environmental Protection Licence (EPL) 21266.

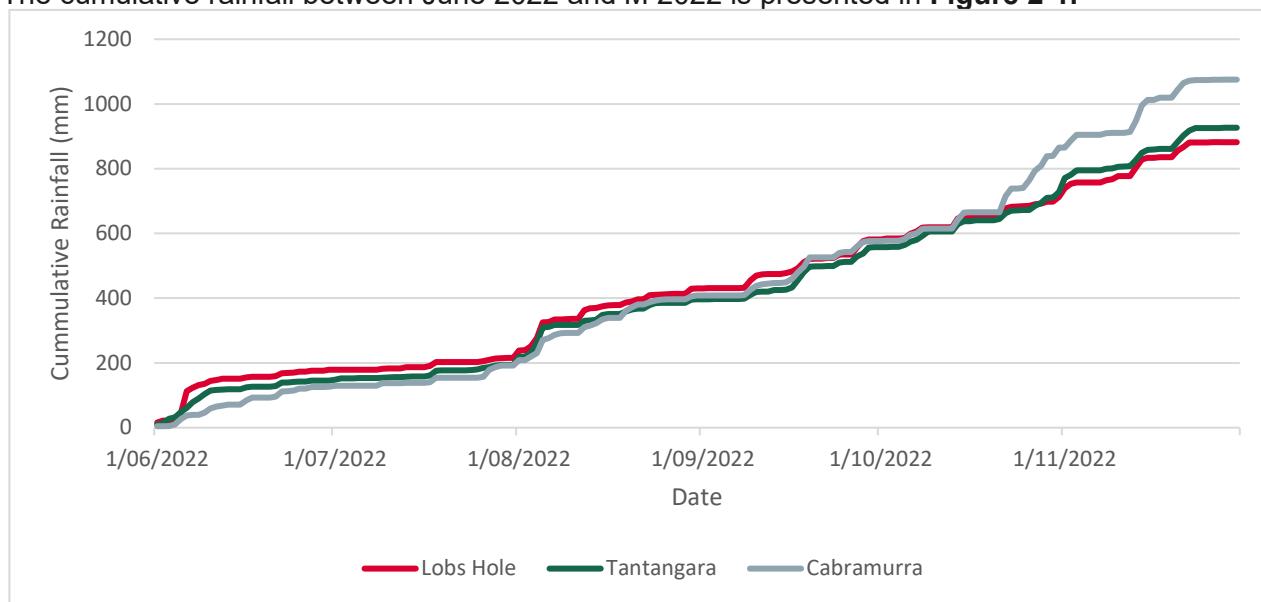
Figure 2-1: Cumulative Rainfall across Lobs Hole, Tantangara and Cabramurra.

The previous Biannual Monitoring Report (S2-FGJV-ENV-REP-0052) noted above-average rainfall. The conditions for this reporting period followed a similar pattern with La Niña conditions.

The cumulative rainfall between June 2022 and M 2022 is presented in **Figure 2-1**.

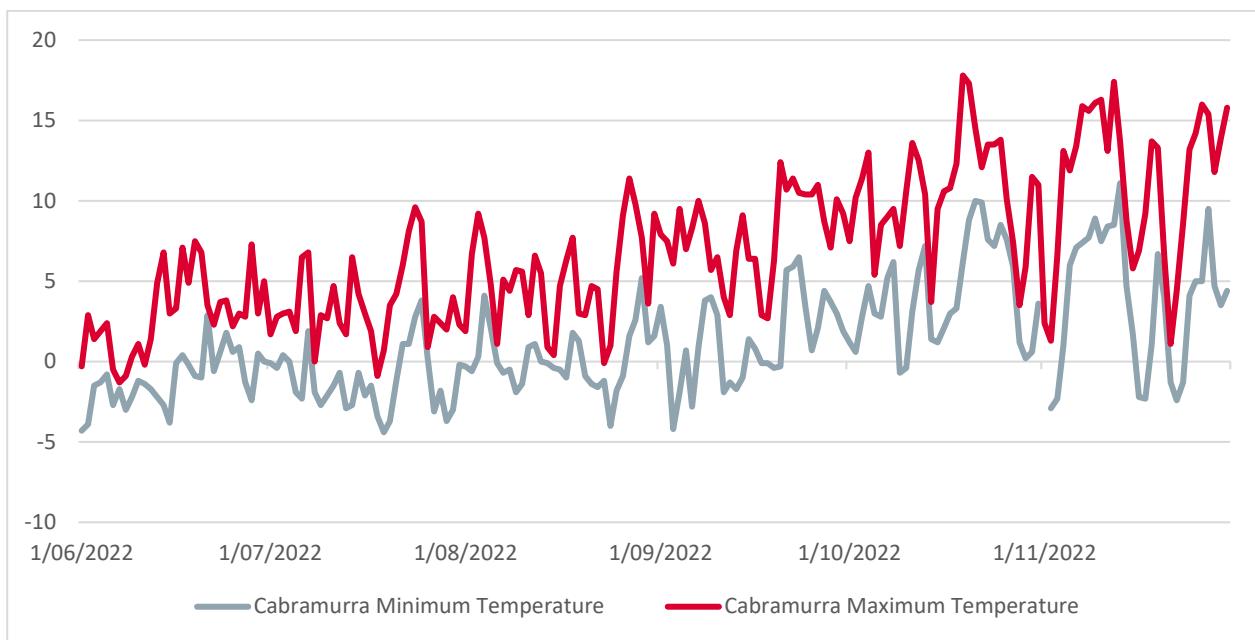
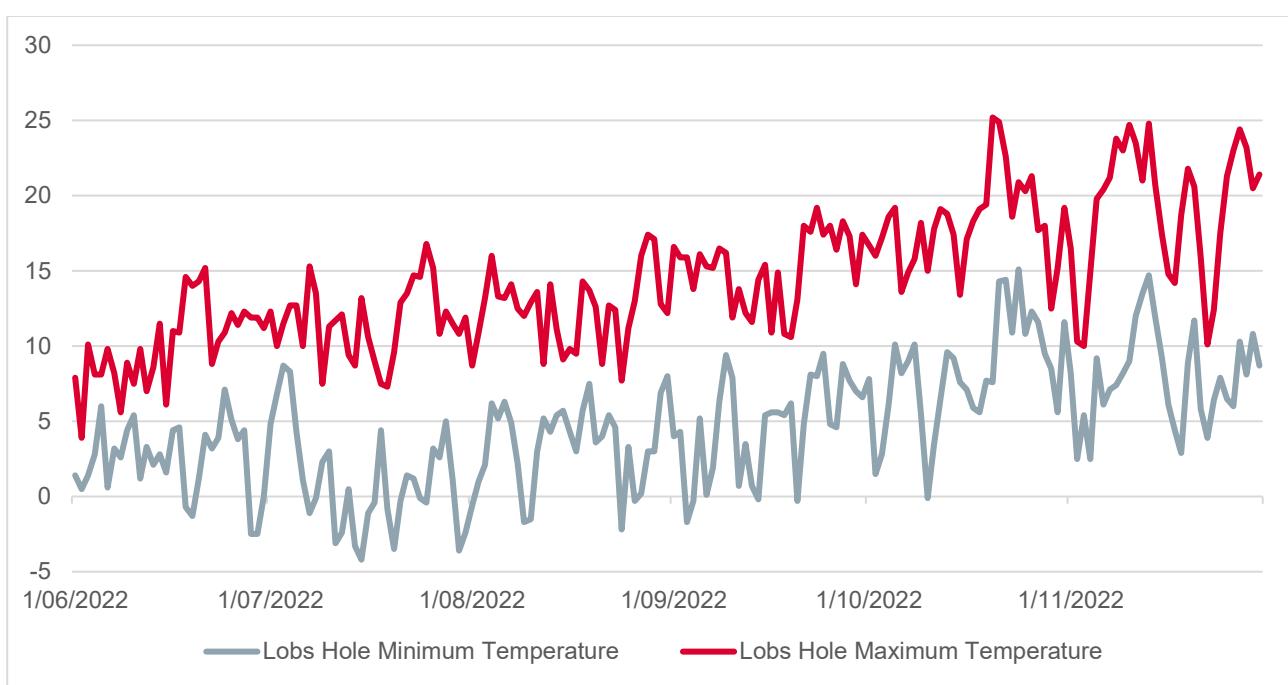
Figure 2-3: Lobs Hole - Minimum and Maximum Temperatures

Figure 2-1 to Figure 2-4 show temperature maximum and minimums across the project at Lobs Hole and Cabramurra weather stations.
