Abel Ecology

Document No: 2469-FAUNA-LET-02-ISS-1

RE: Review of Lobs Hole Road fauna underpass remote camera monitoring for the period of 11 August 2022 to 12 December 2022.

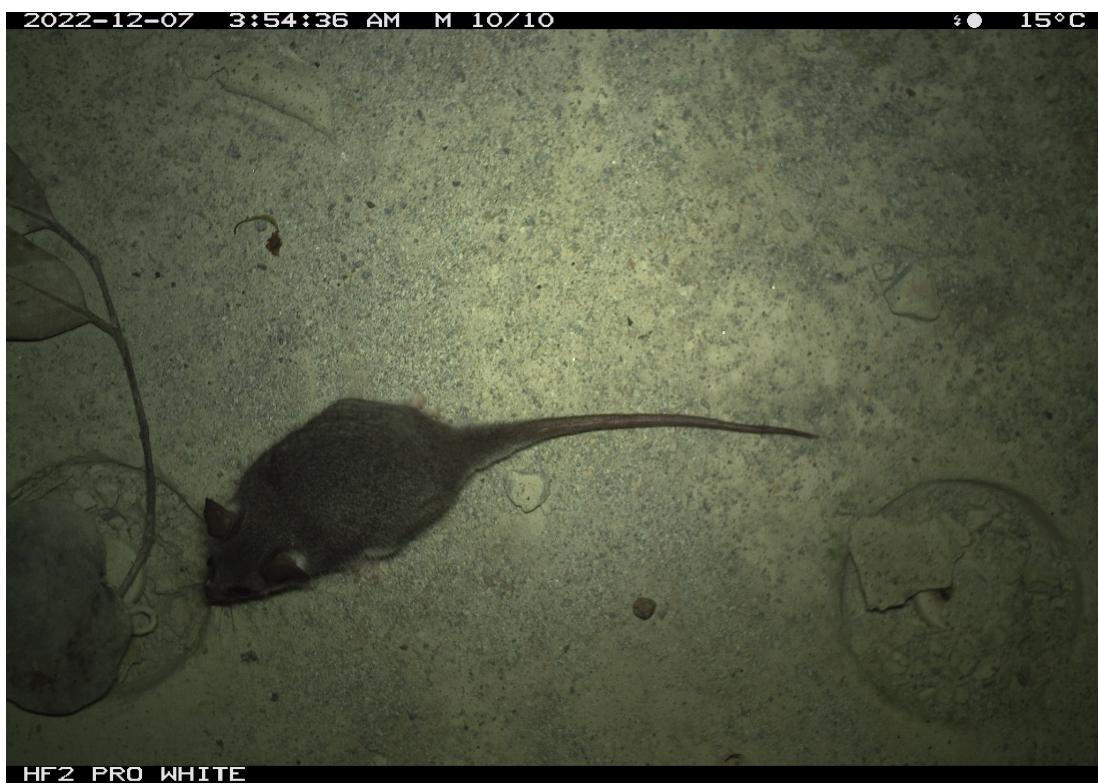
Figure 1. Remote camera image of Eastern-Pygmy Possum *Cercartetus nanus* recorded using a fauna underpass along Lobs Hole Ravine Road, Cabramurra NSW during December 2022.

As would be expected, the level of fauna activity within the fauna underpasses increased as the average air temperature at the site during the day increased, being the natural transition from winter into spring. AE is delighted to report Eastern Pygmy-Possum was detected once at Underpass 3 West (Figure 1). The most frequently detected species using the fauna underpasses during all reporting periods was Bush Rat (Figure 3 and Figure 4). AE is also delighted to report no feral predators (red fox Figure 9 and cats Figure 10) were detected 'within' the fauna underpass entrances during this reporting period, and this coincided with a significant drop in the detection of House Mouse (Figure 7). It is unclear if introduced predators were able to move freely through the fauna underpasses and the presence of a grill (shadow) was detected in photos from Underpass 4 East on 20 October 2022. AE has not been informed when grills on the outside of fauna underpasses were installed. The presence of foxes and cats appears to be linked to the presence of House Mouse, as no foxes or cats were recorded in the fauna underpasses after 21 June 2022 as previously reported. The design of the fauna underpasses was to have obstructive habitat within the underpasses to facilitate threatened fauna movement through the underpasses and to exclude feral predators. This design feature is currently being real-world tested by onsite feral predators. Previously AE recommended that a site inspection is made to determine if improvements can be made to deny predator entry into the fauna underpasses past the camera positions. It would appear the addition of a grill on the outside of the fauna underpass entrances has helped to deter feral predators, as the detection frequency of potential prey species has not decreased during the reporting periods presented here.

The detection of six native species (Eastern Pygmy-Possum, Brown Antechinus [Figure 2], Bush Rat, Highlands Copperhead, *Lampropholis delicata*, and *L. guichenoti*) using the fauna underpasses is a positive outcome, and this is an event that SHL should strive to maintain and improve. The detection of Eastern Pygmy-Possum using the fauna underpass (Underpass 3 West, Figure 1) is a significant accomplishment for the project and should be acknowledged.

The six fauna underpasses are functioning as a corridor for small mammal movement. The target species - Smoky Mouse and Broad-toothed Rat have not yet been recorded utilising the fauna underpasses. Eastern-Pygmy Possum *Cercartetus nanus* was recorded during this reporting period. The detection of Eastern Pygmy-Possum using the fauna underpass (Underpass 3 West, Figure 1) is a significant accomplishment for the project and should be acknowledged.

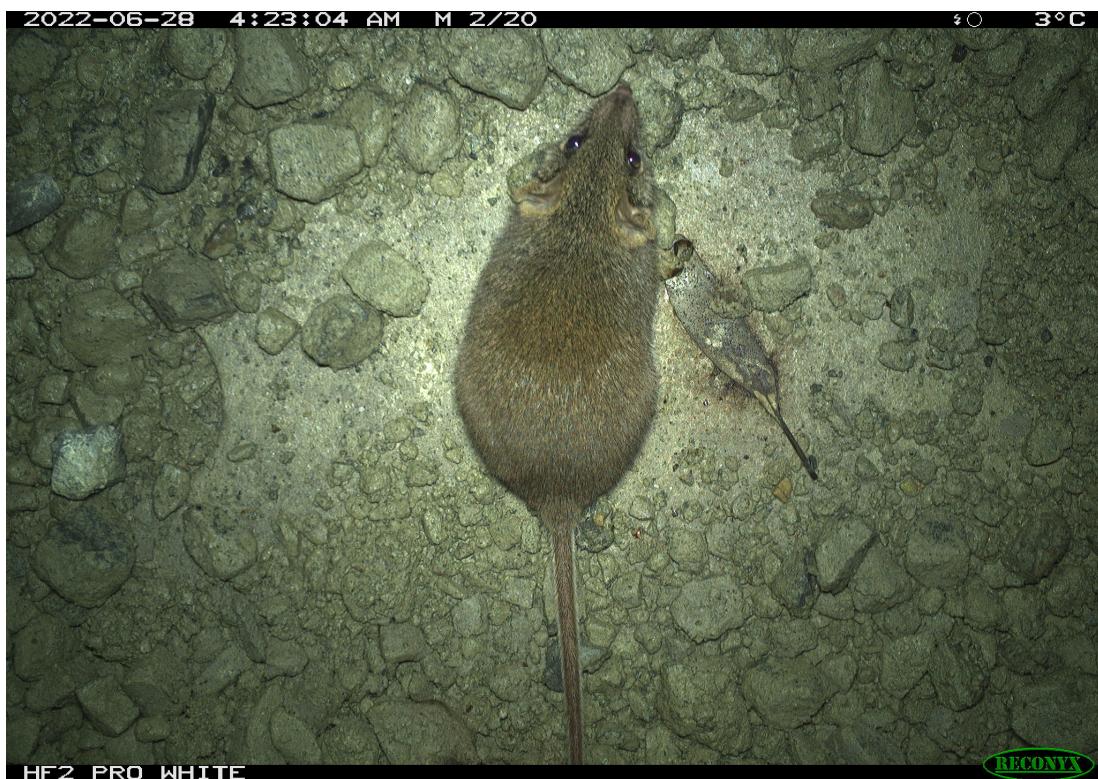
Figure 2. Remote camera image of Brown Antechinus *Antechinus stuartii* recorded using a fauna underpass along Lobs Hole Ravine Road, Cabramurra NSW during June 2022.

The detection of six native species (Eastern Pygmy-Possum, Brown Antechinus [Figure 2], Bush Rat, Highlands Copperhead, *Lampropholis delicata*, and *L. guichenoti*) using the fauna underpasses is a positive outcome, and this is an event that SHL should strive to maintain and improve.

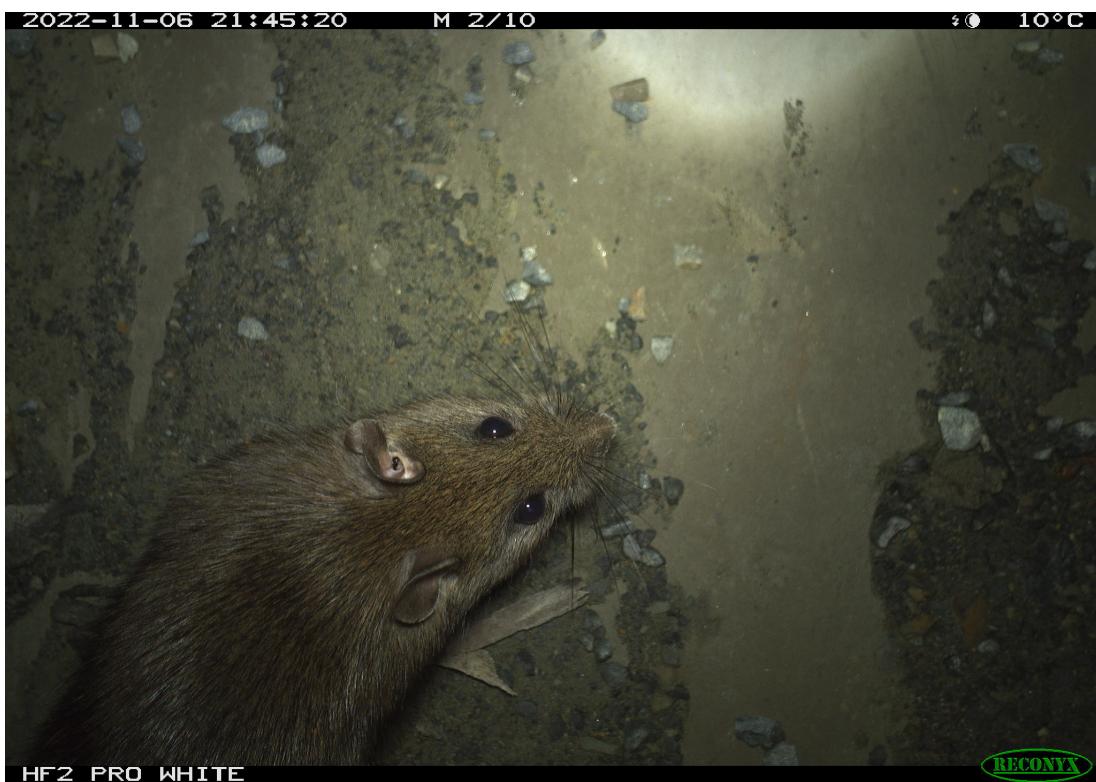
Figure 3. A regular user of the fauna underpasses along Lobs Hole Ravine Road, Cabramurra NSW is the Bush Rat *Rattus fuscipes*.

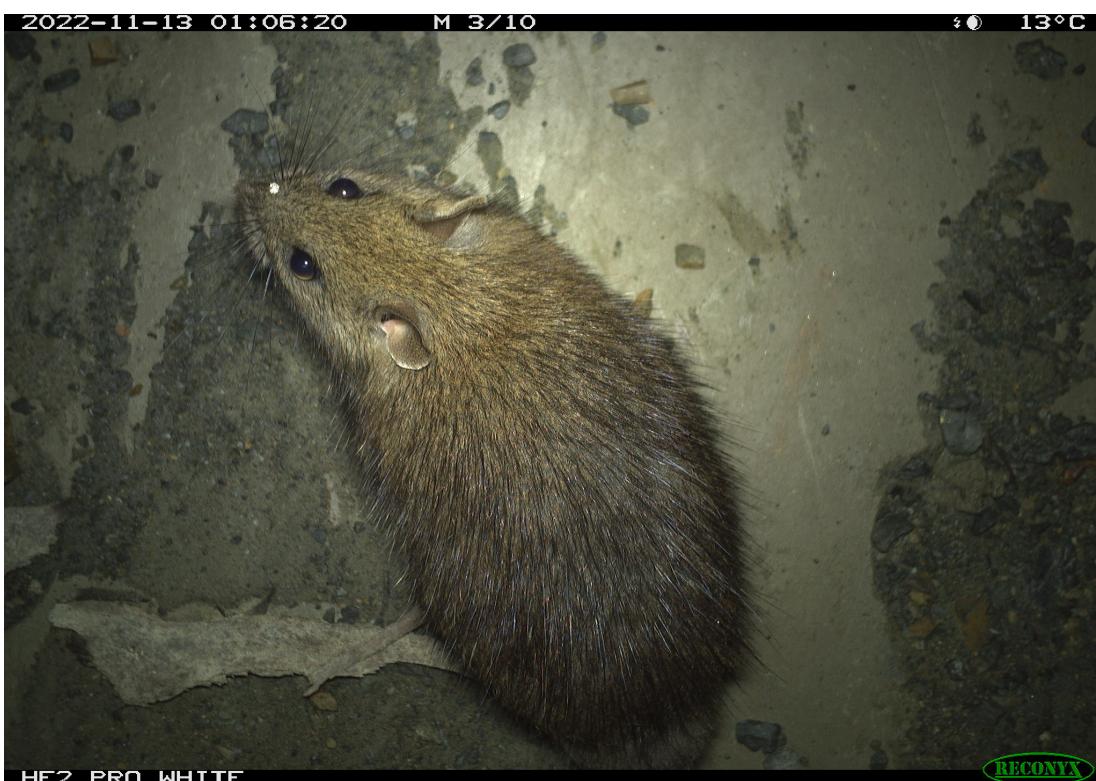
Figure 4. A regular user of the fauna underpasses along Lobs Hole Ravine Road, Cabramurra NSW is the Bush Rat *Rattus fuscipes*.

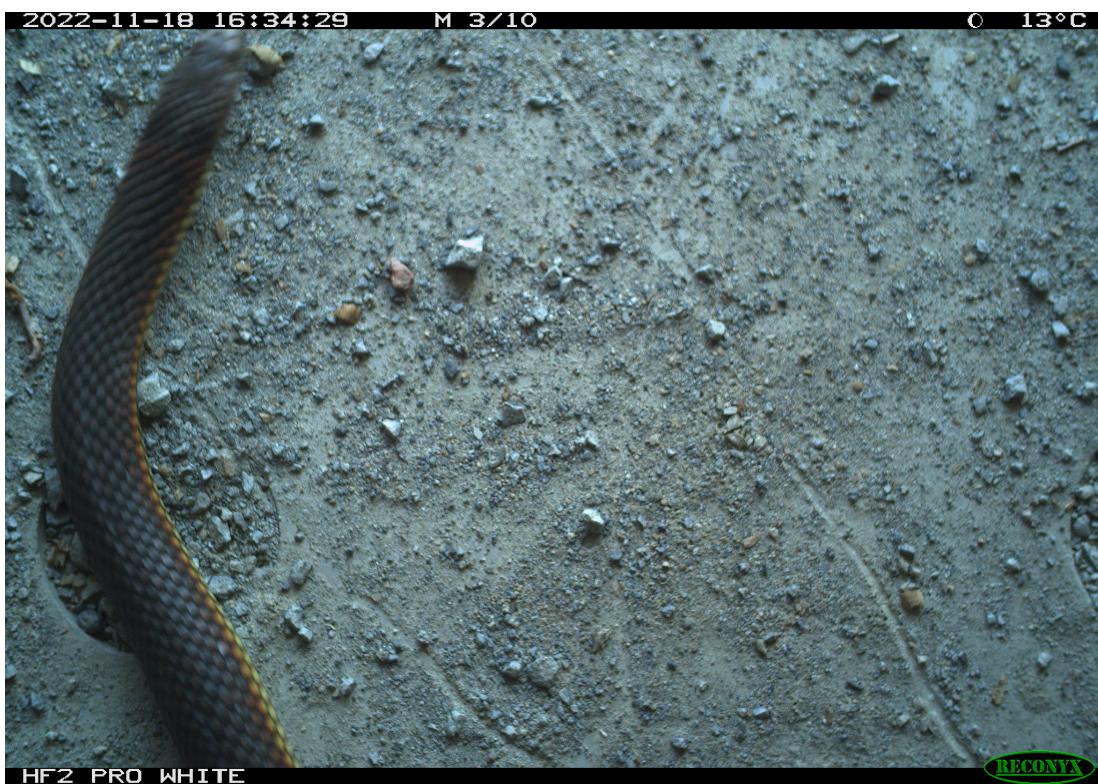
Figure 5. Remote camera image of Highlands Copperhead *Austrelaps ramsayi* recorded using a fauna underpass along Lobs Hole Ravine Road, Cabramurra NSW during November 2022.

Incidental records of Grey Fantail and White-browed Scrubwren within the fauna underpass entrances were interesting and unexpected. Small birds are not expected to forage or to go beyond the entrance to pass through the underpass. *Lampropholis* sp. (skinks) and Cooperheads (snakes, Figure 5), were also interesting observations; the skinks and the snakes using the fauna underpass as habitat. Both reptile species would use the fauna underpass as shelter and the Cooperheads would also use the underpass for hunting the skinks. Snakes preying on mice could not be ruled out.

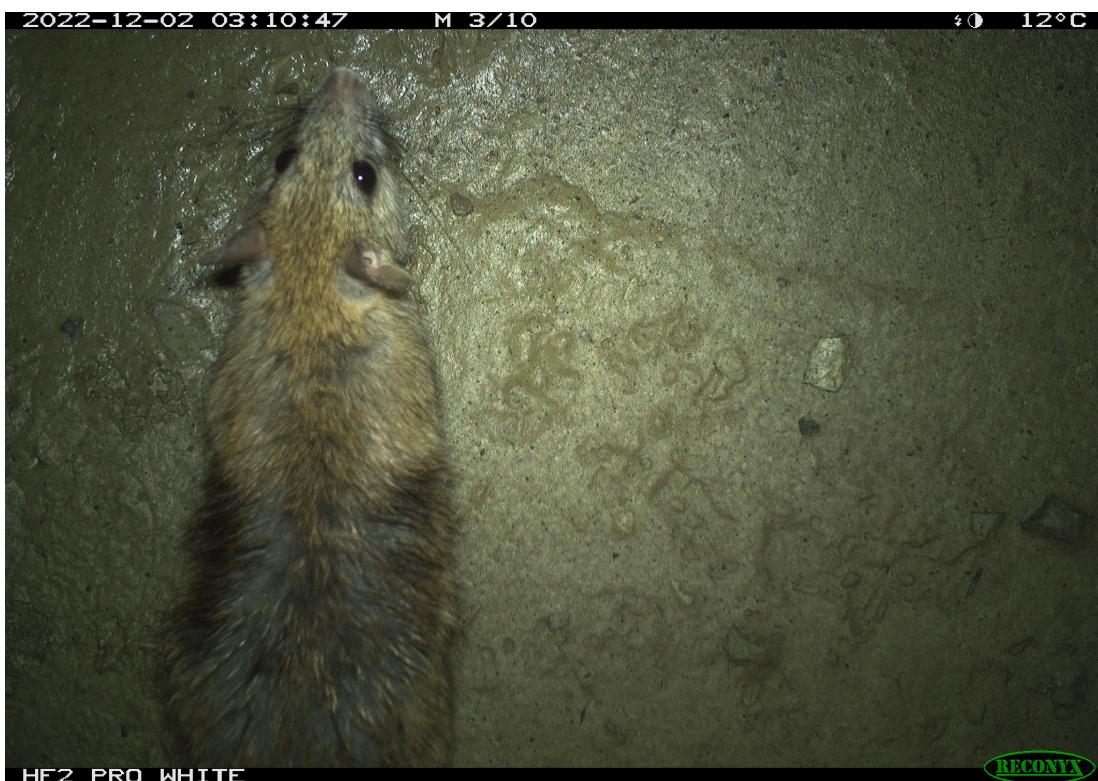
Figure 6. Remote camera image of Black Rat *Rattus rattus* recorded using a fauna underpass along Lobs Hole Ravine Road, Cabramurra NSW during December 2022.

Rabbit/s (Figure 8) were recorded from one fauna underpass (#6) during the 11 August – 22 September 2022 monitoring period. The fauna underpass would offer temporary shelter to rabbits. A new introduced species was detected being Black Rat *Rattus rattus* (Figure 6) at Underpass 5 during the 4 November – 12 December 2022 reporting period.

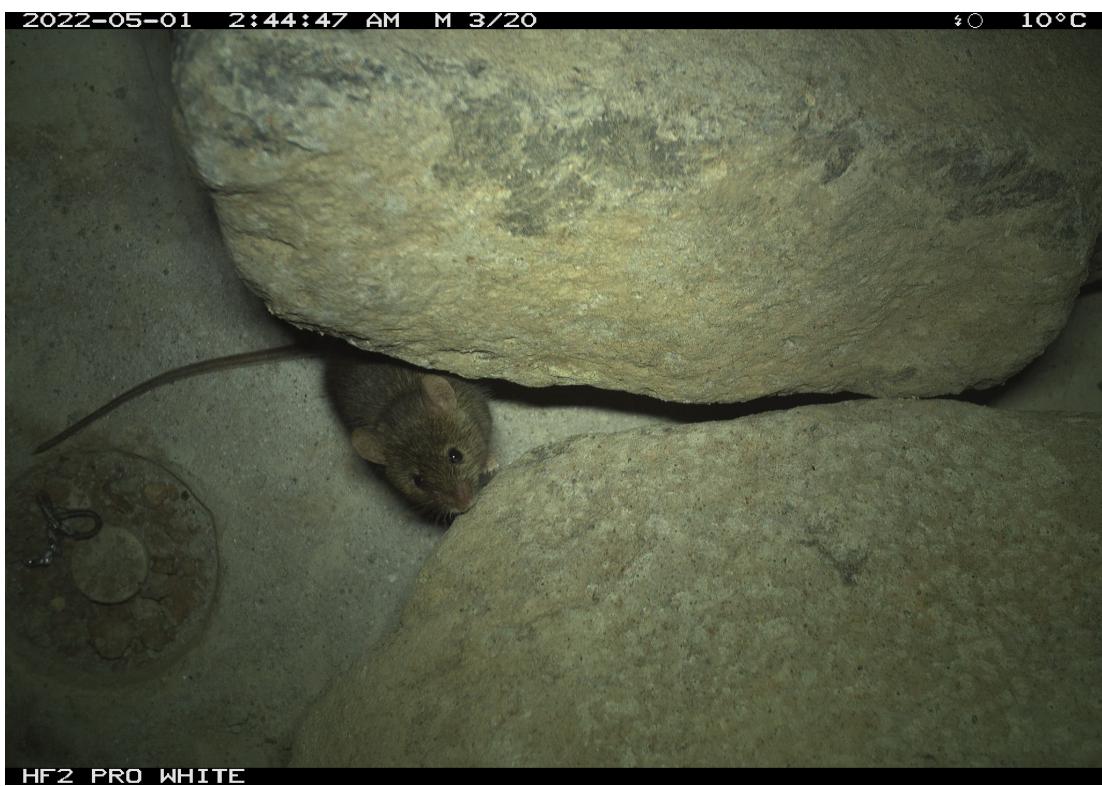
Figure 7. Remote camera image of House Mouse *Mus musculus* recorded using a fauna underpass along Lobs Hole Ravine Road, Cabramurra NSW during May 2022.

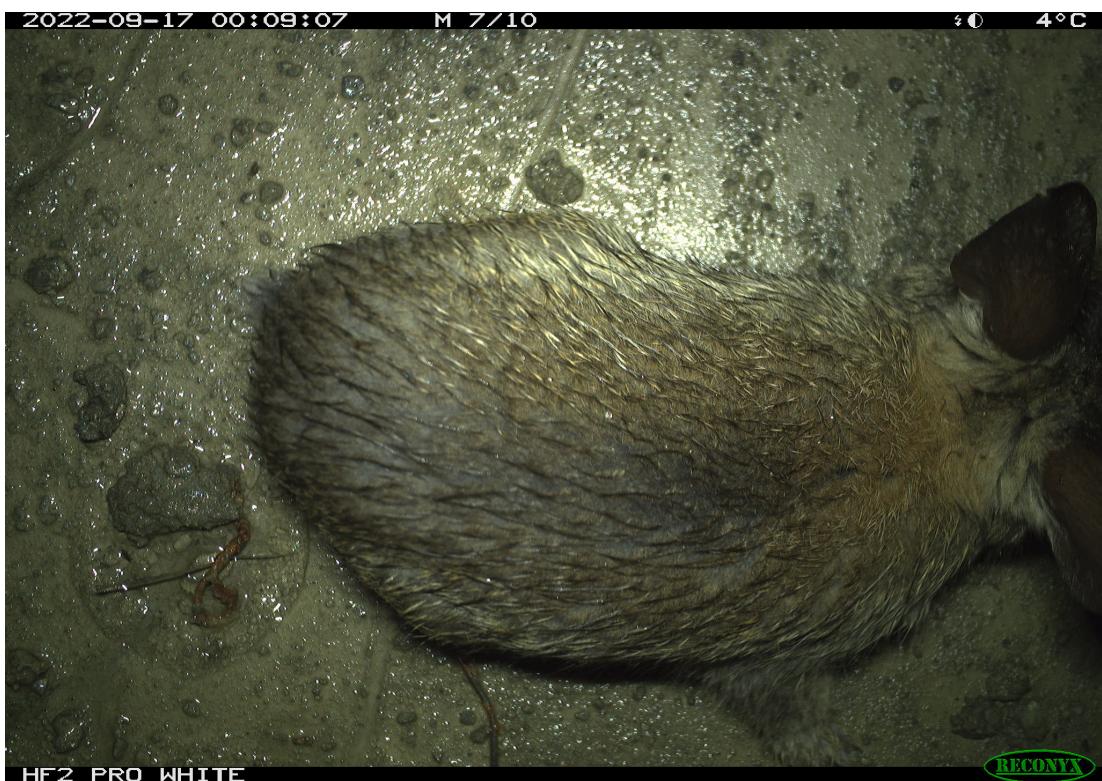
Figure 8. Remote camera image of Rabbit *Oryctolagus cuniculus* recorded using a fauna underpass along Lobs Hole Ravine Road, Cabramurra NSW during September 2022.

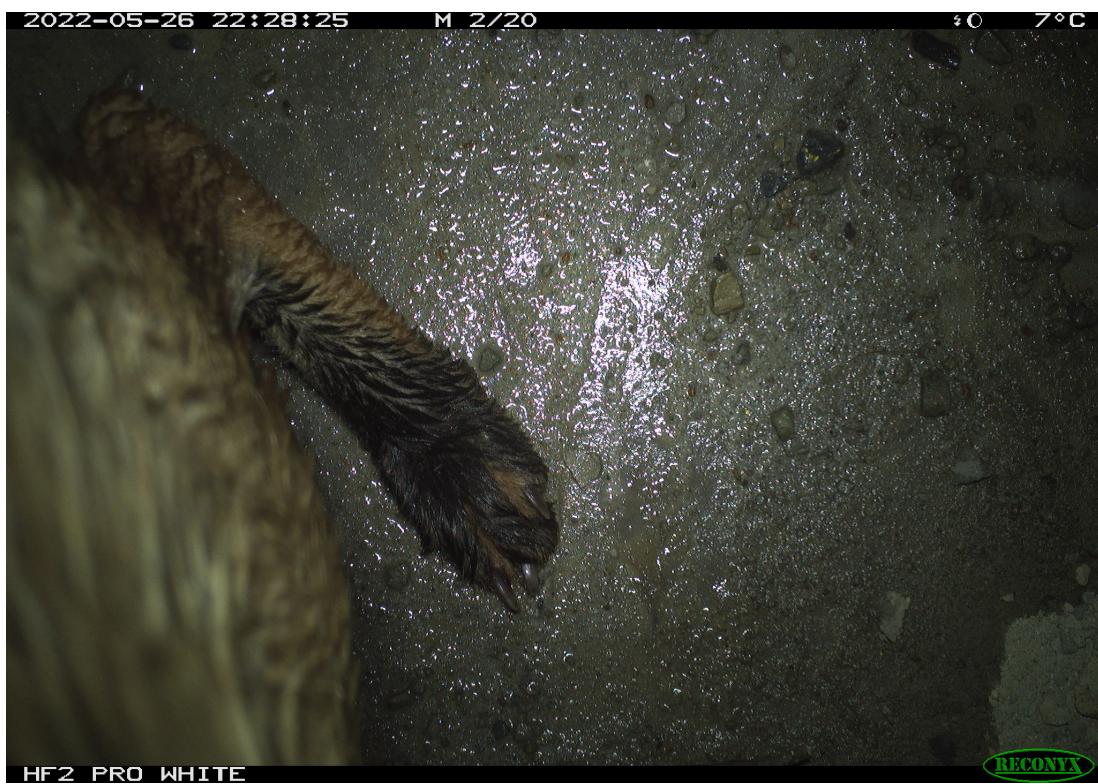
Figure 9. Remote camera image of Red Fox *Vulpes vulpes* recorded using a fauna underpass along Lobs Hole Ravine Road, Cabramurra NSW during May 2022.

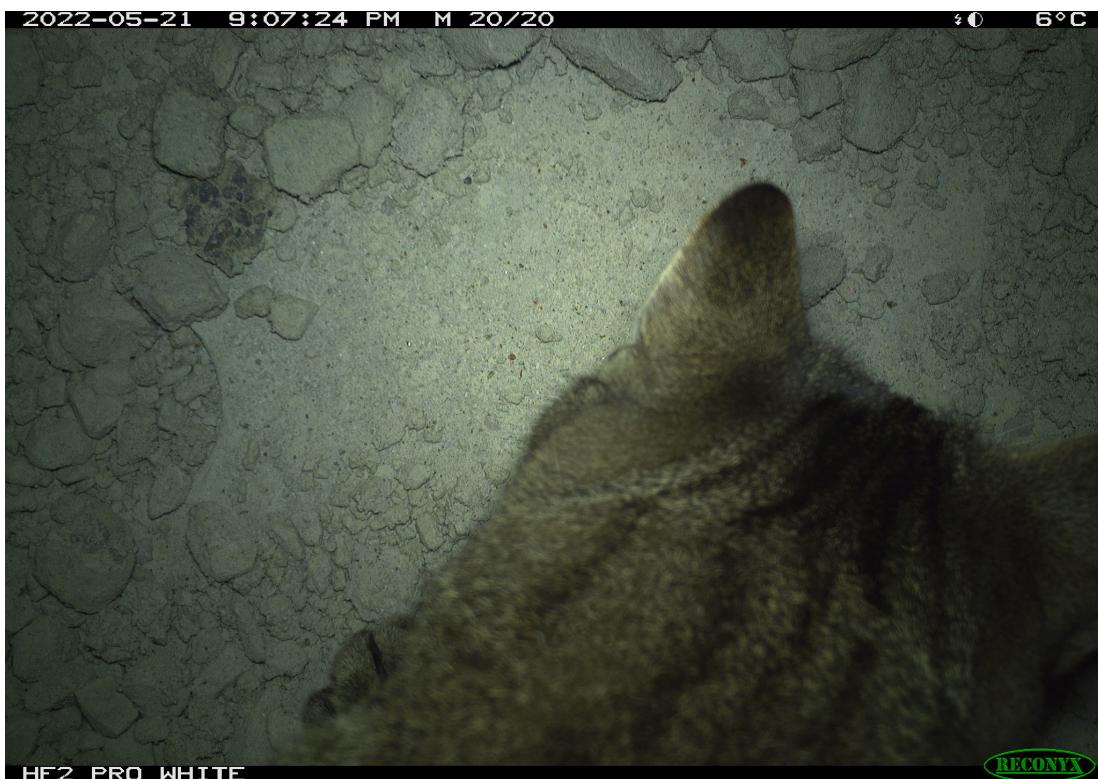
Figure 10. Remote camera image of Feral Cat *Felis catus* recorded using a fauna underpass along Lobs Hole Ravine Road, Cabramurra NSW during May 2022.
