Subject: Tintangara Fish Weir Rehabilitation Plan

Snowy 2.0 – Tantangara Fish Weir Site Specific Rehabilitation Plan

Title	Tantangara Fish Weir Rehabilitation Plan	
Document Number	S2-SHL-ENV-PLN-0013 Rev 3	
	Name	Position
Originator	Ben Croome	Senior Environment Advisor
Approval	Peter Cowper	Environmental and Planning Manager

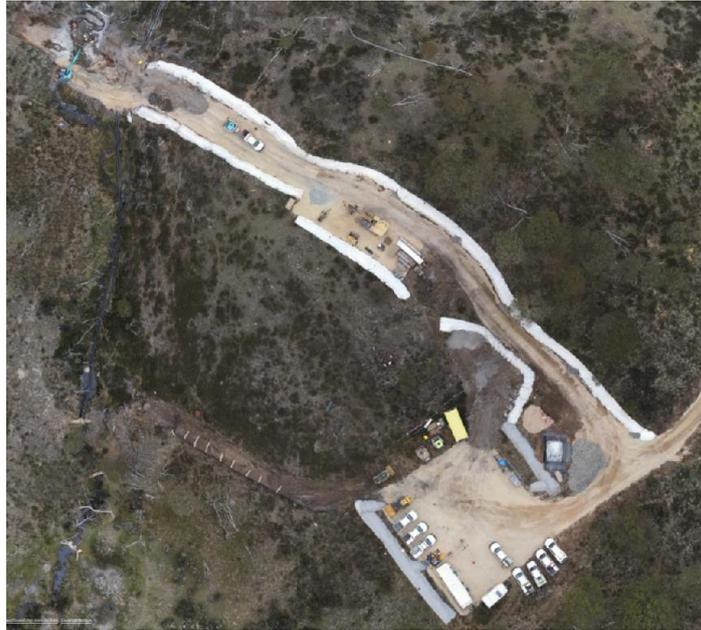
Figure 2-3 Fish Weir and Laydown (March 2025)

To support construction, a laydown area with a site office has been established in close vicinity of the Tantangara Creek fish weir work area (Figure 2-3). The Tantangara Creek fish weir laydown and work area is approximately 0.8ha with approximately 0.5ha of temporary access track and passing bays. All the disturbed areas are to be revegetated. Appendix B provides further detail of individual sites to be rehabilitated inclusive of the 8 passing bays, weir site and associated laydown and section of track to be removed between the SMH and Eucumbene River. There are three (3) main areas to be rehabilitated as part of the fish weir works:

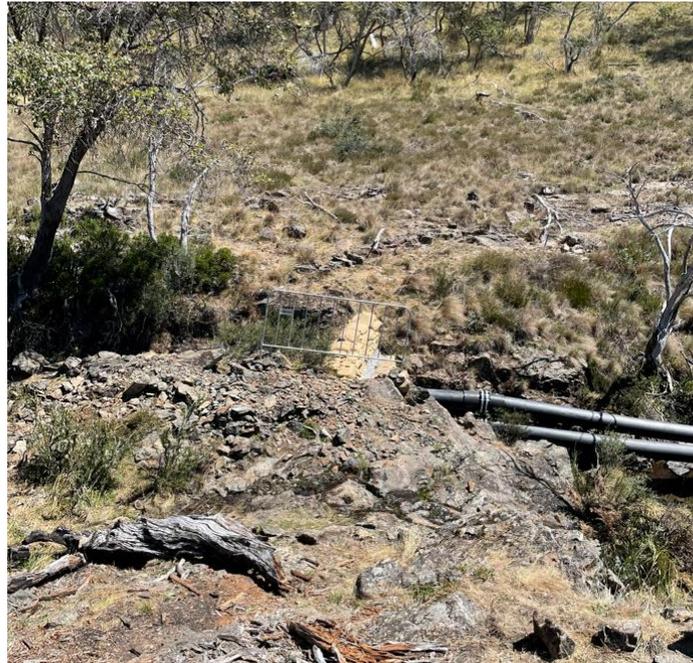
Figure 3-1 Temporary creek diversion

Prior to and during construction of the weir structure, a temporary stream diversion is required to enable works, this will be achieved through implementation of a temporary coffer dam and pipework to divert the creek around the site (refer Figure 3-1). All materials used for the diversion will be removed at the completion of the weir.

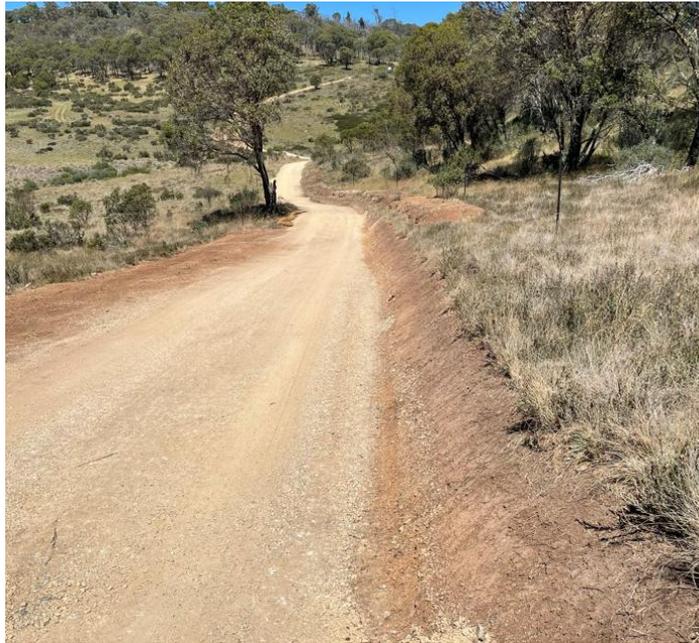
Figure 3-2 Batter to be retained between passing bay 8 and the weir site

Excess material removed from the section of track between the Snowy Mountains Highway and Eucumbene River and areas such as passing bays will be used to sheet Nungar Creek and Alpine Creek trails.

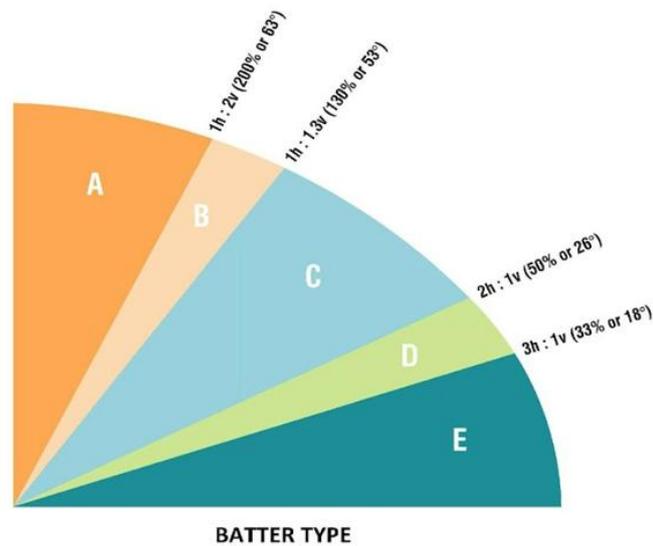
Figure 3-3 demonstrates the revegetation decision making process for determining stabilisation techniques, materials, and vegetation depending on the gradient of the area to be rehabilitated. The majority of the areas to be rehabilitated have a gradient of under 33 % (class E batter) with seeding and mulching the preferred treatment.

Snowy 2.0 Revegetation Decision Making Tool			
Batter Type	Temporary Revegetation Options *	Permanent Revegetation	Permanent Revegetation Description
A	N/A	Structural reinforcement	Reinforcement measures may include terramesh, gabion walls, shotcreting, rock bolting and soil nails
B	N/A	Geo mesh and grassing	Geo mat is required to provide rock dowels to retain soil containing grass seed
C	<ul style="list-style-type: none"> • Soil binder 	Jute mesh + planting & hydromulching	Jute mesh is required to hold soil while vegetation is established
D	<ul style="list-style-type: none"> • Soil binder • Hydromulching 	Planting & hydromulching	Tube stock planting density (1 plant / 2m ²) with hydromulch applied to the remainder of the area
E	<ul style="list-style-type: none"> • Direct seeding • Mulched timber • Soil binder • Hydroseeding • Hydromulching • Straw mulching 	Planting & hydromulching Direct seeding	Tube stock planting density (1 plant / 2m ²) with hydromulch applied to the remainder of the area

*temporary revegetation method depends on temporal span and / or proximity to sensitive receptors

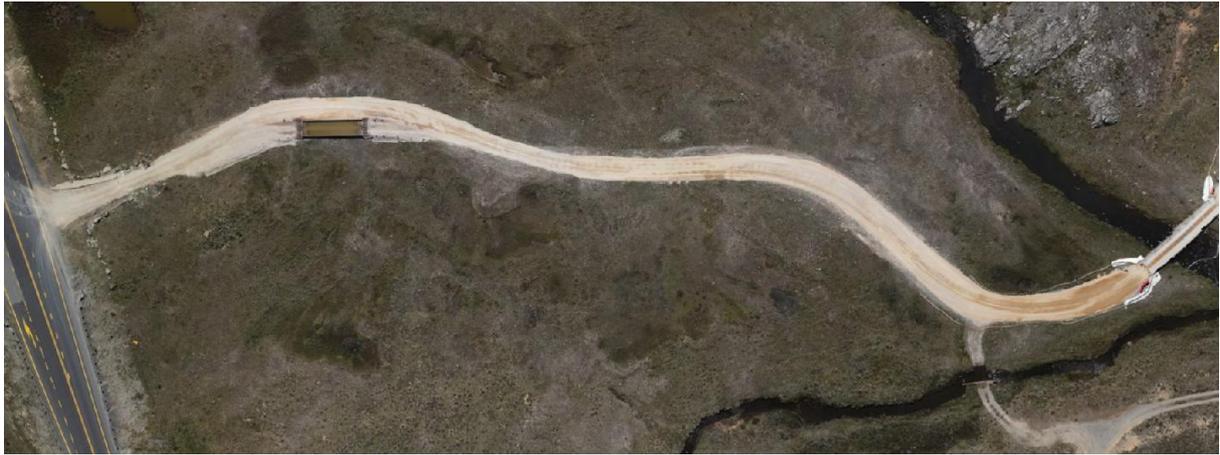
Figure 5-1 Snowy Mountains Highway – Eucumbene rehabilitation

- Snowy Mountains Highway to Eucumbene River – 1,900m² (refer Figure 5-1)
- Fish Weir and Laydown Area - 8000 m² (refer Figure 5-2)
- Passing Bays 1300 m² – For passing bays that have been reshaped and topsoiled in March 2025, a thinner coverage of 2 tonnes per hectare is to be applied following seeding. If vegetative cover is poor prior to demobilisation, additional straw to be applied at the same time as the remainder of the passing bays.

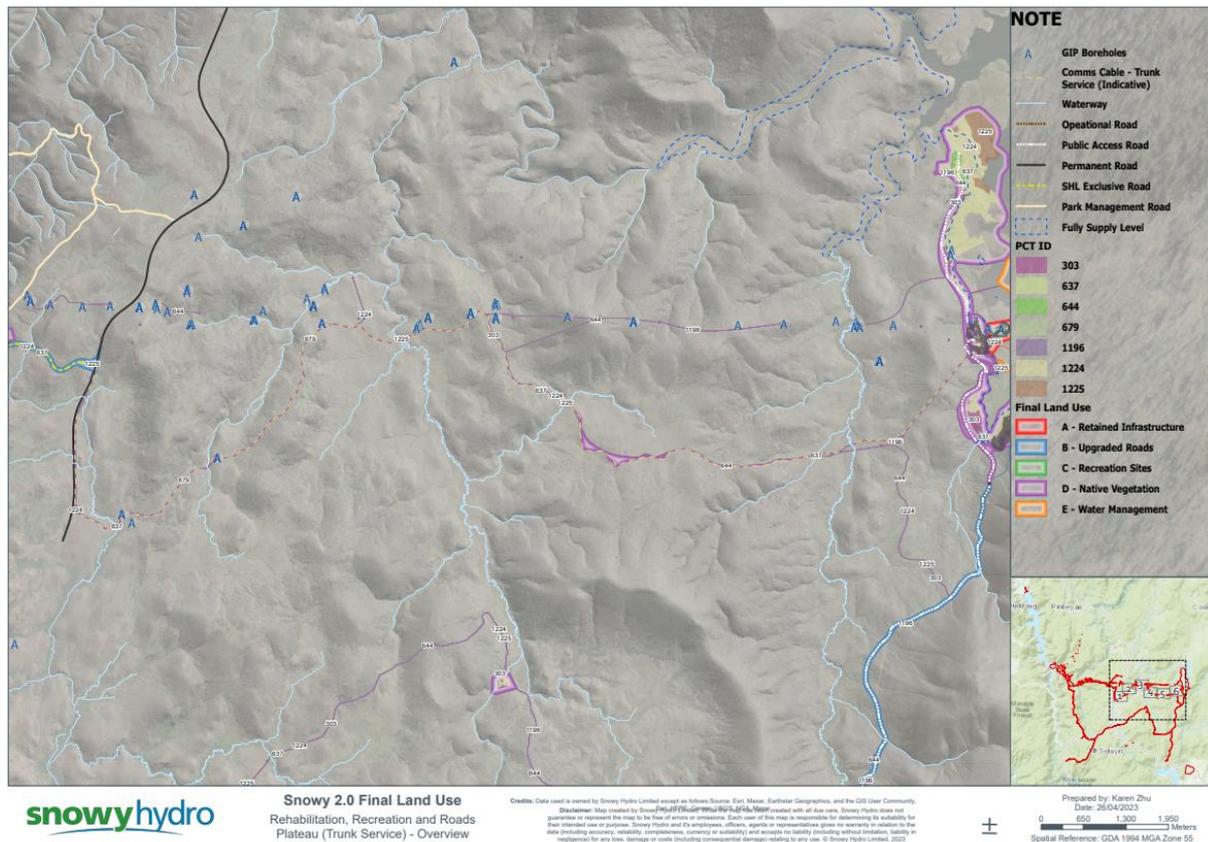
Figure 6-1 Final land use mapping for Plateau (inclusive of the Tantangara Fish Weir)

It is envisaged that the future use of this site is a combination of native vegetation, access road and permanent infrastructure (refer Figure 6-1).

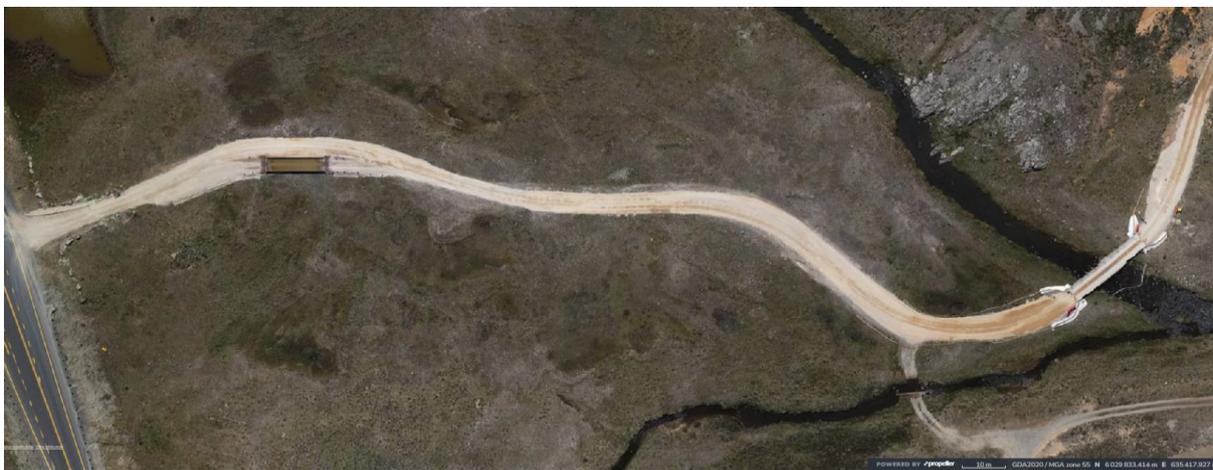
Figure B2 - Pre-rehabilitation aerial - SMH to Eucumbene River

- Bridge removed – Gabion to be retained on both sides – geofabric material removed
- Formed track approximately 750m³ of gravel and weed wash to be removed – Stockpile made available for NPWS
- Surplus topsoil from local stockpiles to be applied and surface compaction relieved
- Large boulders which were removed prior to works commencing, be reinstalled to address public access

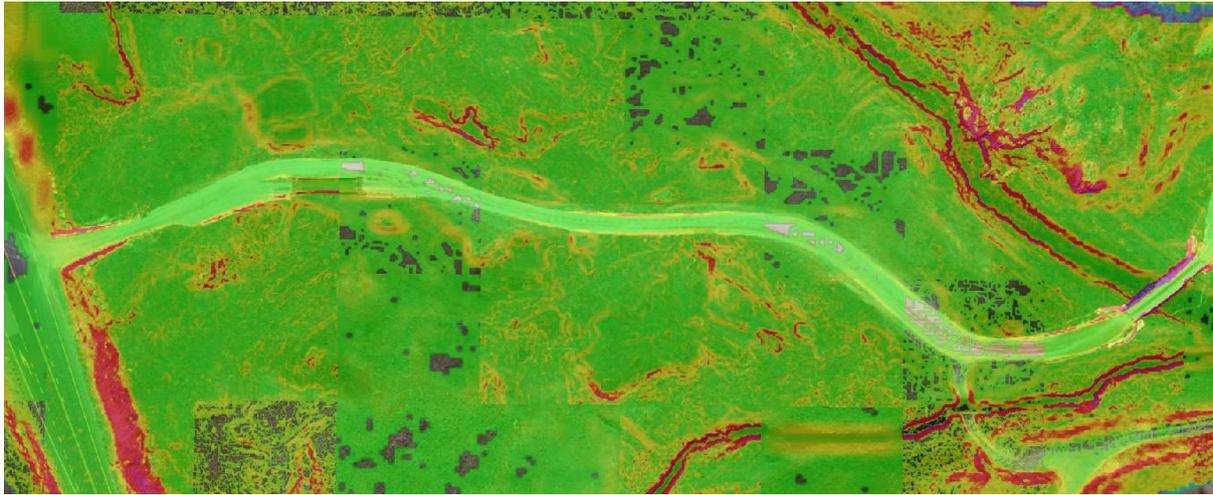
Figure B3 - Gradient Mapping - SMH to Eucumbene River Less than 33% - No additional erosion features required

Less than 33% - No additional erosion features required

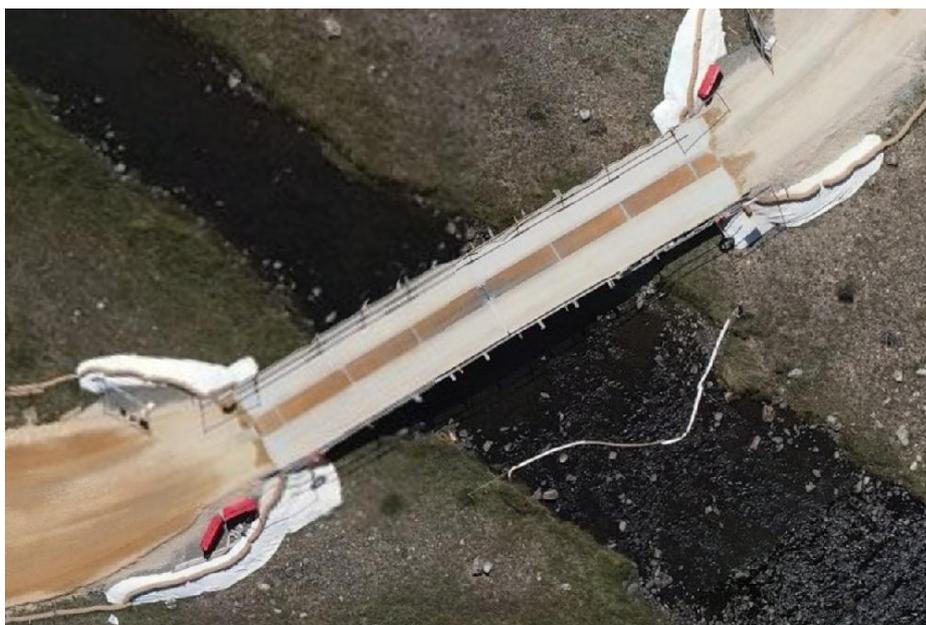
Figure B5 - Eucumbene River PCT 637 (Alpine bogs and fens)/1225 (>40m²)

This site will be sown and planted with primary species on the batters and in the disturbed areas of the waterway zone. All species selected for the first pass of rehabilitation are considered primary species for this PCT. This site will be monitored, and additional planting and sowing will be done with secondary species as part of the rehabilitation and maintenance program. This site will use a mix of primary species from PCT's 637 , 1225 and 1224 in the rehabilitation.

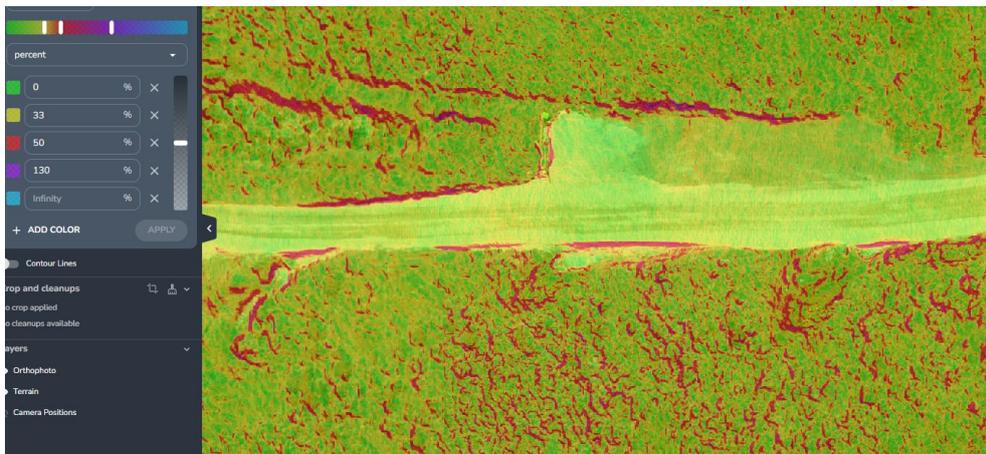
Figure B8 - Gradient Mapping

Gradient less than 33% - Class E slope – No additional slope breaks required

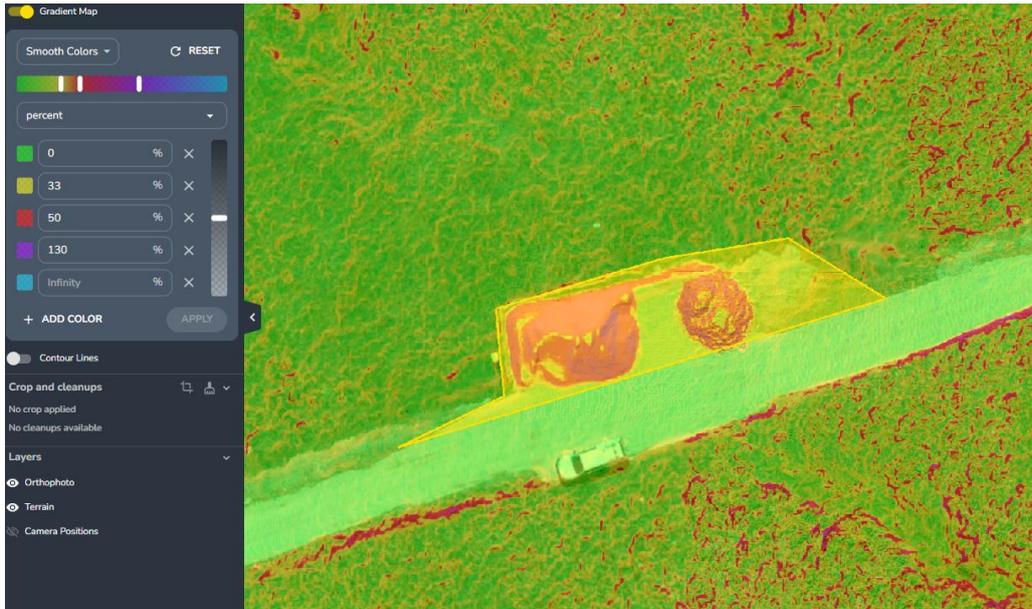
Figure B12 - Gradient Mapping

Gradient Less than 3% - Class E slope excluding stockpile to be removed

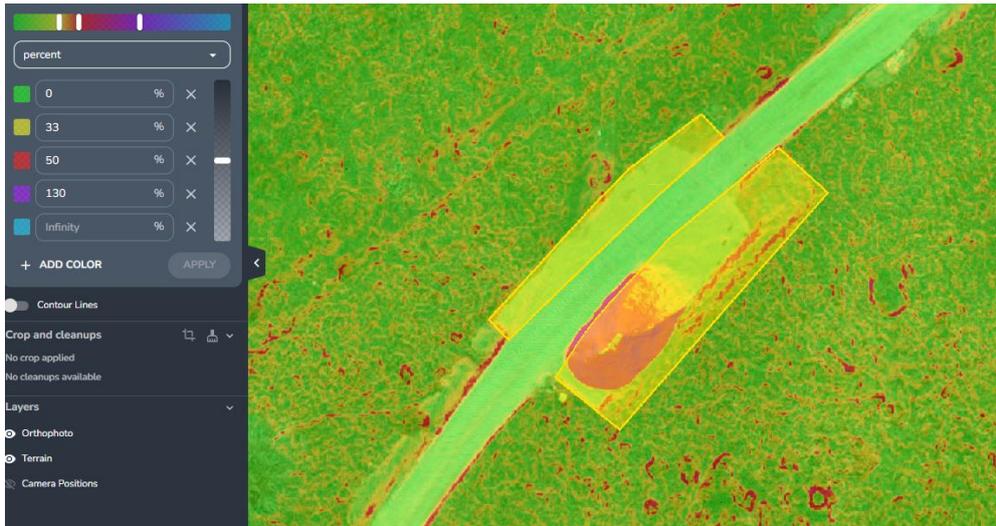
Figure B16 - Gradient Mapping

Gradient less than 33% no additional controls required

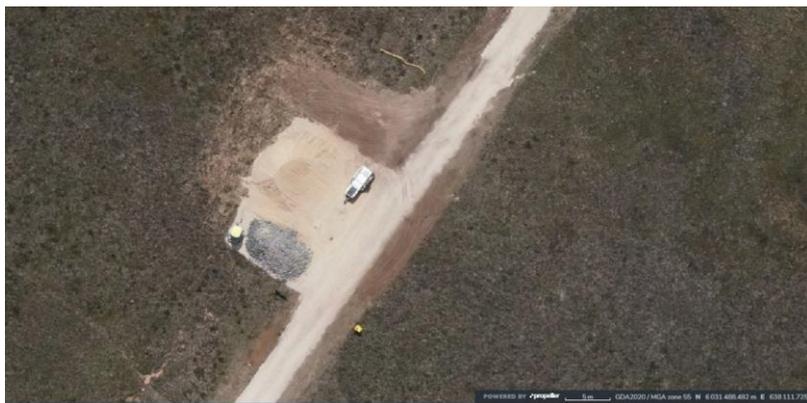
Figure B19 - Pre-rehabilitation aerial

- Stockpiles removed
- Passing bay size reduced, topsoil to be applied and surface compaction relieved

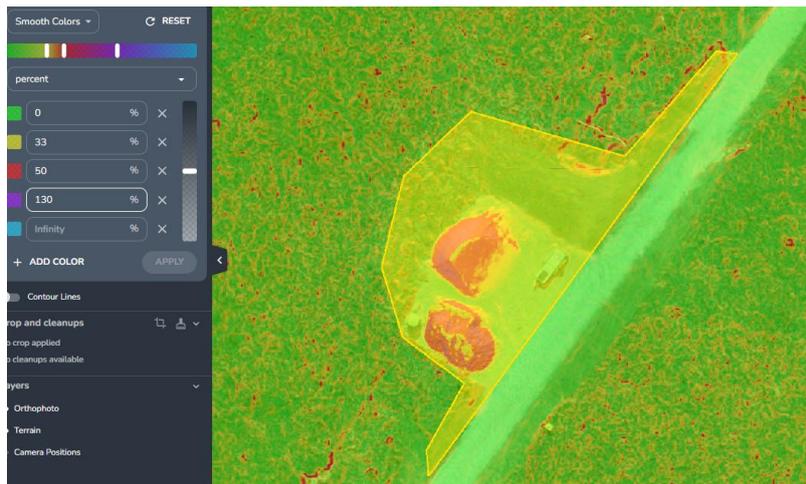
Figure B20 - Gradient Mapping

Gradient less than 33% no further treatment

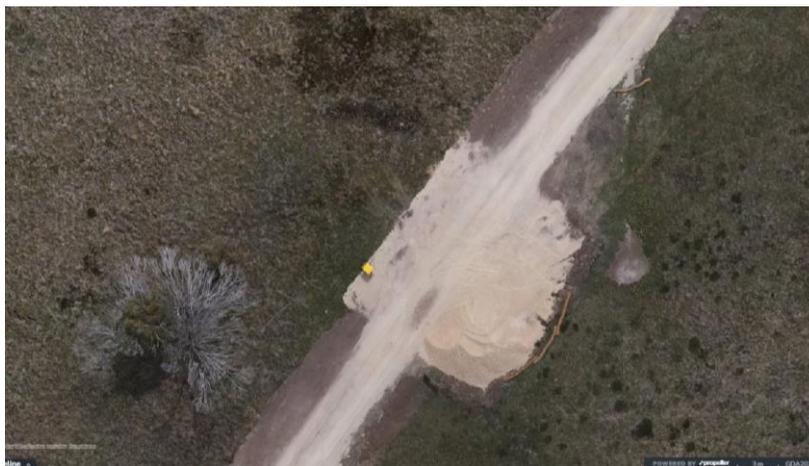
Figure B23 - Pre-rehabilitation aerial

- Stockpiles removed
- Passing bay size reduced, topsoil to be applied and surface compaction relieved

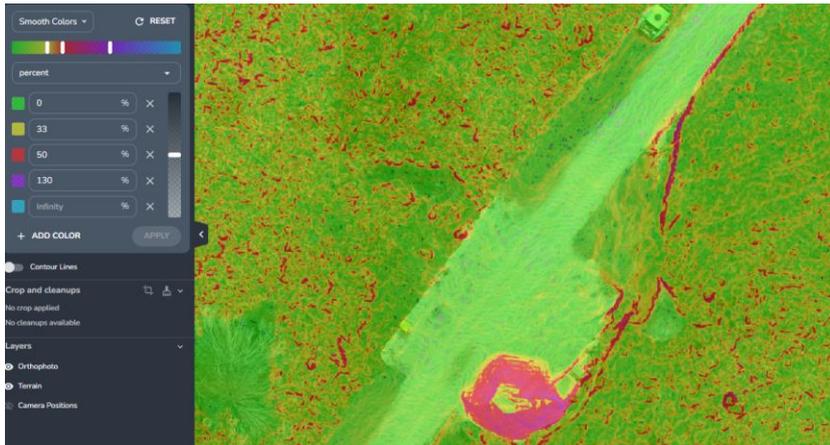
Figure B24 - Gradient Mapping

Gradient less than 33% no additional treatment

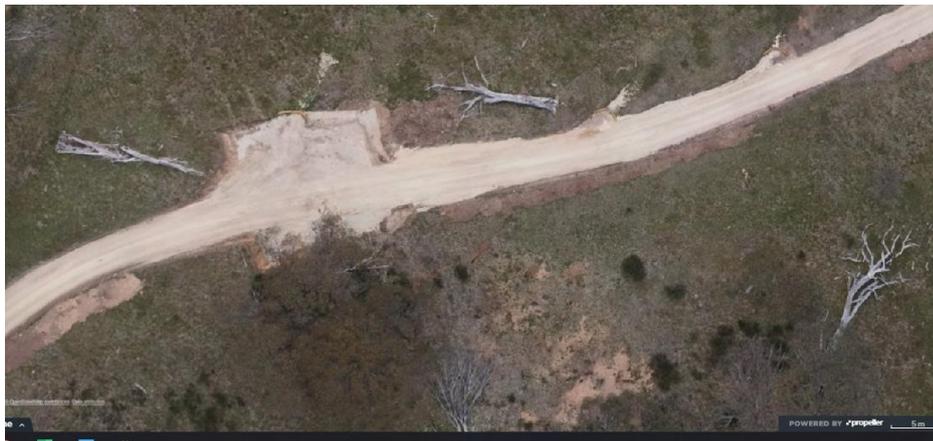
Figure B25 - Pre-rehabilitation aerial

Current Status - Cut infilled to natural level, topsoiled and seeded with rock lined drain installed to manage surface water from roll over. Cut on eastern side of road still requires reshaping upon completion of works

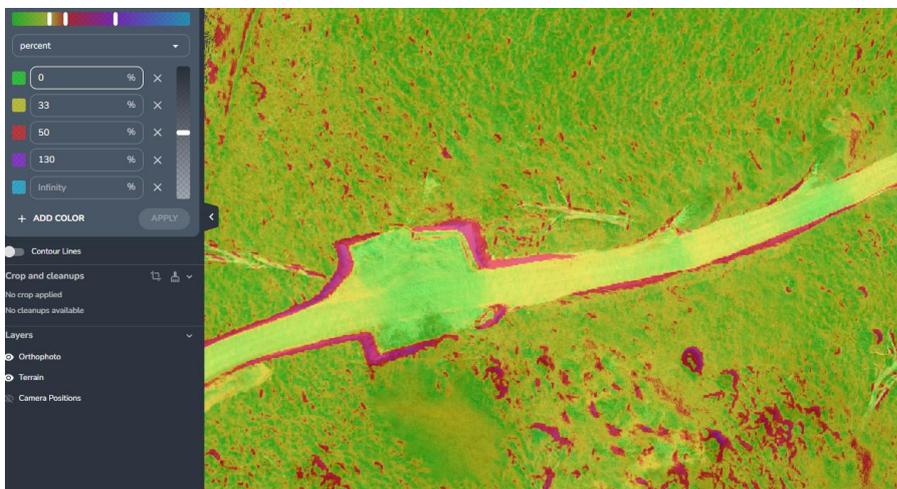
Figure B27 - Gradient Mapping

Batters originally 50 – 130% see below, now less than 33% straw mulch applied and rock armour at base of stockpile

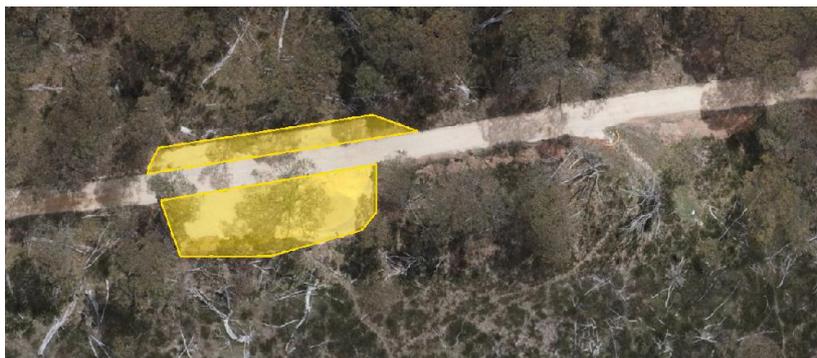
Figure B31 - Pre-rehabilitation aerial

- Stockpiles removed
- Passing bay size reduced, topsoil to be applied and surface compaction relieved

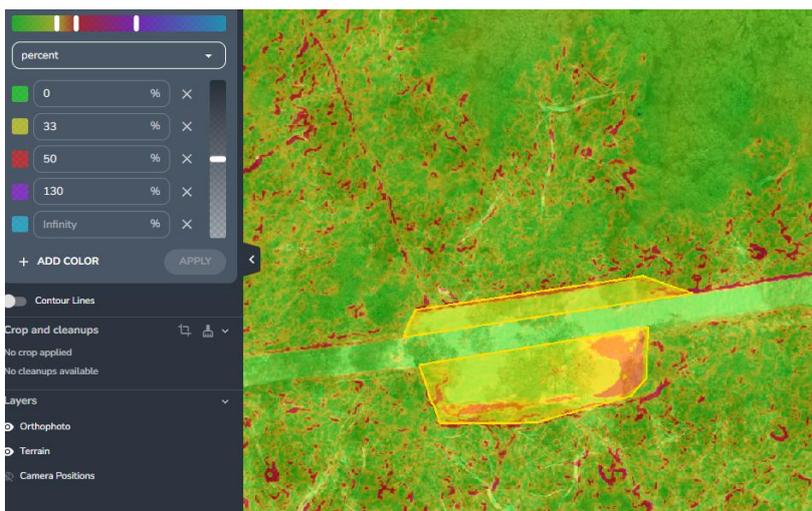
Figure B32 - Gradient Mapping

Gradient less than 33% no further treatment

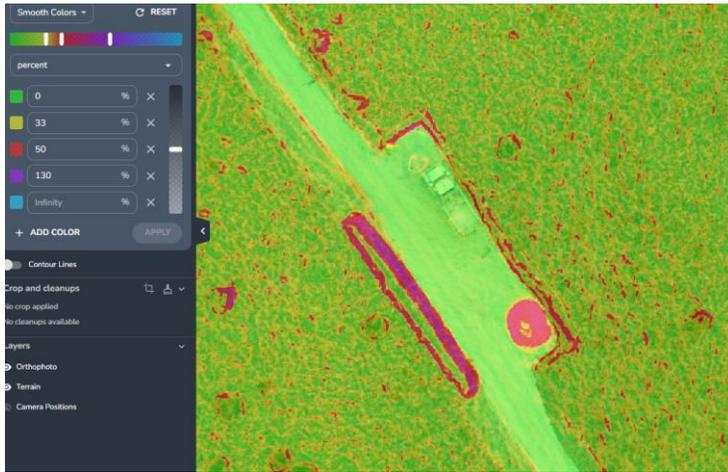
Figure B37 - Gradient Mapping

Gradient less than 33% excluding stockpiles no further treatment

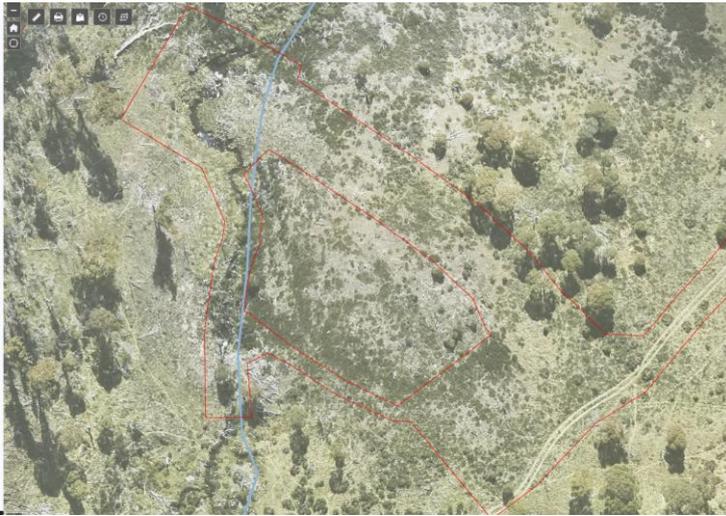
Figure B39 - Fish Weir and site laydown

- Construction equipment and materials removed from site
- Any potentially contaminated soil removed and disposed of appropriately
- Stockpiles removed
- Landform reinstated to natural levels
- Surplus topsoil to be applied and surface compaction relieved
- Undulating surface roughness maintained

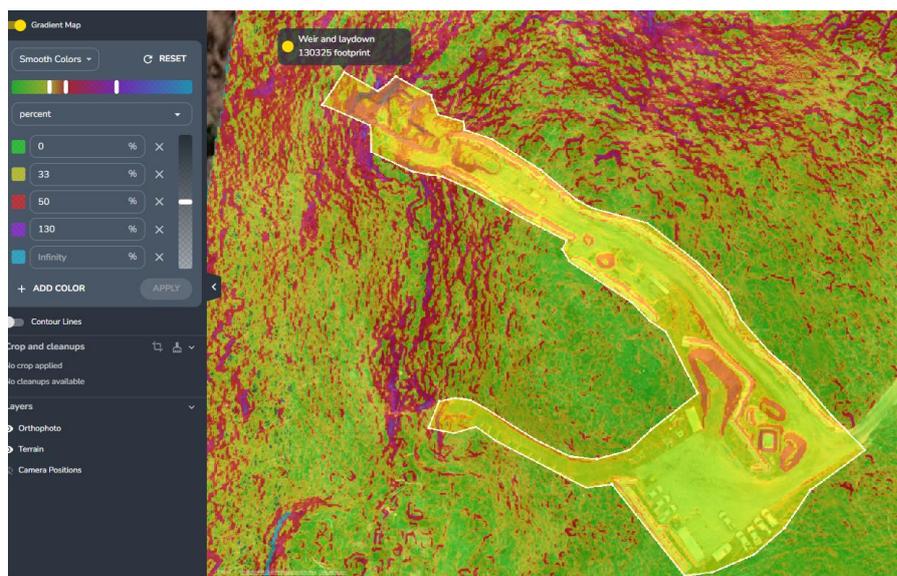
Figure B41 - Gradient Mapping

Gradient less than 33% for majority of laydown with access to the weir less than 50 (%. This area will require some slope breaks in the form of coir logs no more than 5 metres apart).
