Snowy 2.0 – Tantangara Surface Depression Rehabilitation Plan

Subject: Snowy 2.0 Main Works (SSI 9687) Tantangara Surface Depression Rehabilitation Plan

Title	Tantangara Surface Depression - Site Specific Rehabilitation Plan		
Document Number	S2-SHL-ENV-PLN-0004		
	Name	Position	Date
Originator	Ben Croome	Senior Environmental Advisor	07/11/2023
Review	Haofei Zhi	Environmental Scientist	13/12/2023
Approval	Chris Buscall	Environmental Manager	11/04/2024

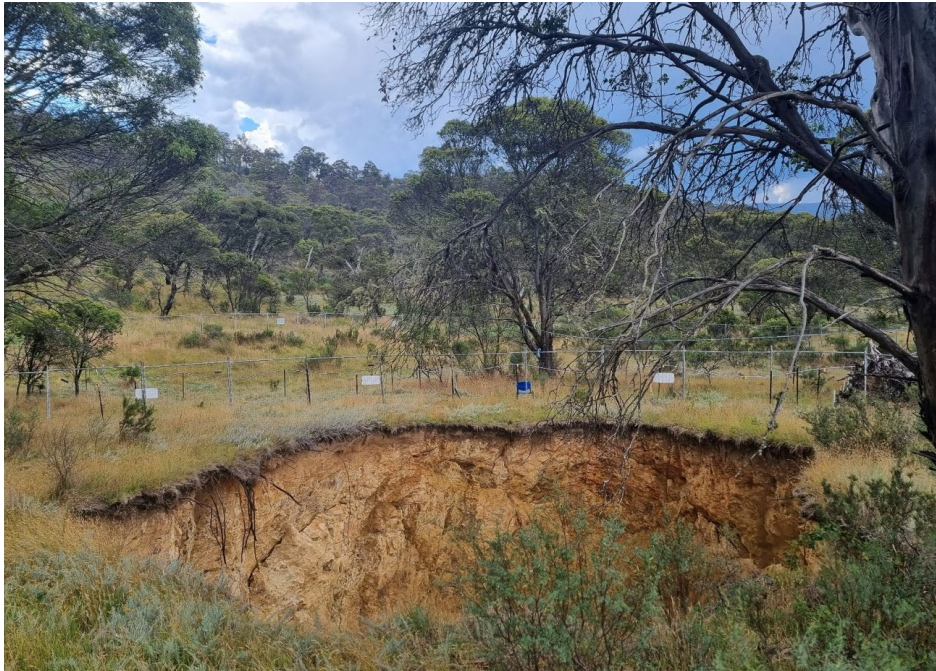
Figure 3: Surface current site condition facing West North West

The site currently consists of uncleared Black Sally grassy low woodland and sub-alpine dry grassland (see Figures 3 & 4). The surface depression occurred in the vegetation community mapped as Black Sally, associated habitat of the Alpine She-oak Skin and Broad toothed Rat. Approximately 300m² has been impacted by the subsidence with the remainder of the MOD2 footprint undisturbed. To conduct the remediation works, vegetation clearing will be required within the MOD2 boundary to facilitate appropriate access around the surface depression to conduct works safely.

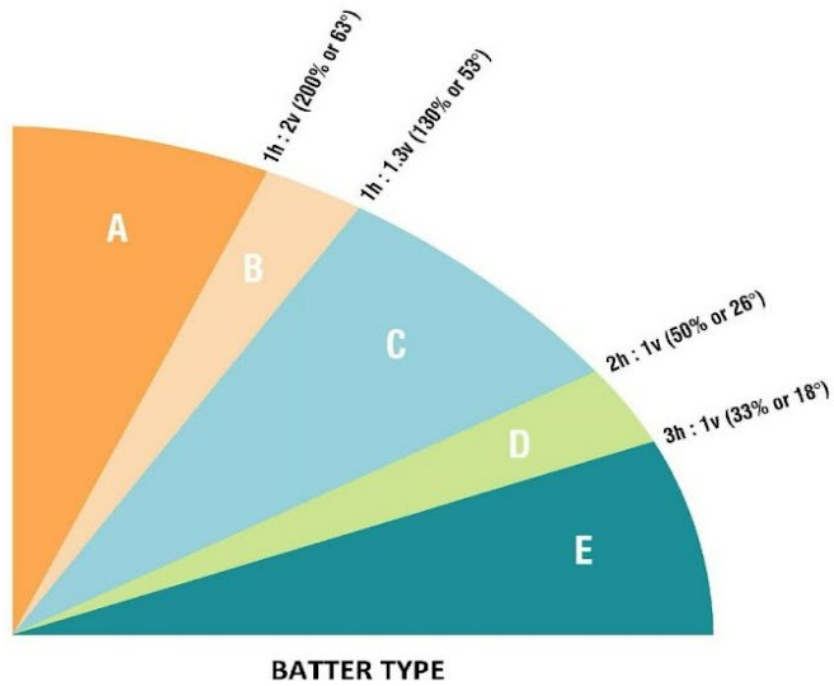
Figure 8: Vegetation decision making tool

Snowy 2.0 Revegetation Decision Making Tool			
Batter Type	Temporary Revegetation Options *	Permanent Revegetation	Permanent Revegetation Description
A	N/A	Structural reinforcement	Reinforcement measures may include terramesh, gabion walls, shotcreting, rock bolting and soil nails
B	N/A	Geo mesh and grassing	Geo mat is required to provide rock dowels to retain soil containing grass seed
C	<ul style="list-style-type: none"> Soil binder 	Jute mesh + planting & hydromulching	Jute mesh is required to hold soil while vegetation is established
D	<ul style="list-style-type: none"> Soil binder Hydromulching 	Planting & hydromulching	Tubestock planting density (1 plant / 2m ²) with hydromulch applied to the remainder of the area
E	<ul style="list-style-type: none"> Direct seeding Mulched timber Soil binder Hydroseeding Hydromulching Straw mulching 	Planting & hydromulching Direct seeding	Tubestock planting density (1 plant / 2m ²) with hydromulch applied to the remainder of the area

**temporary revegetation method depends on temporal span and / or proximity to sensitive receptors*

The gradient of the surrounding land is less than 4h:1v. Stabilisation will be undertaken in accordance with Batter Type E shown in Figure 8 on the following page.
