REPORT

QUARTERLY ENVIRONMENTAL WATER REPORT DECEMBER 2025 – FEBRUARY 2026

S2-ENV-WA-GEN-REP-FGJV0149

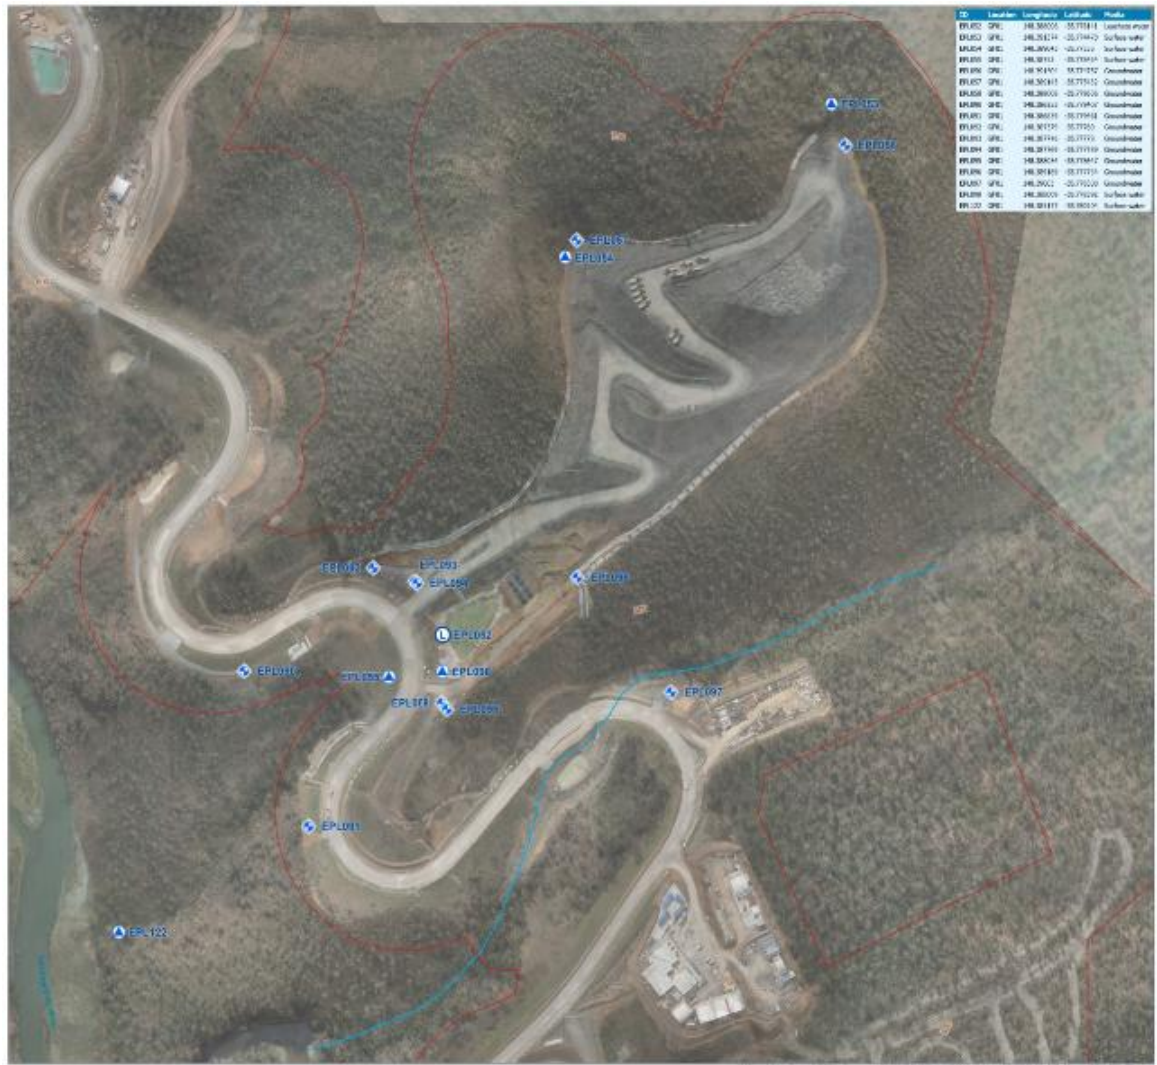
EPL Locations
 GF01

The GF01 PSE monitoring network comprises two upstream reference sites (EPL56 and EPL57) and nine downstream locations (EPL58, EPL90, EPL91, EPL92, EPL93, EPL94, EPL95, EPL96, and EPL97). During this period, physicochemical parameters remained stable; however, minor fluctuations in metal concentrations were detected downstream. Specifically, Iron exhibited transient spikes during January and February, most notably at EPL90, where levels peaked in early February before receding to within WQO limits. Also, similar trends were observed at EPL91 and EPL94. These increases are likely attributed to the significant groundwater drawdown in the aquifer caused by the dry season, which tends to concentrate dissolved metals. It's important to highlight that no construction activities occurred within the GF01 and Main Yard PSE area during this timeframe. To ensure ongoing compliance, remediation scopes and strategies of water extraction operations remain active at this site to mitigate potential impacts associated with leachate.

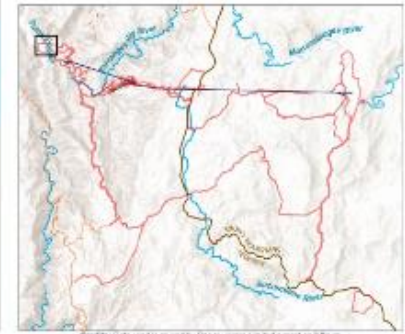
EPL Locations
 Ravine Bay

- Groundwater
- Surface water
- Leachate water
- Reservoir
- Construction Envelope
- Access / Construction Tunnel
- Hydraulic Tunnel
- Primary Road
- Arterial Road
- Drainage
- Major Contour (50m)

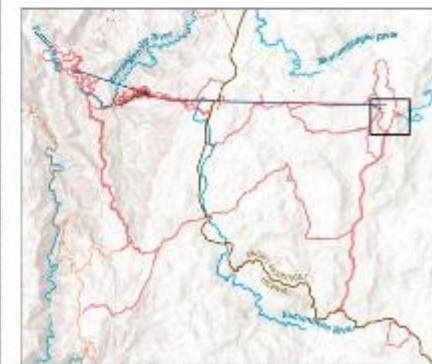
EPL Locations Tantangara

- Surface water
- Diffusion Point
- Reservoir
- STP - Inflow Vol
- WTP - Inflow Vol
- WTP - Discharge Point
- Construction Envelope
- Access / Construction Tunnel
- Hydraulic Tunnel
- Primary Road
- Arterial Road
- Drainage
- Major Contour (50m)

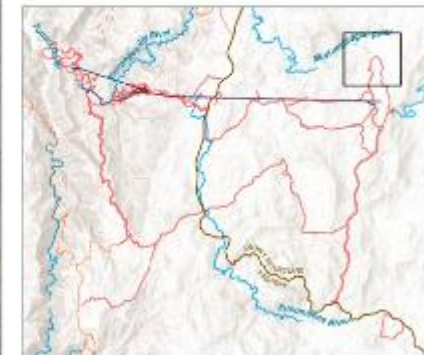
EPL Locations
 Tantangara Emplacement

- Groundwater
- Surface water
- Leachate water
- Reservoir
- Construction Envelope
- Access / Construction Tunnel
- Hydraulic Tunnel
- Primary Road
- Arterial Road
- Drainage
- Major Contour (50m)

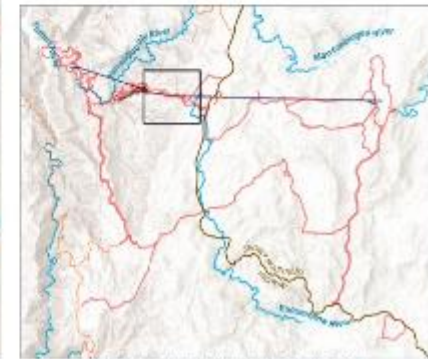
EPL Locations
 Marica

- Groundwater
- Surface water
- Leachate water
- Construction Envelope
- Access / Construction Tunnel
- Hydraulic Tunnel
- Primary Road
- Arterial Road
- Drainage
- Major Contour (50m)

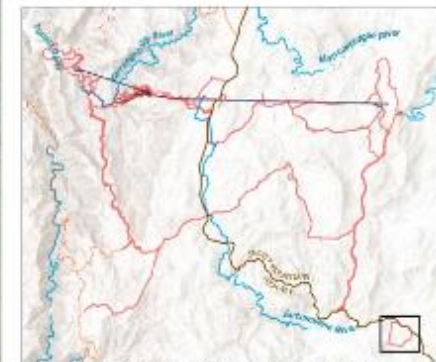
EPL Locations
 Rock Forest

- Construction Envelope
- Surface water
- Leachate water
- Access / Construction Tunnel
- Hydraulic Tunnel
- Primary Road
- Arterial Road
- Drainage
- Major Contour (50m)
