**Snowy Hydro 2.0 Main Works EPL Sampling: 01 - 31 January 2026**

Monthly water sampling and analysis is performed as part of the Snowy 2.0 Approval Conditions, Environmental Protection Licence No 21266 - Variation 26 September 2025, and the approved Water Management Plan to ensure that works are not impacting on nearby receiving waters.

**Snowy Hydro 2.0 Main Works**

**Monthly EPL Sampling: 01-31 January 2026 - Discharge Water**

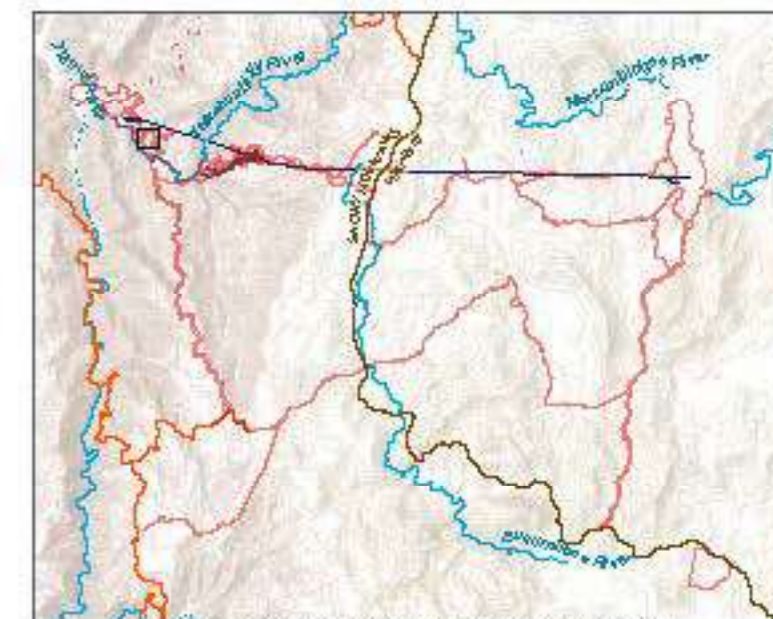
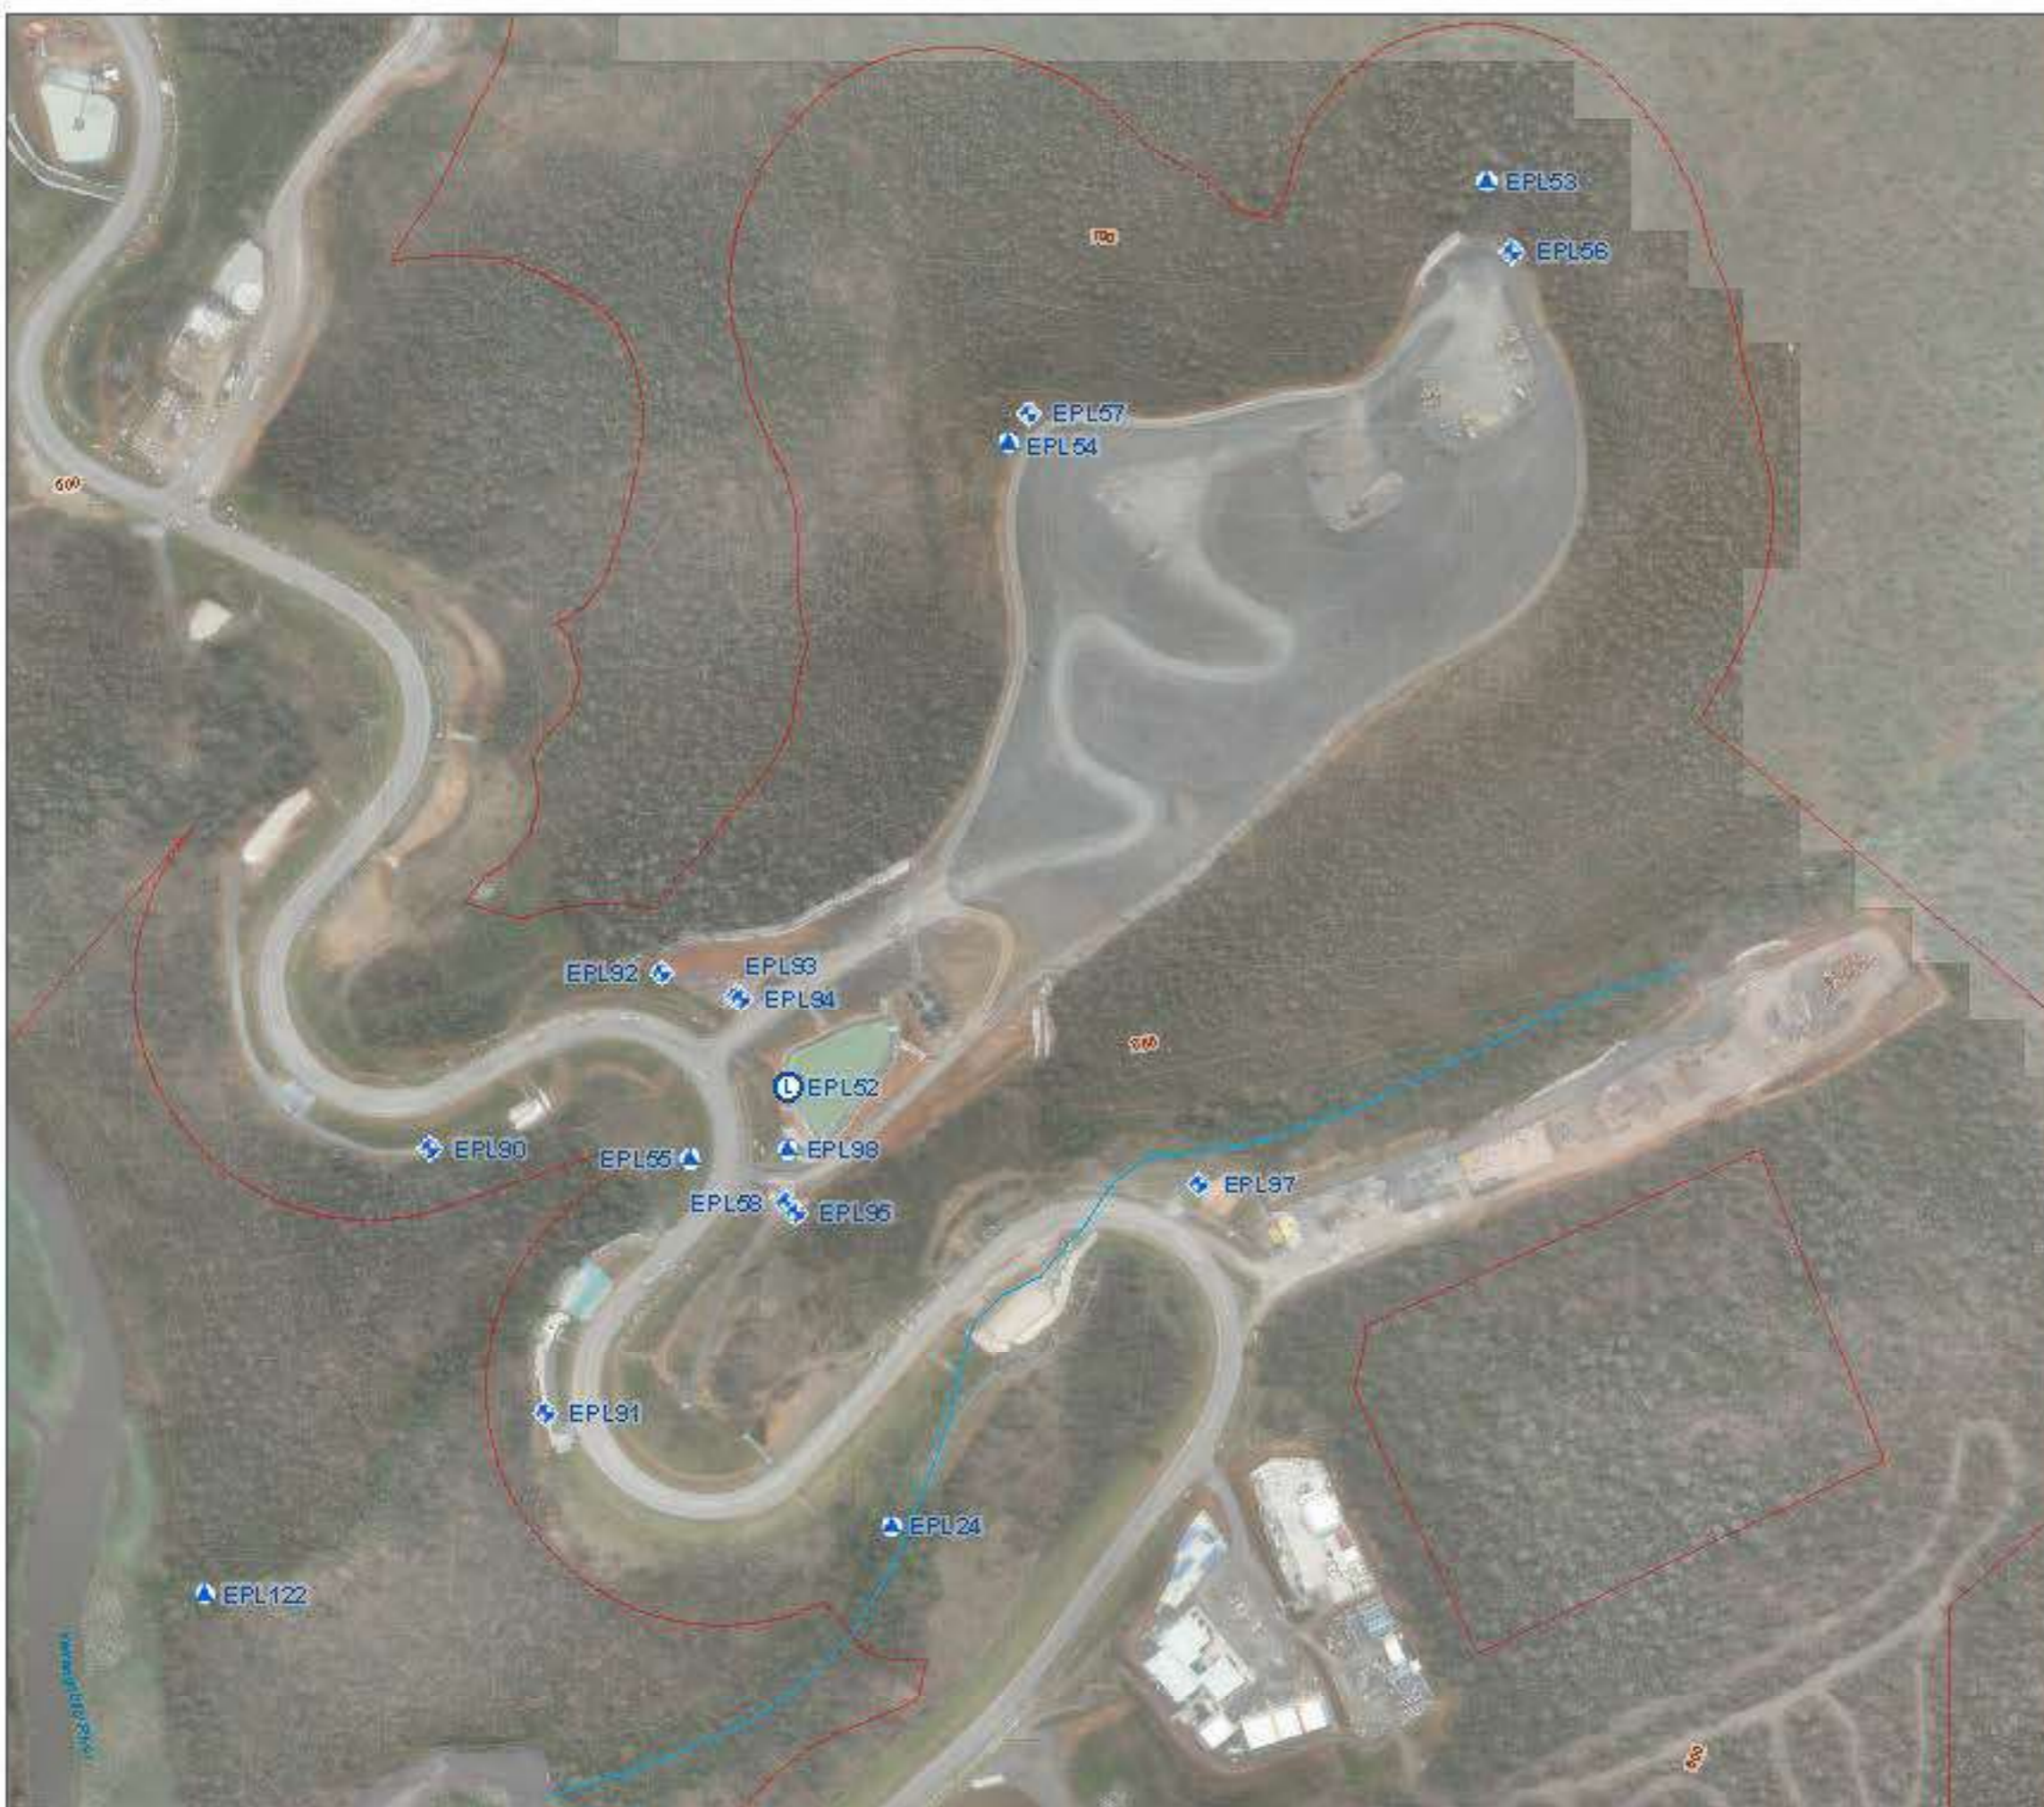
- Groundwater
- Surface water
- Leachate water
- Construction Envelope
- Access / Construction Tunnel
- Hydraulic Tunnel
- Primary Road
- Arterial Road
- Drainage
- Major Contour (50m)

ID #	Location	Longitude	Latitude	Media
ERL24	Lobs Hole	148.388545	-35.779893	Surface water
ERL52	GF01	148.388006	-35.778141	Leachate water
ERL53	GF01	148.391374	-35.774478	Surface water
ERL54	GF01	148.389043	-35.77555	Surface water
ERL55	GF01	148.38753	-35.778434	Surface water
ERL56	GF01	148.391504	-35.774757	Groundwater
ERL57	GF01	148.389143	-35.775432	Groundwater
ERL58	GF01	148.388008	-35.778606	Groundwater
ERL90	GF01	148.386253	-35.778407	Groundwater
ERL91	GF01	148.386839	-35.779461	Groundwater
ERL92	GF01	148.387379	-35.77769	Groundwater
ERL93	GF01	148.387746	-35.77778	Groundwater
ERL94	GF01	148.387769	-35.77789	Groundwater
ERL95	GF01	148.388054	-35.778647	Groundwater
ERL97	GF01	148.39003	-35.778508	Groundwater
ERL98	GF01	148.388009	-35.778392	Surface water
ERL122	GF01	148.385177	-35.780204	Surface water

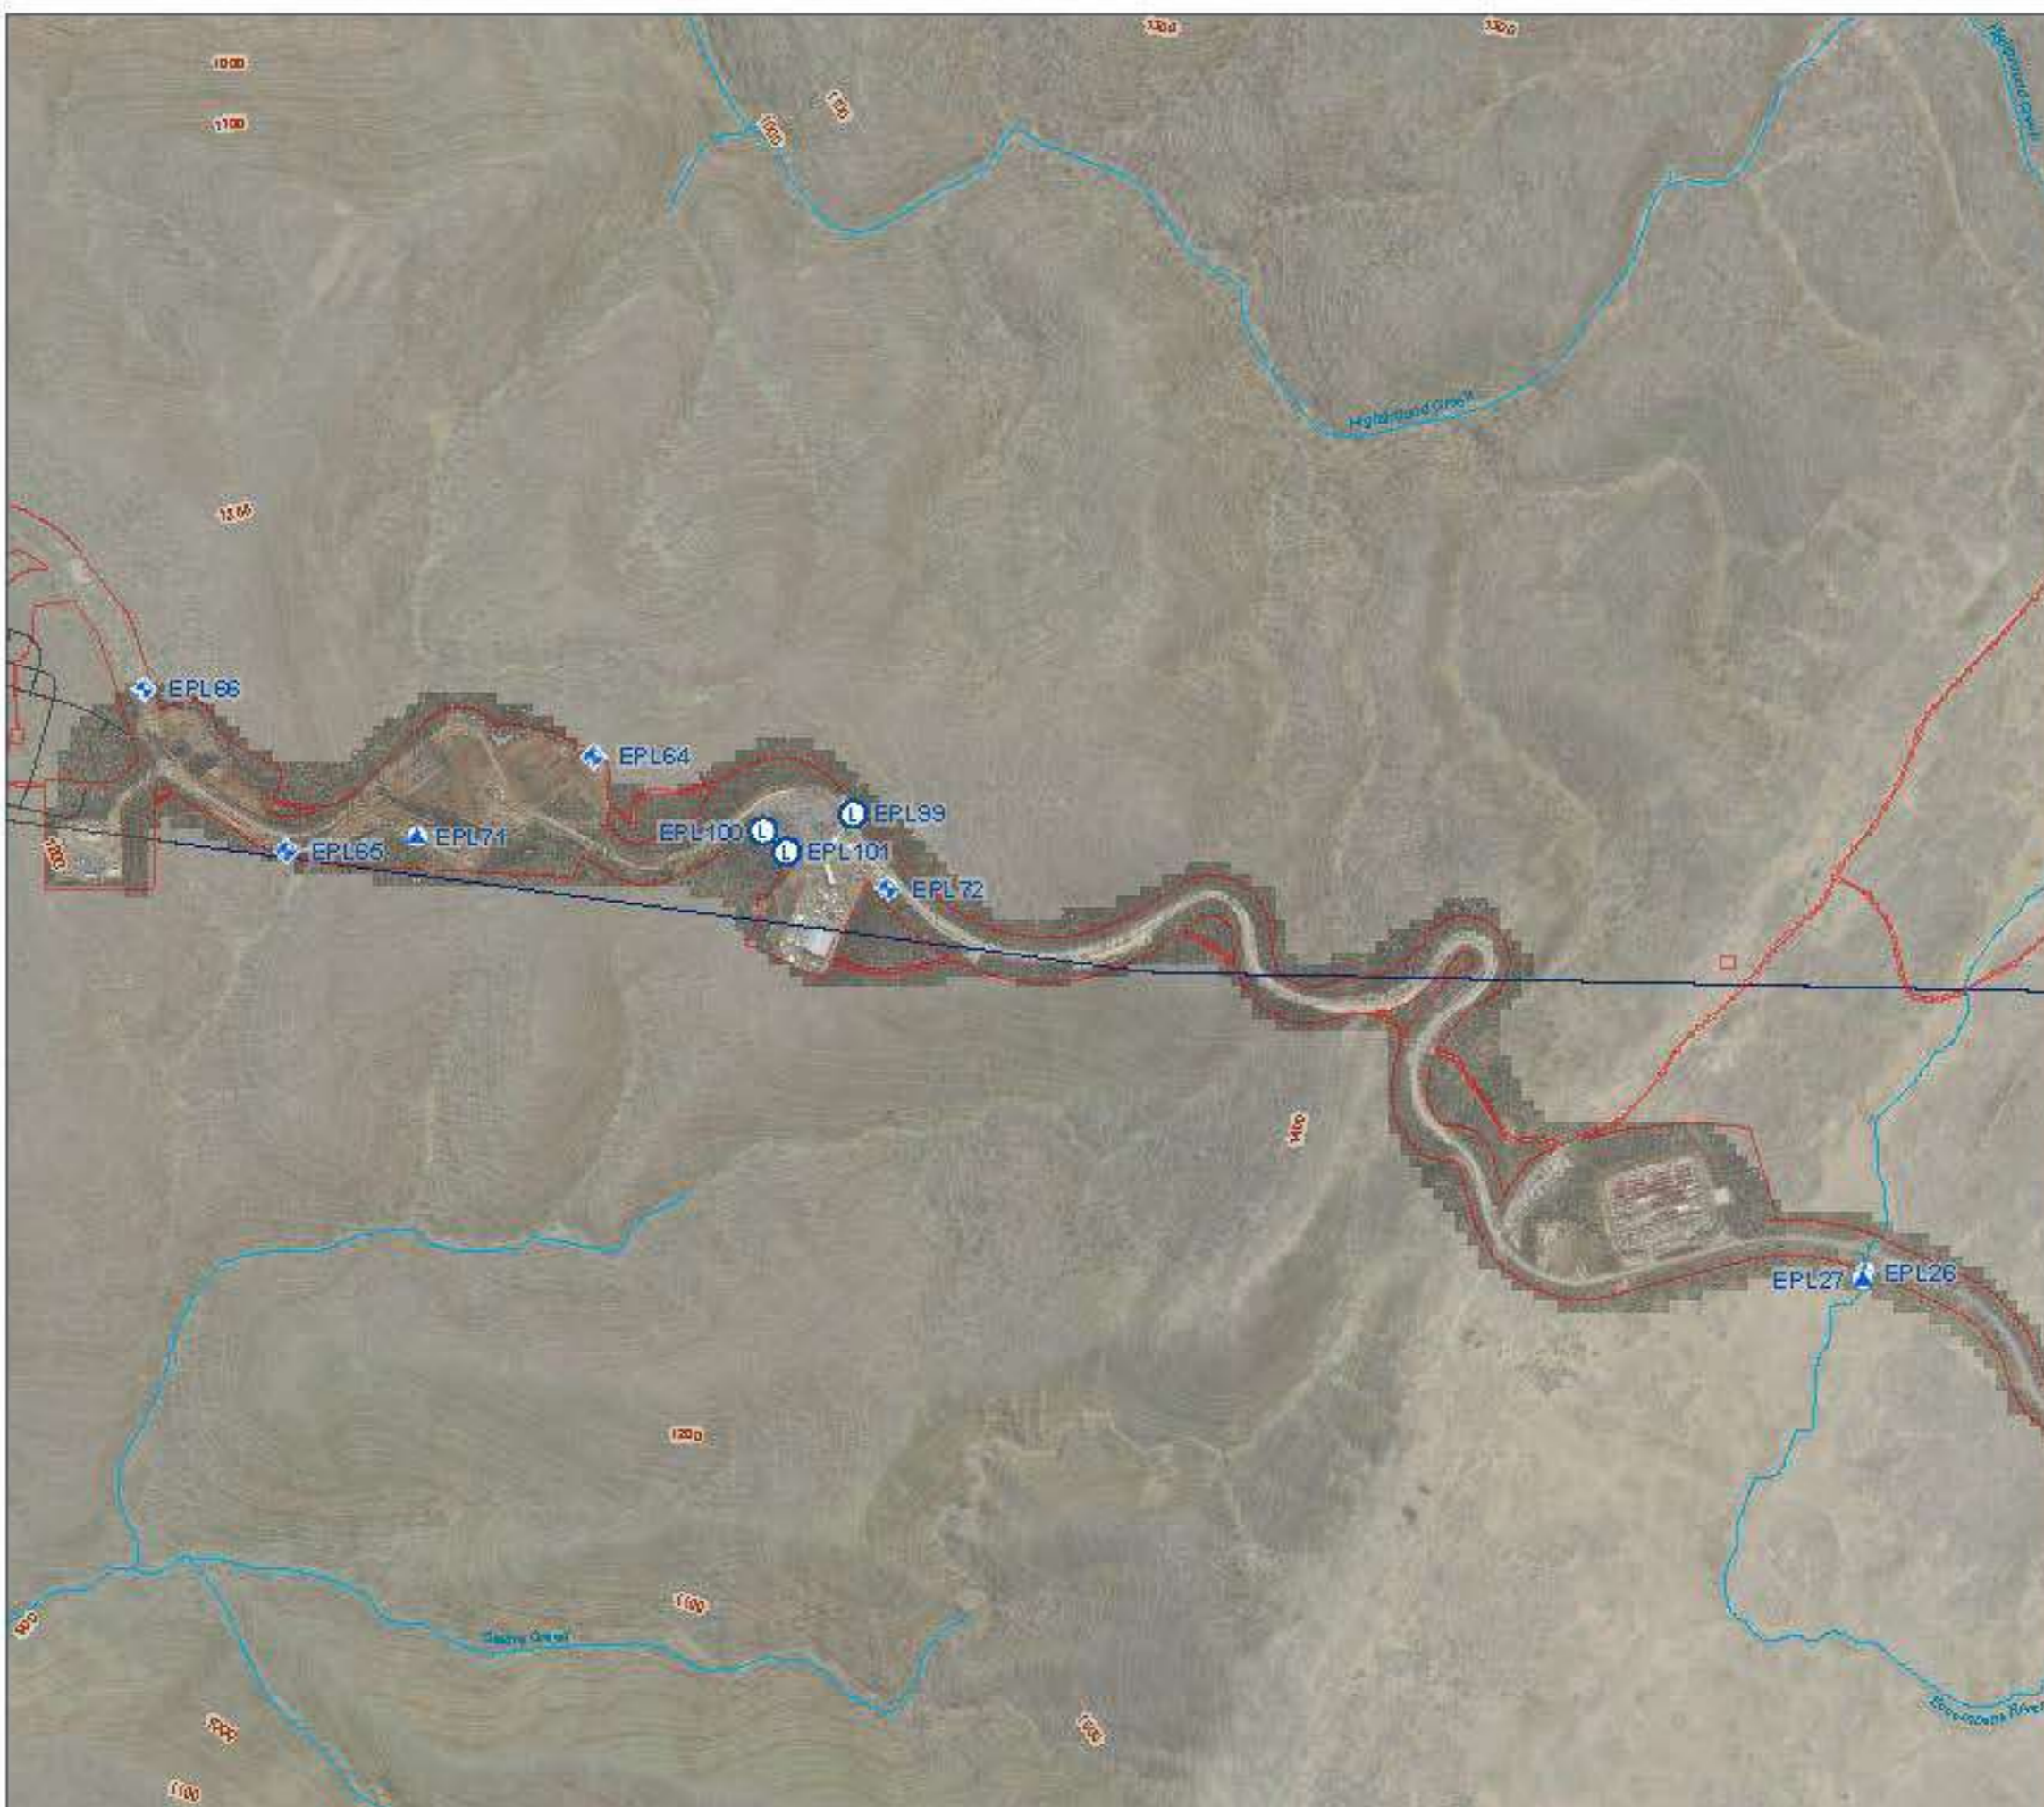
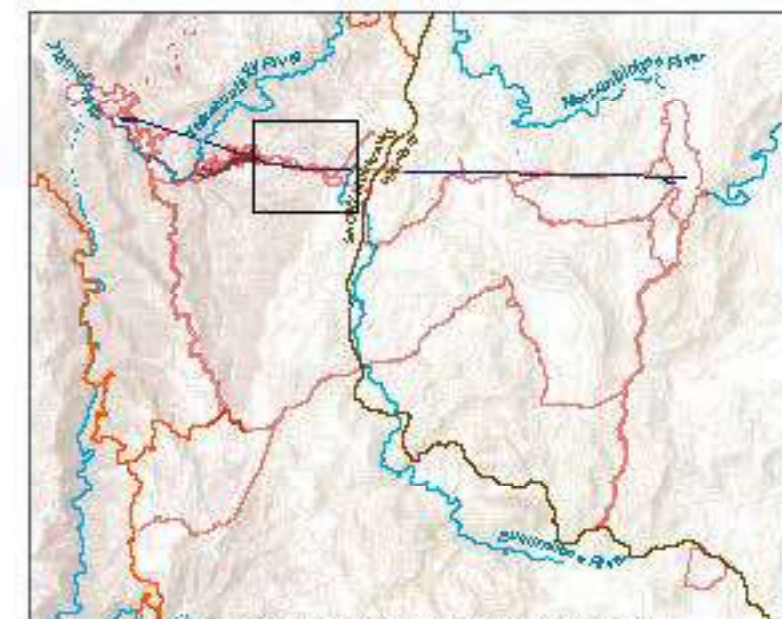
## EPL Locations Marica

ID #	Location	Longitude	Latitude	Media
EPL26	Marica	148.488265	-35.79435	Surface water
EPL27	Marica	148.48821	-35.79447	Surface water
EPL71	Marica	148.452542	-35.786057	Surface water
EPL72	Marica	148.464127	-35.786946	Groundwater
EPL99	Marica	148.463248	-35.785469	Leachate water
EPL100	Marica	148.461039	-35.785835	Leachate water
EPL101	Marica	148.461624	-35.786252	Leachate water
EPL64	Marica	148.456856	-35.784402	Groundwater
EPL65	Marica	148.449348	-35.786373	Groundwater
EPL66	Marica	148.445797	-35.783195	Groundwater

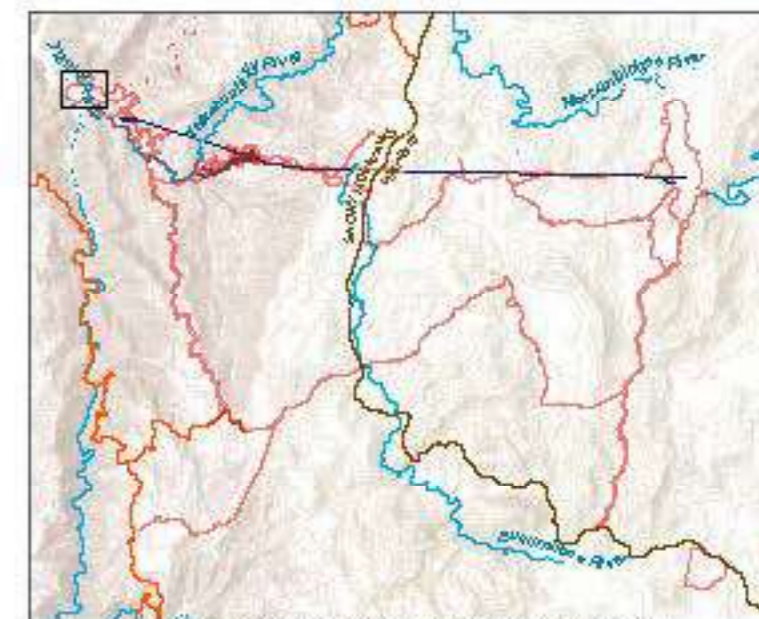
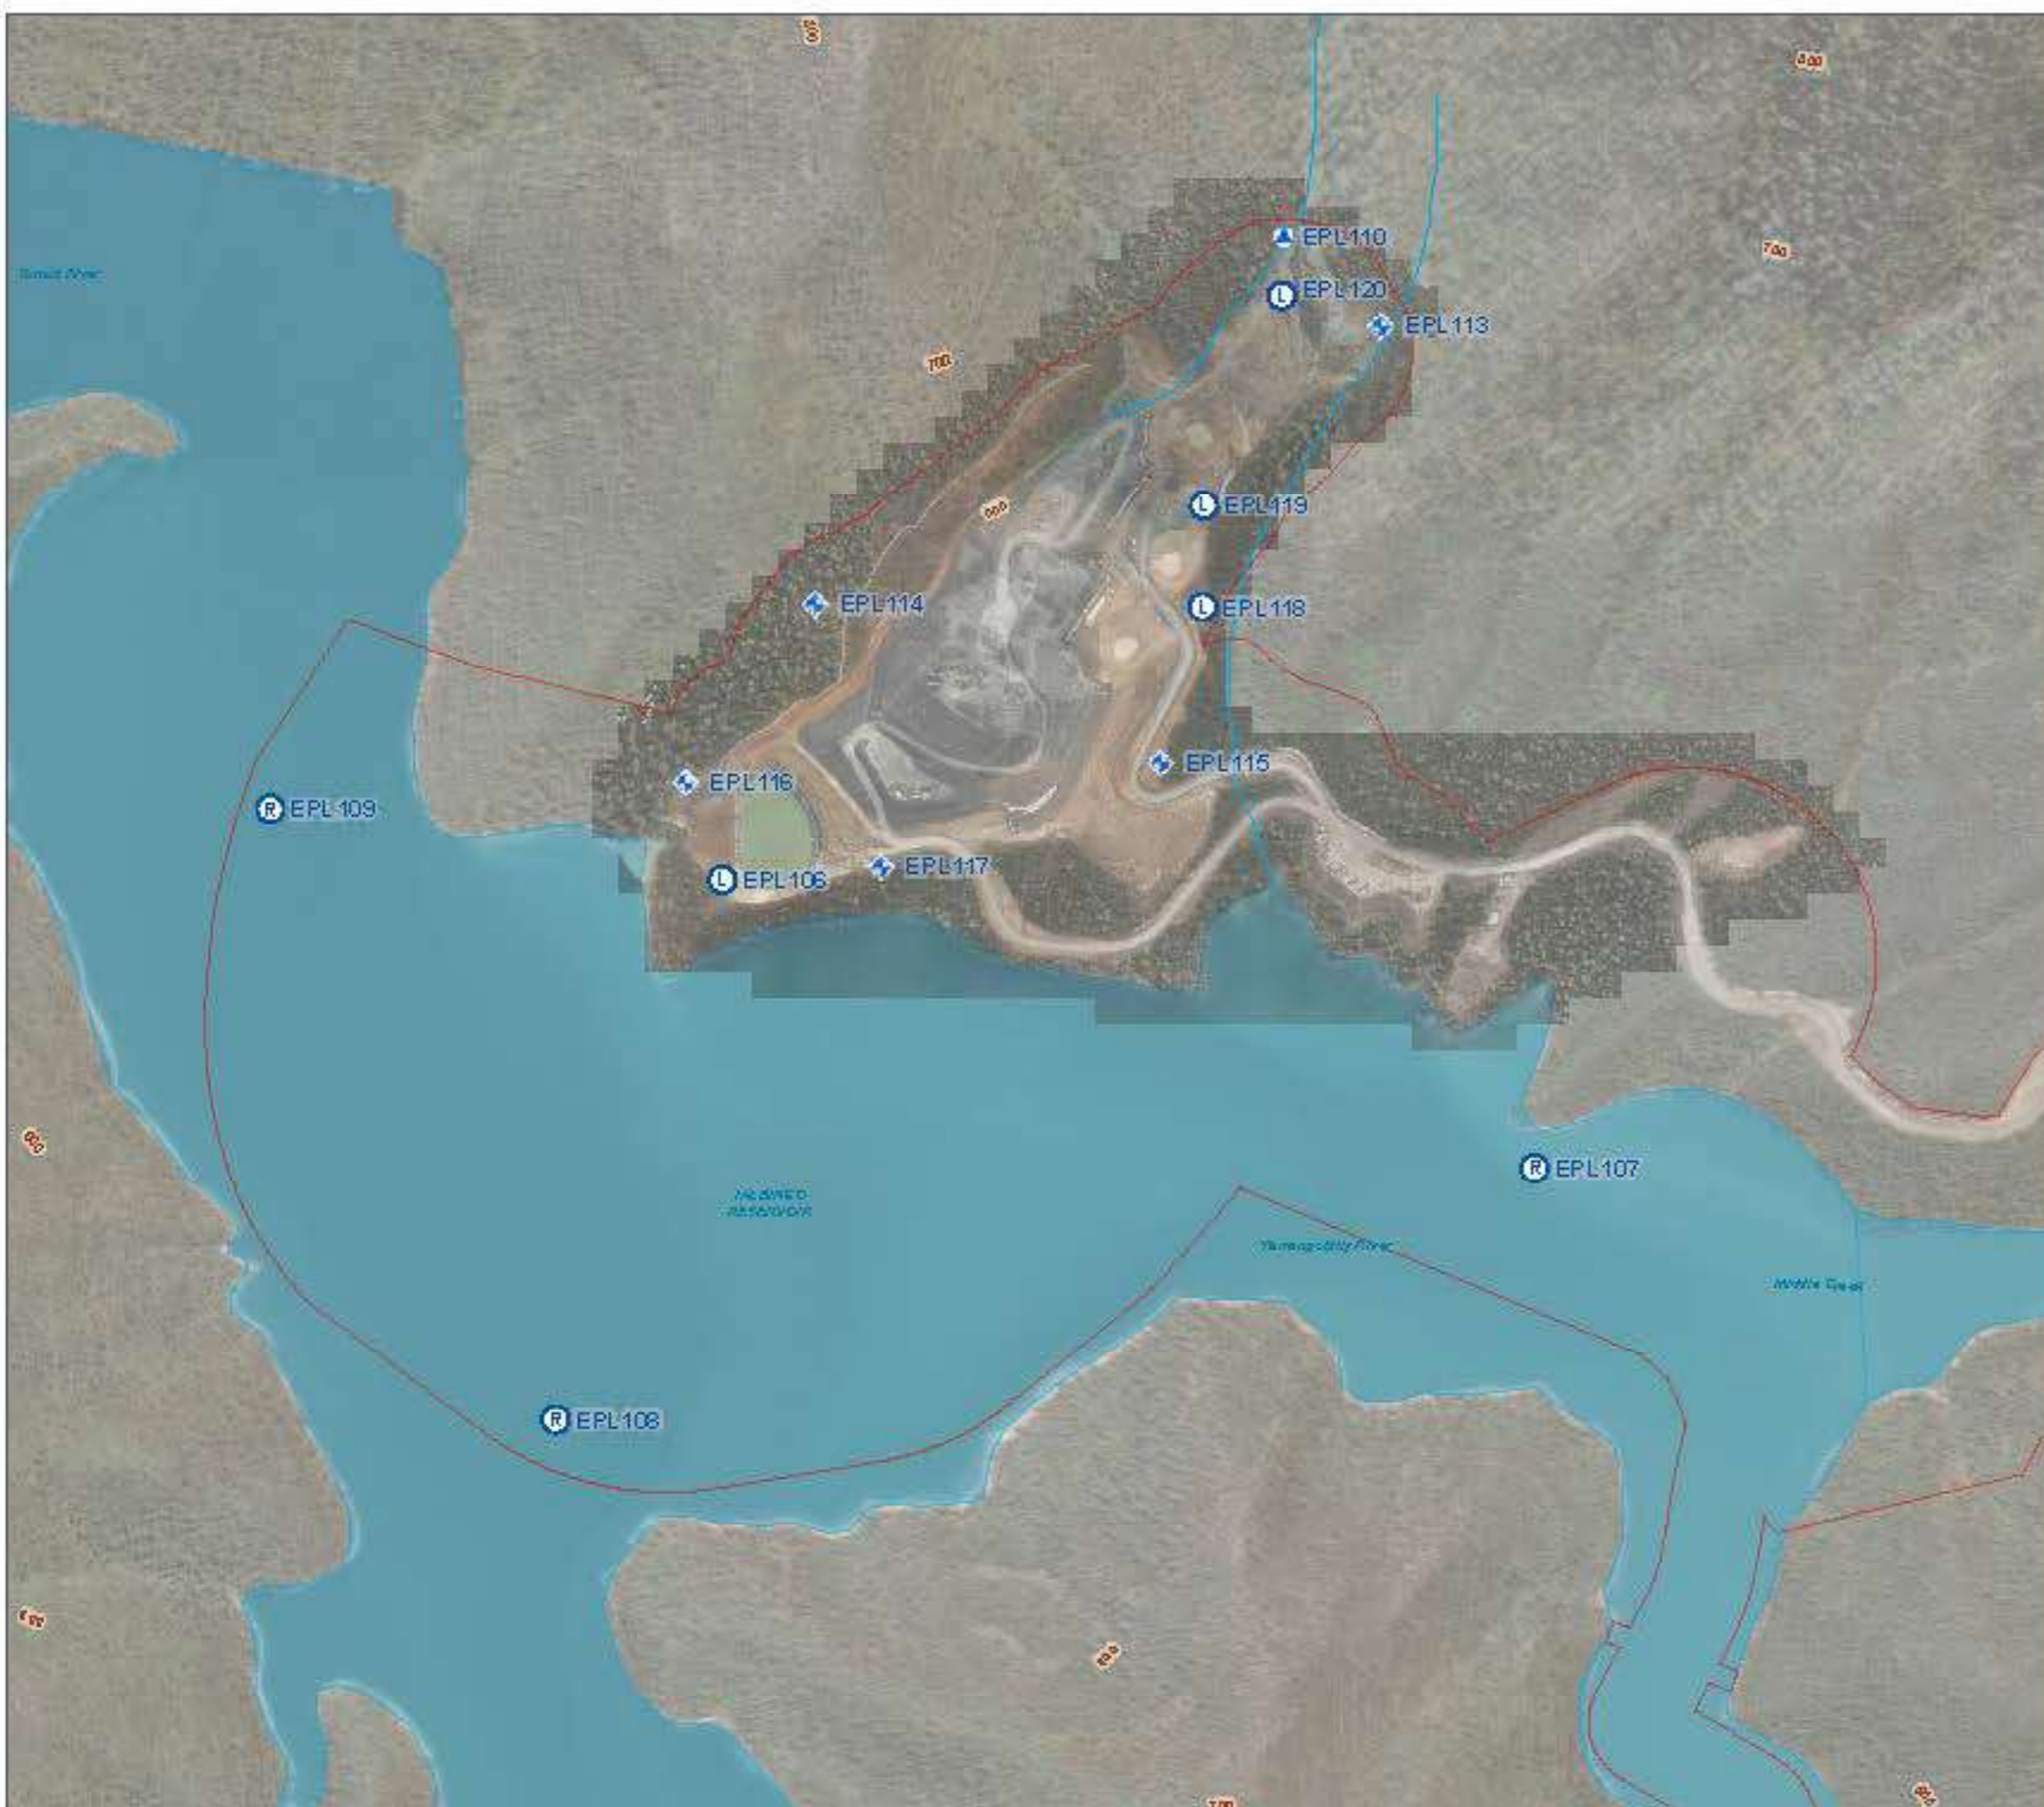
- Groundwater
- Surface water
- Leachate water
- Reservoir
- Construction Envelope
- Access / Construction Tunnel
- Hydraulic Tunnel
- Primary Road
- Arterial Road
- Drainage
- Major Contour (50m)

ID #	Location	Longitude	Latitude	Media
EPL106	Ravine Bay	148.357205	-35.75806	Leachate water
EPL107	Ravine Bay	148.365751	-35.760429	Reservoir
EPL108	Ravine Bay	148.355537	-35.762692	Reservoir
EPL109	Ravine Bay	148.35246	-35.757508	Reservoir
EPL110	Ravine Bay	148.362993	-35.752503	Surface water
EPL113	Ravine Bay	148.364023	-35.75325	Groundwater
EPL114	Ravine Bay	148.35814	-35.755696	Groundwater
EPL115	Ravine Bay	148.36178	-35.757011	Groundwater
EPL116	Ravine Bay	148.35681	-35.757232	Groundwater
EPL117	Ravine Bay	148.35887	-35.757928	Groundwater
EPL118	Ravine Bay	148.362196	-35.755675	Leachate water
EPL119	Ravine Bay	148.362196	-35.754811	Leachate water
EPL120	Ravine Bay	148.362978	-35.753004	Leachate water

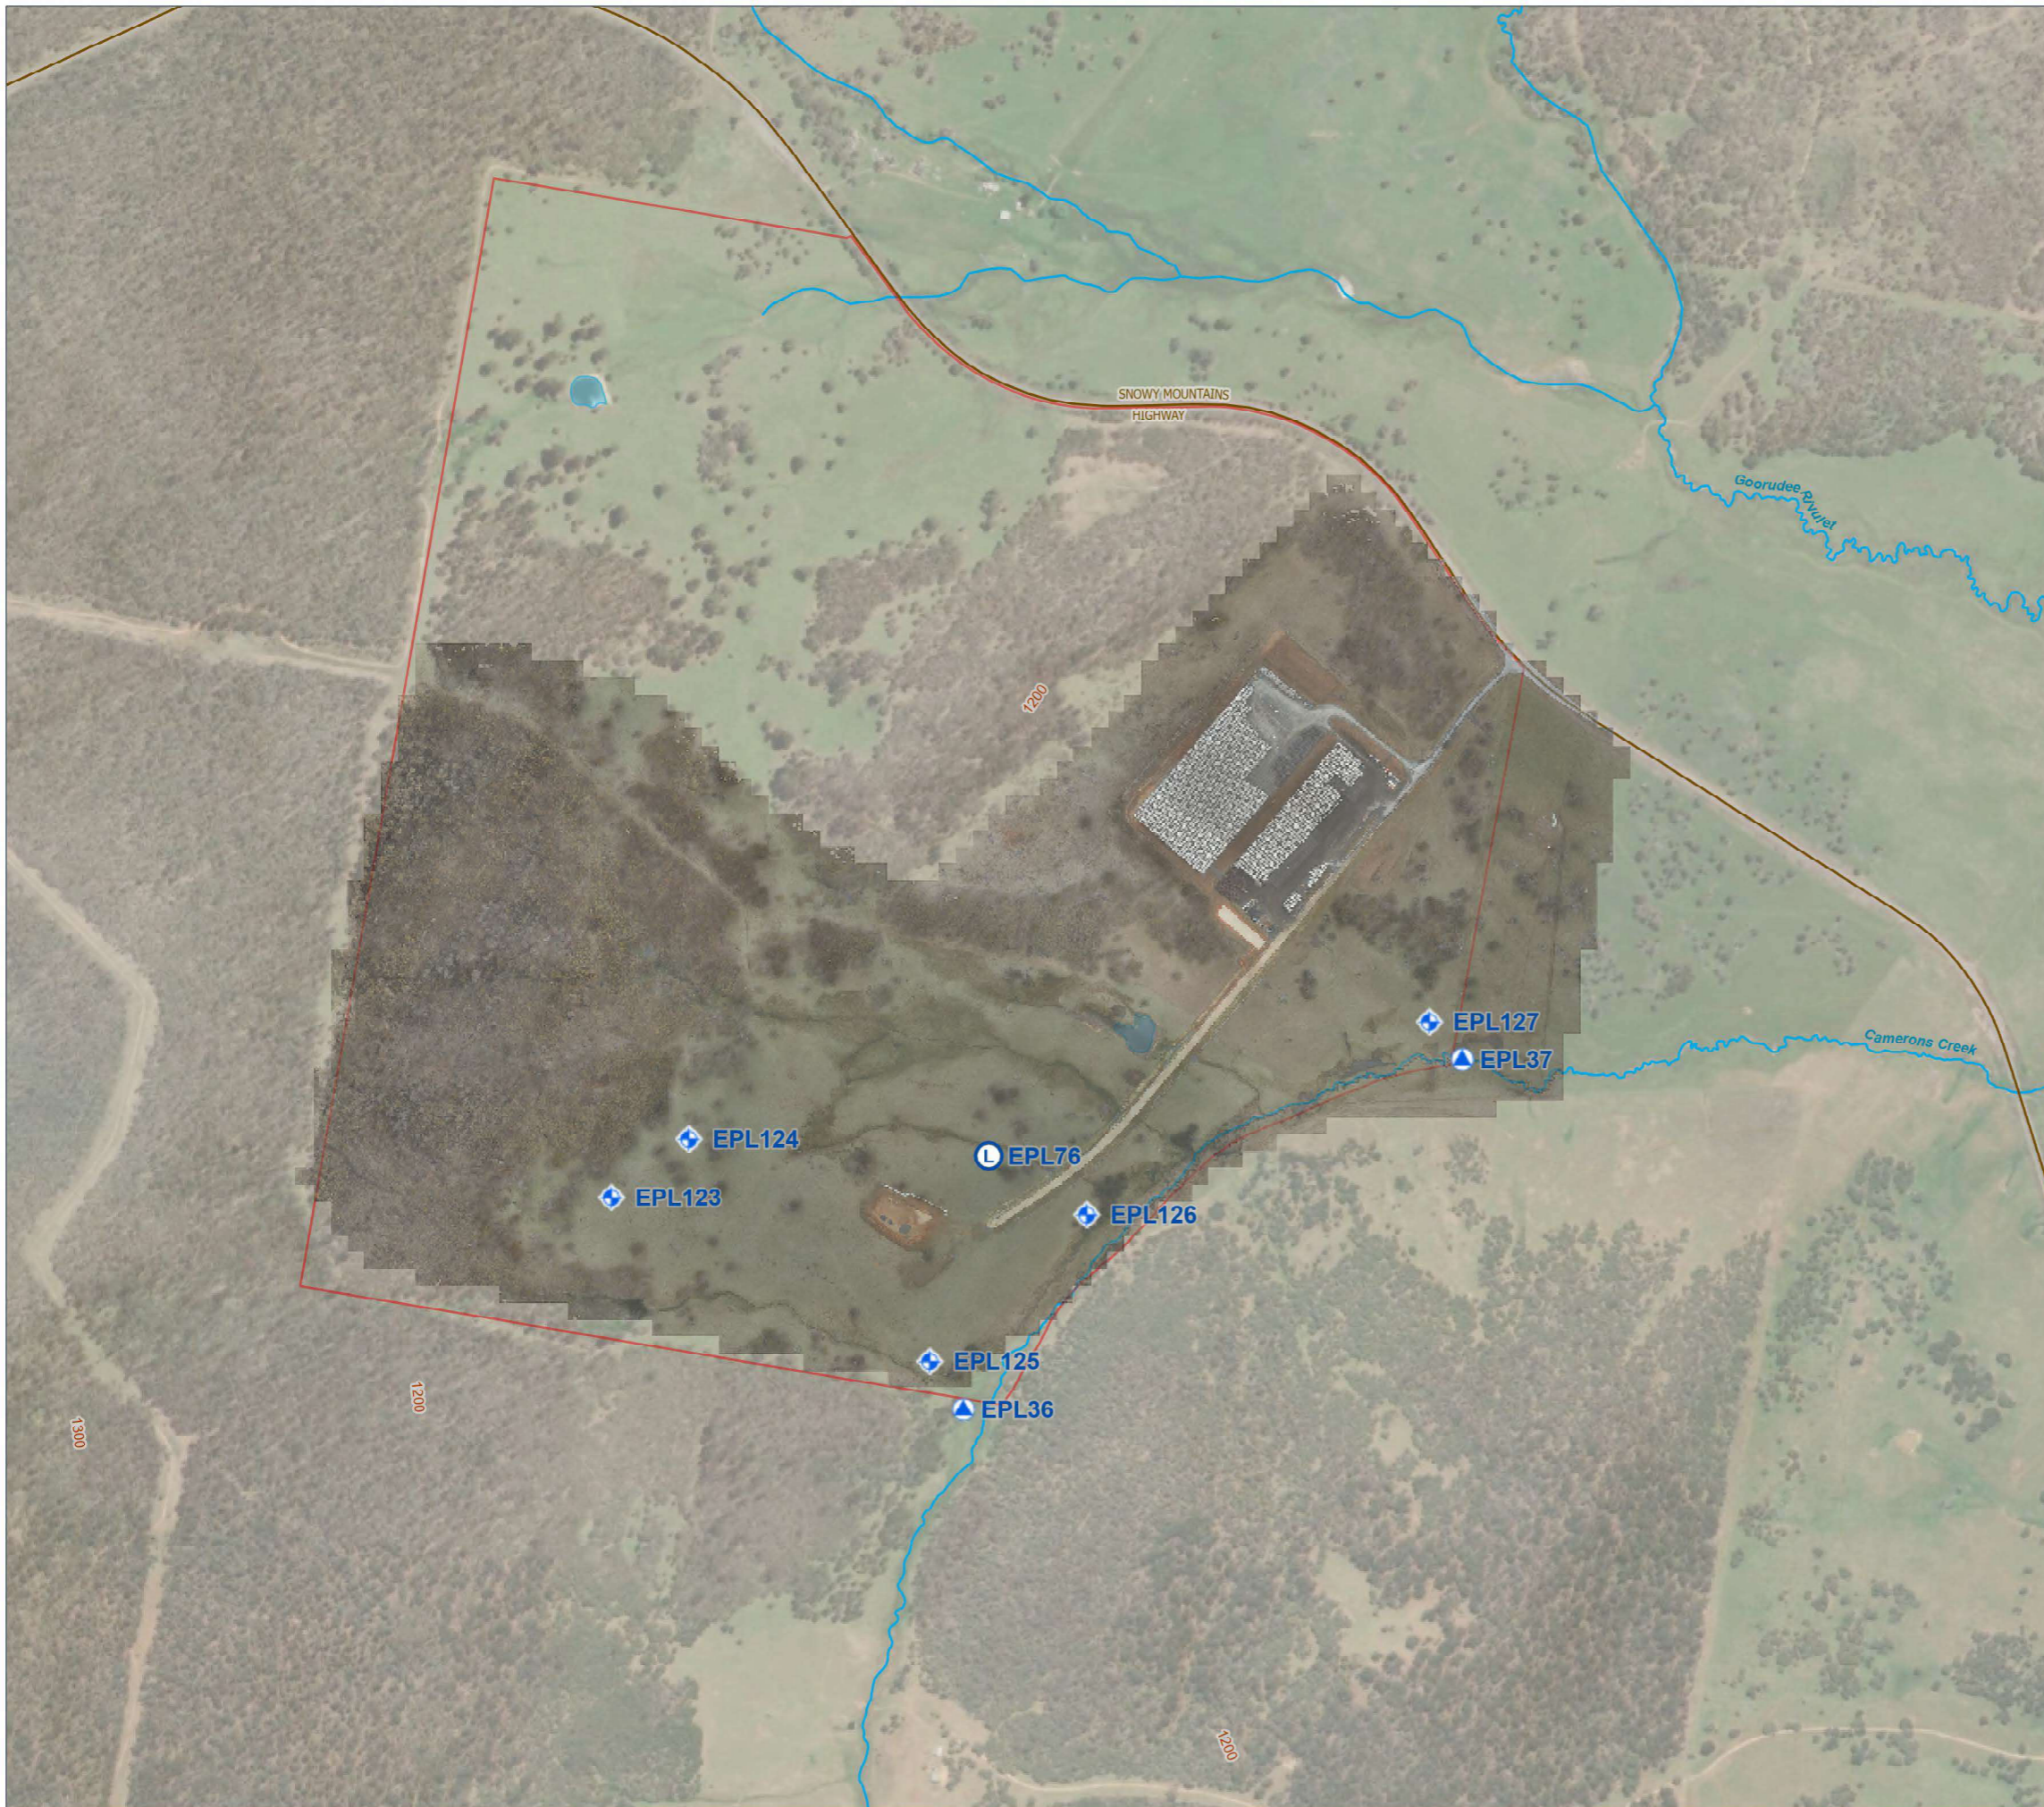
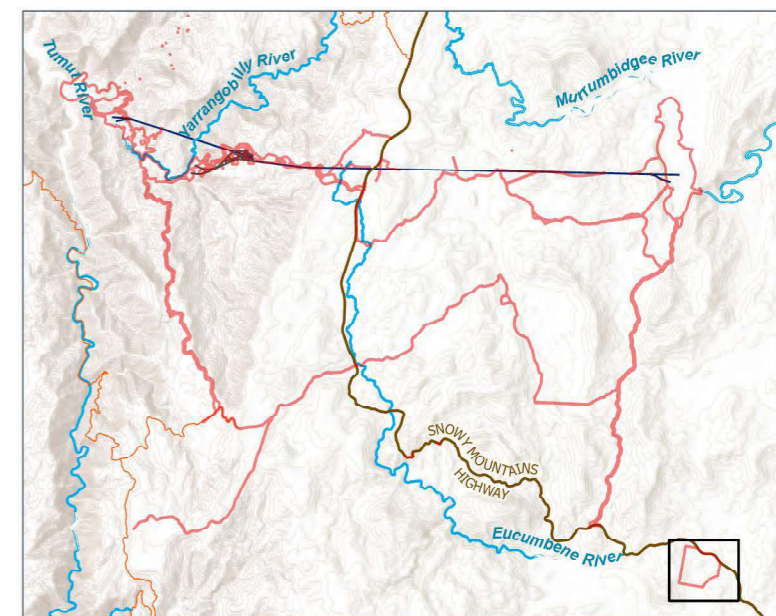
## EPL Locations Rock Forest

ID #	Location	Longitude	Latitude	Media
EPL36	Rock Forest	148.66727	-35.952445	Surface water
EPL37	Rock Forest	148.675353	-35.94766	Surface water
EPL76	Rock Forest	148.667612	-35.949055	Leachate water
EPL123	Rock Forest	148.661442	-35.949692	Groundwater
EPL124	Rock Forest	148.662695	-35.948896	Groundwater
EPL125	Rock Forest	148.66671	-35.951806	Groundwater
EPL126	Rock Forest	148.669243	-35.949814	Groundwater
EPL127	Rock Forest	148.674808	-35.947165	Groundwater
