Subject: Snowy 2.0 - Main Works - Talbingo Rock Platform Trial Validation Report

# SNOWY 2.0 MAIN WORKS – TALBINGO ROCK PLATFORM TRIAL VALIDATION REPORT

S2-ENV-AP-GEN-REP-FGJV0152

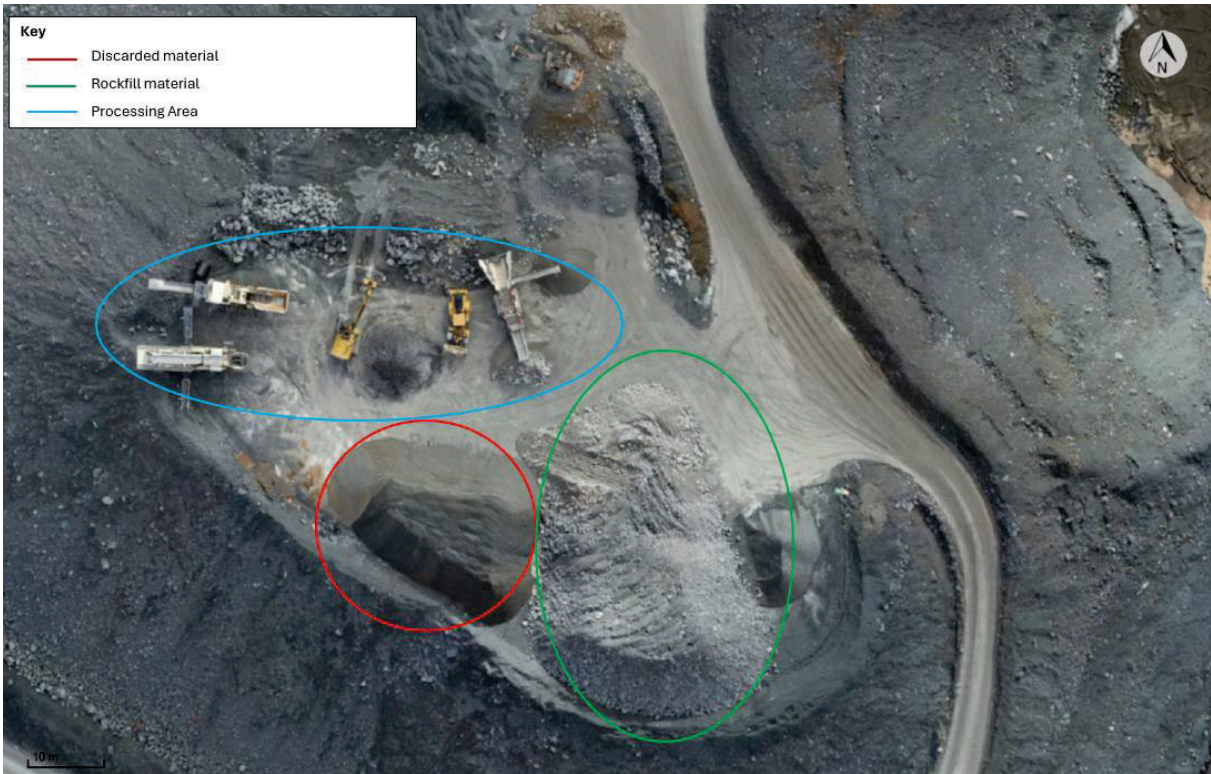
Figure 2-1 Rockfill Processing Area

Material was processed at the Ravine Bay Permanent Spoil Emplacement (PSE) as detailed in Section 5.3 of the approved Management Plan. Figure 2-1 below shows the setup within the PSE.

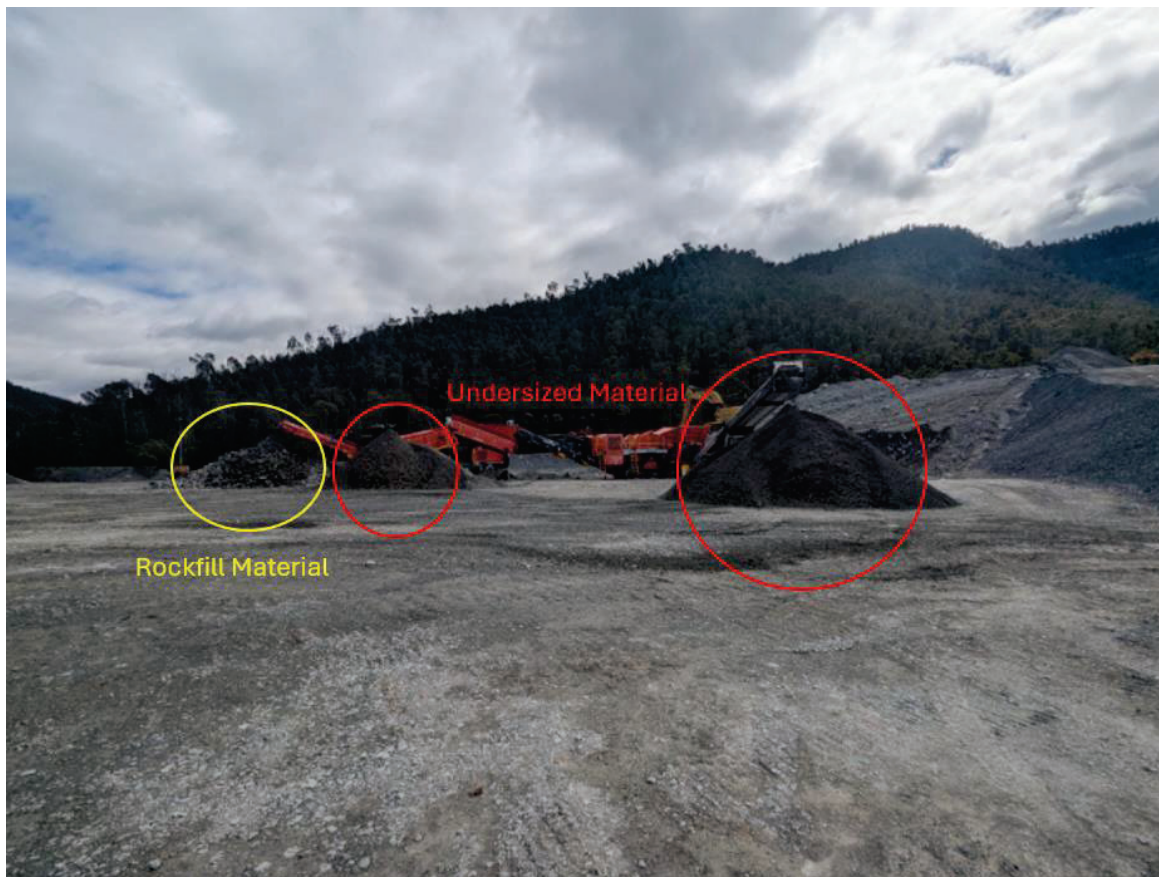
**Figure 2-3 Screen and Crusher Setup Showing Removal of Undersized Material**

Undersized material which passed through the screen was stockpiled separately and discarded as per Figure 2-3 and Figure 2-4, leaving a workable product as the final as per Figure 2-5. This material was stockpiled separately to spoil within the Ravine Bay PSE pending use as part of the Talbingo rock platform.

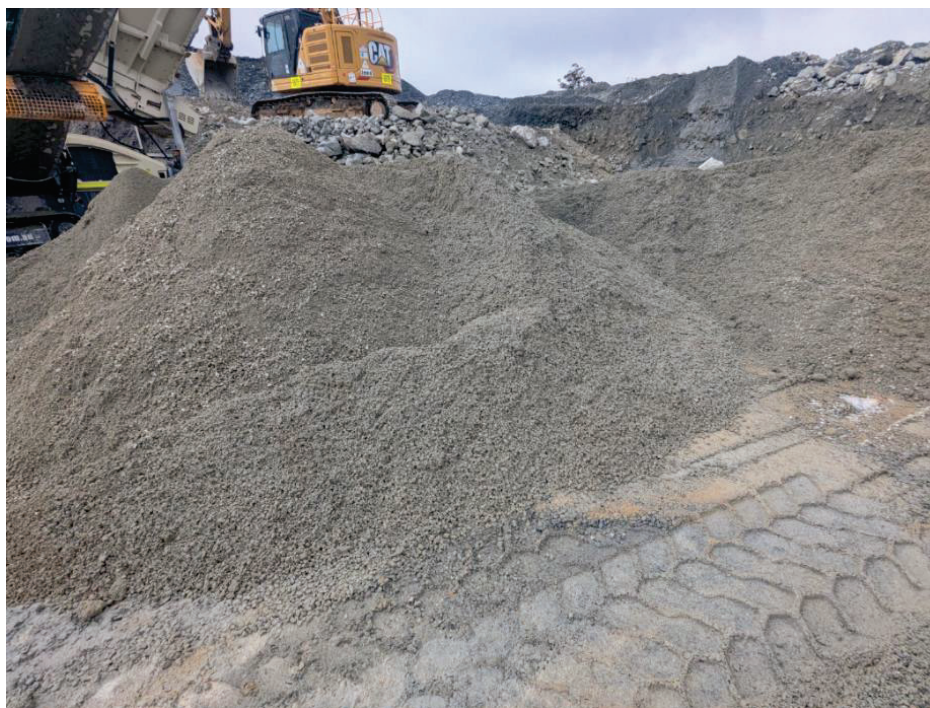
**Figure 2-4 Discarded Undersized Material**

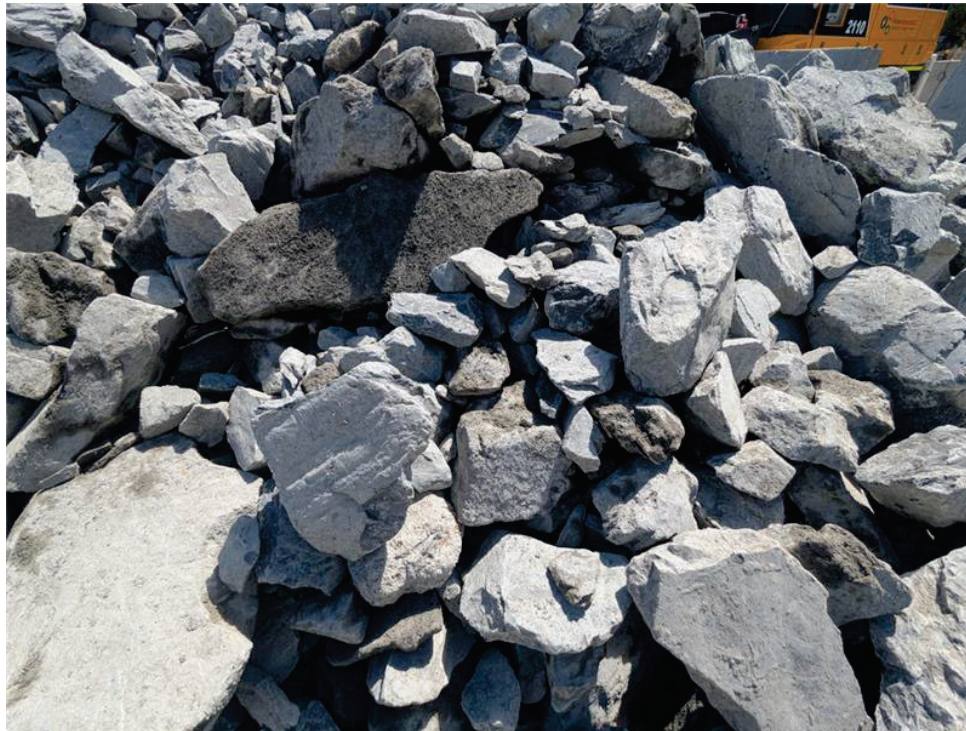
**Figure 2-5 Rockfill Material for in Reservoir Placement**

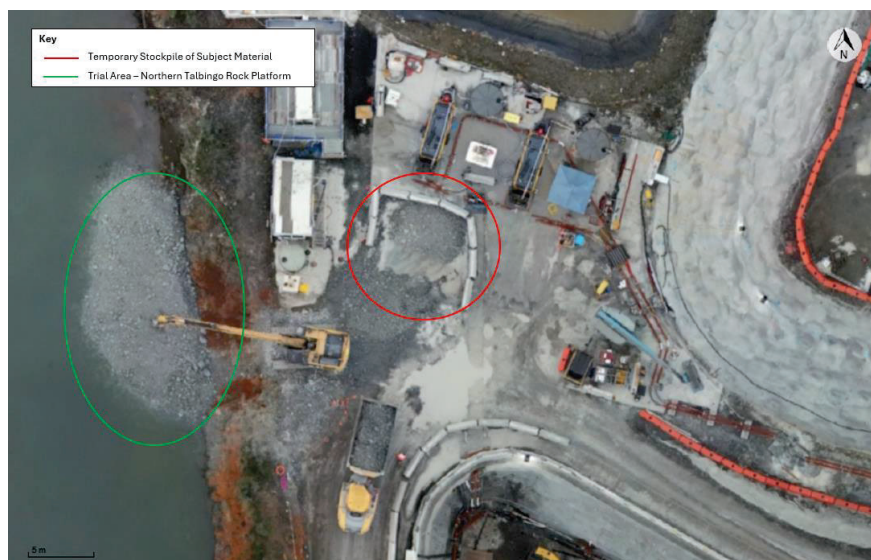
**Figure 2-6 Trial Spoil Emplacement Work Area**

Following material screening, rinsing and the receipt of acceptable analytical results and reservoir impact assessment, a material permit was issued authorising the transport of material from Ravine Bay to the Talbingo intake where it was temporarily stockpiled on hardstand in a bunded area adjacent to the rockfill platform as shown in Figure 2-6.

The rockfill material was subsequently placed as part of the northern Talbingo rock platform using an excavator from 12 February 2026 to 30 March 2026 as per Talbingo Rock Platform Management Plan Revision G.

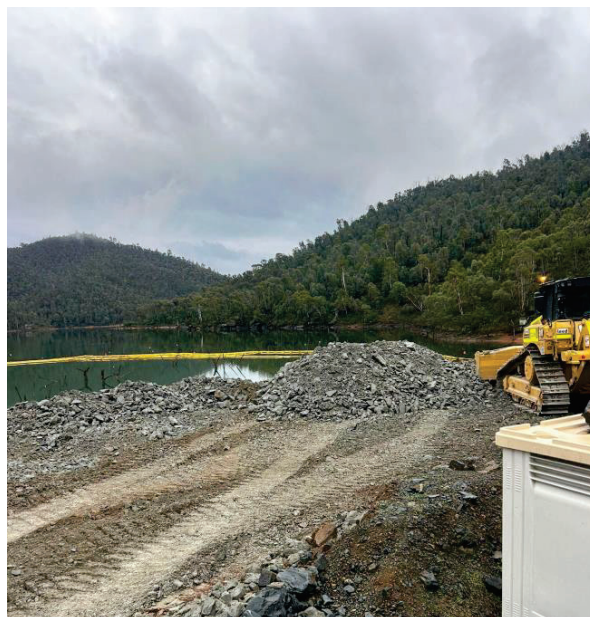
**Figure 2-7 Northern Talbingo Rock Platform Work Area**

On 1 May 2026 approval was received from DPHI with a minor amendment to the previously approved methodology, which allowed use of a dozer for rockfill placement. This methodology was used between the 2 May 2026 and the 3 May 2026 to complete the Trial phase.

The updated placement method was beneficial to trial the proposed method for the Stage 2 full scale emplacement works.

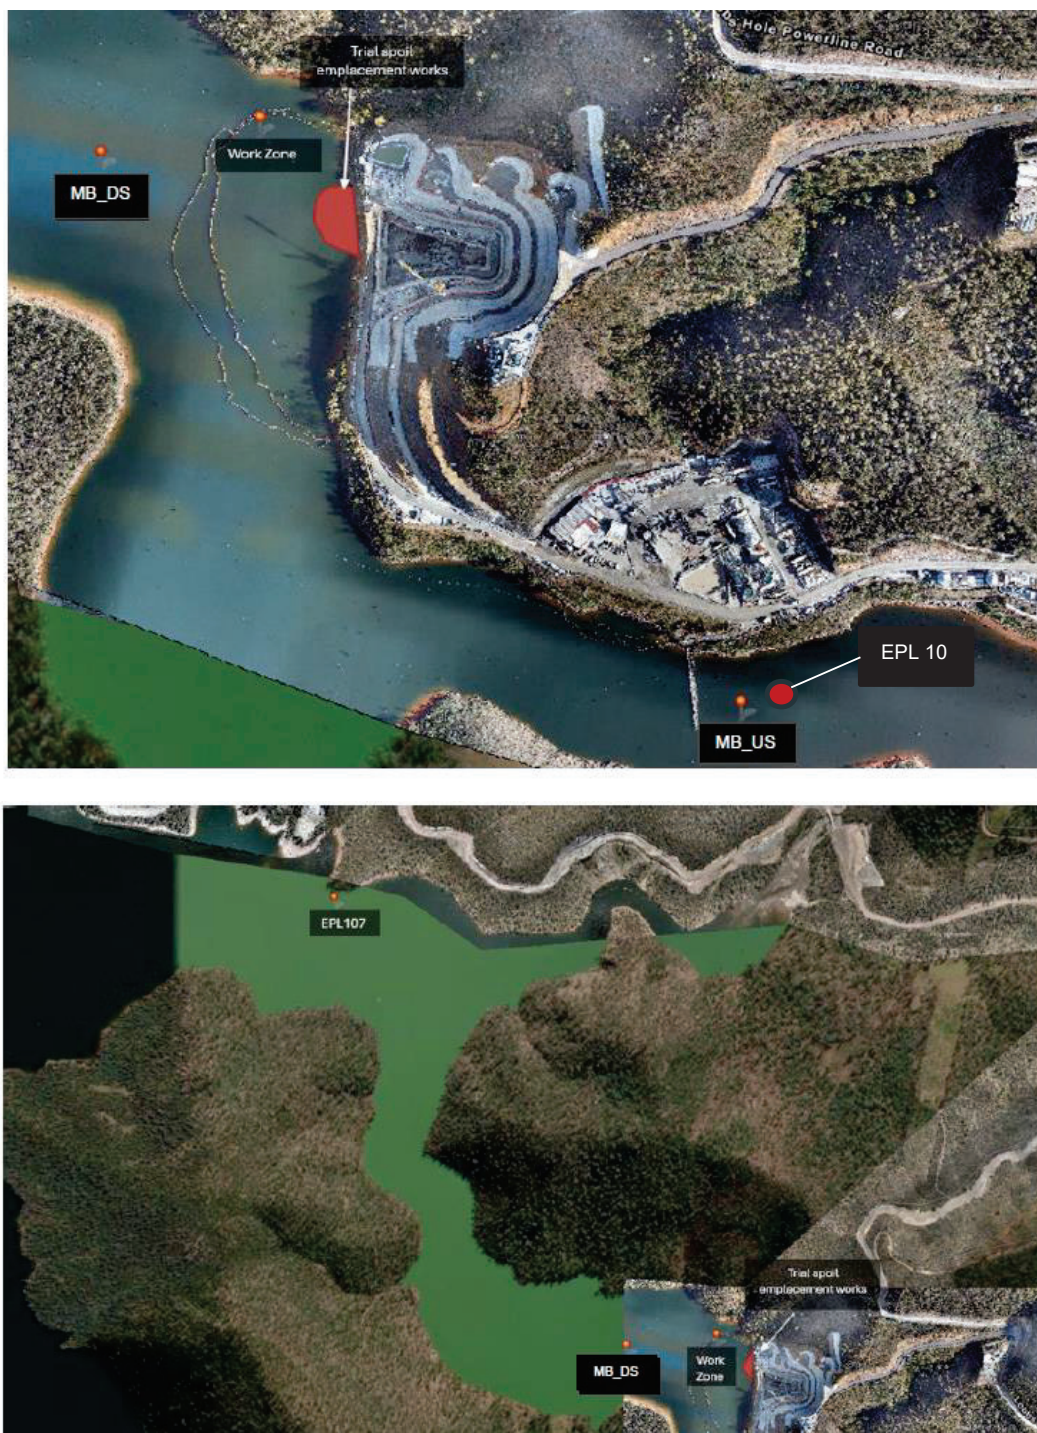
Figure 3-2 Water Quality Monitoring Locations (Trial stage)

| Sample ID | Type | Frequency | Analytes | | |
|---|---|---|---|---|---|
| MB_US<br>MB_DS | Real time (Buoys) | Hourly | Temperature;<br>Turbidity<br>pH<br>Electrical conductivity (EC) | Dissolved Oxygen (DO)<br>Redox Potential<br>Nitrate | |
| EPL10<br>MB_US<br>MB_DS<br>EPL107<br>Work Zone | Comprehensive (Grab sampling) | Bi-Weekly when placement occurring | Aluminium (Dissolved)<br>Ammonia<br>Arsenic (Dissolved)<br>Calcium<br>Chromium (Dissolved)<br>Copper (Dissolved)<br>Cyanide (Total)<br>Iron (Dissolved)<br>Lead (Dissolved) | Manganese (Dissolved)<br>Nickel (Dissolved)<br>Nitrate<br>Nitrite<br>Nitrogen (Total)<br>Nitrite + Nitrate as N (NOx)<br>Oil and Grease<br>Phosphorus (Total)<br>Reactive Phosphorus | Total Iron<br>Total Kjeldahl Nitrogen<br>Total Manganese<br>Total Suspended Solids<br>Turbidity<br>Zinc (Dissolved)<br>Chlorophyll a |

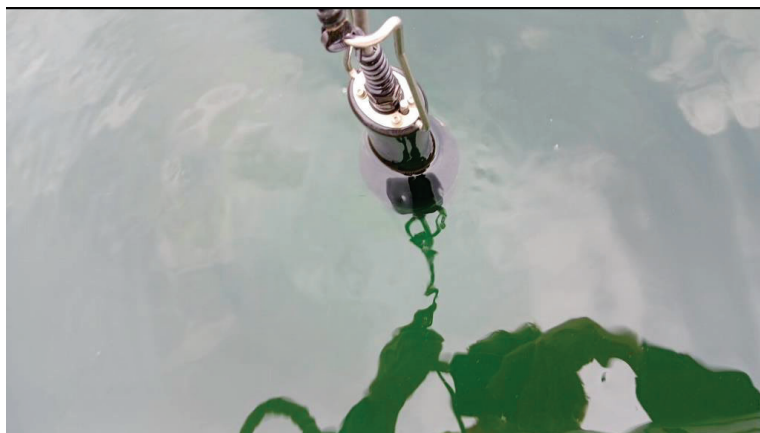
The frequent analytical correlations between the concentrations recorded in above and below gradient locations is another indicator of ambient nutrient cycling. This is further supported when considering the decreased DO saturation levels present on numerous sampling occasions, recorded via Survey 123. Algal activity stemming from elevated ambient temperatures, low water level and green discolouration present within the Talbingo Reservoir is displayed in Figure 3-6 below.

Figure 3-6 Green discolouration and algal particles during sampling on 22 February

The consistency of the concentrations present in above and below gradient locations coincides with preexisting algal activity within the Reservoir persisting across the works timeline. The observed organic matter was noted prior to the works through commentary provided during sampling events. The consistent green water discolouration, elevated waterbody temperatures and reduced reservoir water levels are typically associated with algal growth and decay cycles, whereby ammonia consumption by organic matter rapidly increases algal presence in the waterbody, which then consume nutrients further before eventually decaying and releasing ammonia back into the medium.

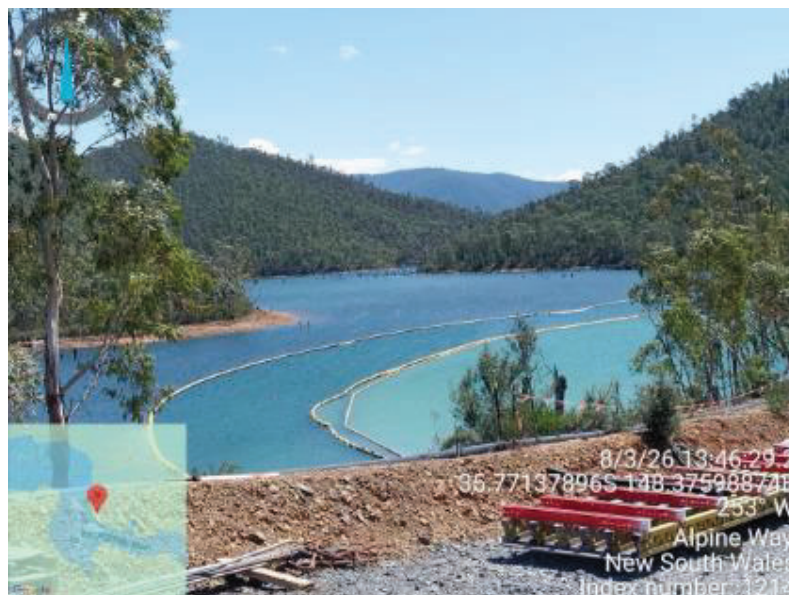
Visual inspections conducted during the spoil emplacement trial focused on monitoring water colour and odour. On 8 March, a localized colour change within the silt curtains was reported to the Environmental Site Coordinator (refer to Figure 3-7). The team immediately reviewed the real-time monitoring buoy data and analysed laboratory sample results; however, the water quality data indicated no chemical anomalies or indicators of an algal bloom presence or elevated toxicity levels.

Figure 3-7 Visual inspection evidence

Following this event, the team maintained continuous inspection, near the silt curtains, to ensure an immediate response if sediment migrated beyond the outermost silt curtain. The silt curtains successfully contained the material (as shown in Figure 3-7) and activation of the Trigger Action Response Plan (TARP) was not required.
