A Post Fire Geomorphic Assessment of Tributary Streams at Lobs Hole

March 2021

Report prepared for:
EMM Consulting and Snowy Hydro Ltd

By:
P. G. Johnston.
BSc, MSc
Fluvial Geomorphologist
Flow and Loam Environmental

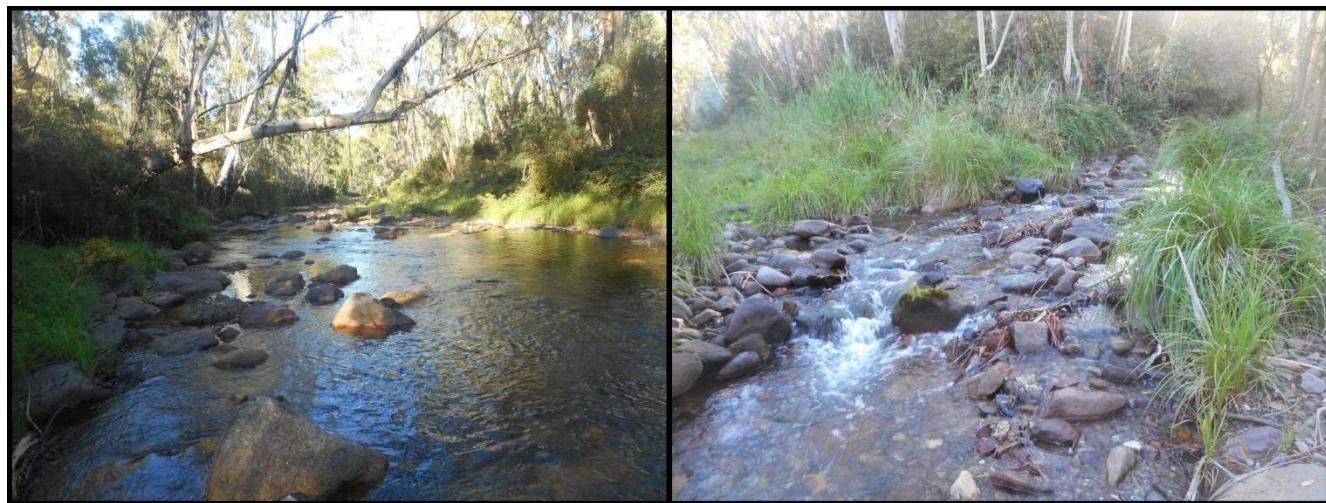
Figure 16 Wallaces Creek (right) at the confluence with the Yarrangobilly River (left)

Wallaces Creek (Figure 1) is laterally confined and planform controlled where it debouches onto the floodplain of the Yarrangobilly River. It has a continuous channel that is incised into the floodplain and is armoured by cobbles and boulders (Figure 16). The combined catchment area of Wallaces Creek and Stable creek is sufficient to maintain a significant base flow and there are discontinuous pockets of floodplain at both banks. Wallaces is a boulder and cobble bed river and boulders and cobbles are exposed in the base of both banks.

The left bank is low to moderate angle and two-stage that indicates bed lowering and channel incision. The right bank is partially undercut and is sub-vertical. The right bank and channel bed consist of matrix supported cobbles and boulders while the left bank has cobbles at base but is fine gravel floodplain fill.

Inspection of the downstream reaches revealed that the channel is decoupled from the floodplain and there was no evidence of recent proximal overbank deposition. The channel capacity is such that all stream power is confined within the channel and there was evidence of recent channel incision and undercutting of the right bank downstream of the bridge crossing.

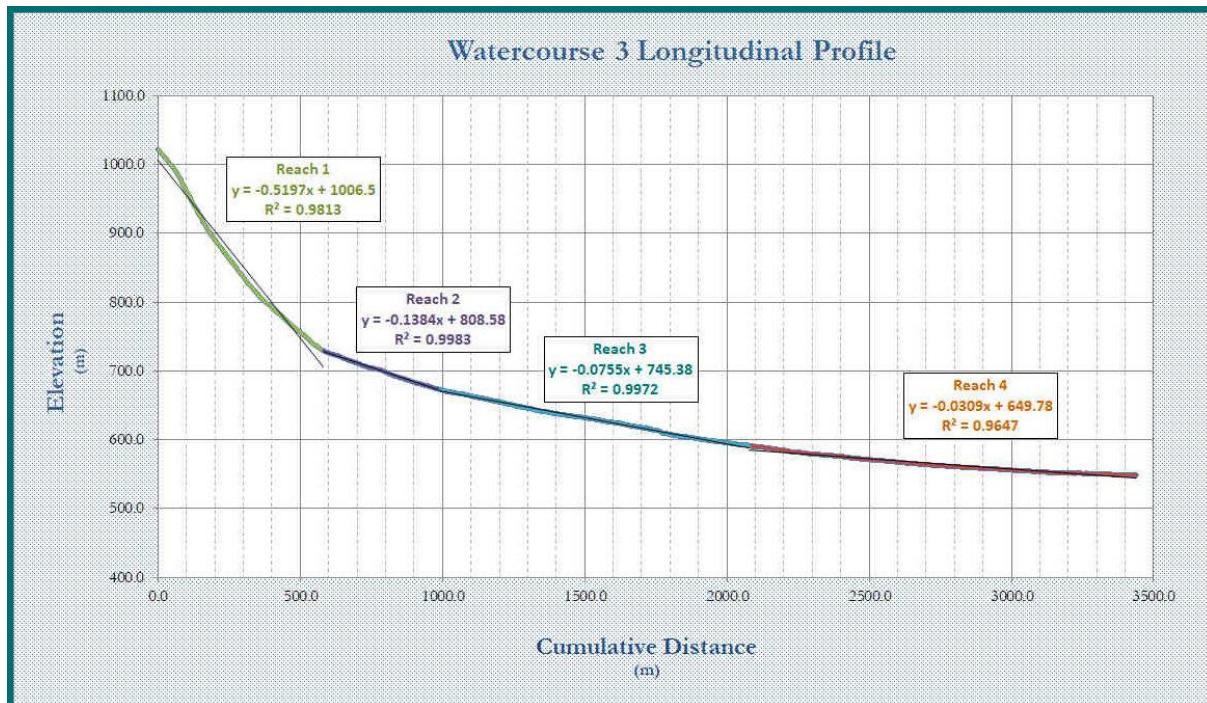
Figure 19; Watercourse 3 longitudinal profile

The upstream zone (Reach 1) of Watercourse 3 is steep and has a slope of -0.5197 (Figure 18, Table 3).

The slope of this reach is such that any discharge from the catchment that flowed into, or thorough, this reach would have very high stream power. Sediment liberated from the surrounding catchment would have low residence times in this reach and would quickly transit down slope.

Figure two shows that channel slope decreases downstream but remains high through Reach 2. The channel slope in Reach 3 would allow for more opportunistic deposition of short term sediment stores, however, it is not until Reach 4 that channel slope decreases sufficiently to allow longer residence time deposition.

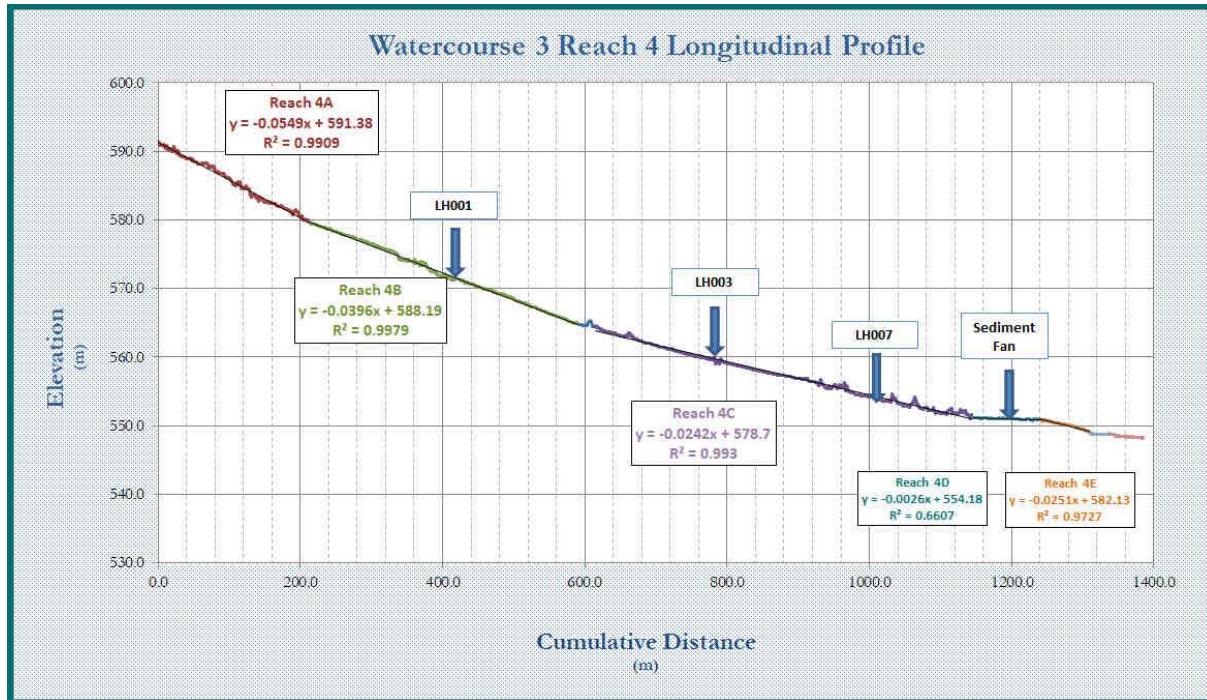
Figure 20; Watercourse 3, Reach 4 longitudinal profile

Greater insight can be gained by a closer examination of Reach 4 (Figure 20). Channel slope is moderately constant throughout Reach 4 until Reach 4D is reached. At Reach 4D the channel slope is very low at -0.0026 and this is the location of the sediment fan. This sediment fan is prograding over a previously deposited sediment fan which is Reach 4F. Reach 4E represents the frontal lobe of the current fan and Reach 4G is the old surface of the paleo Yarrangobilly bedload.

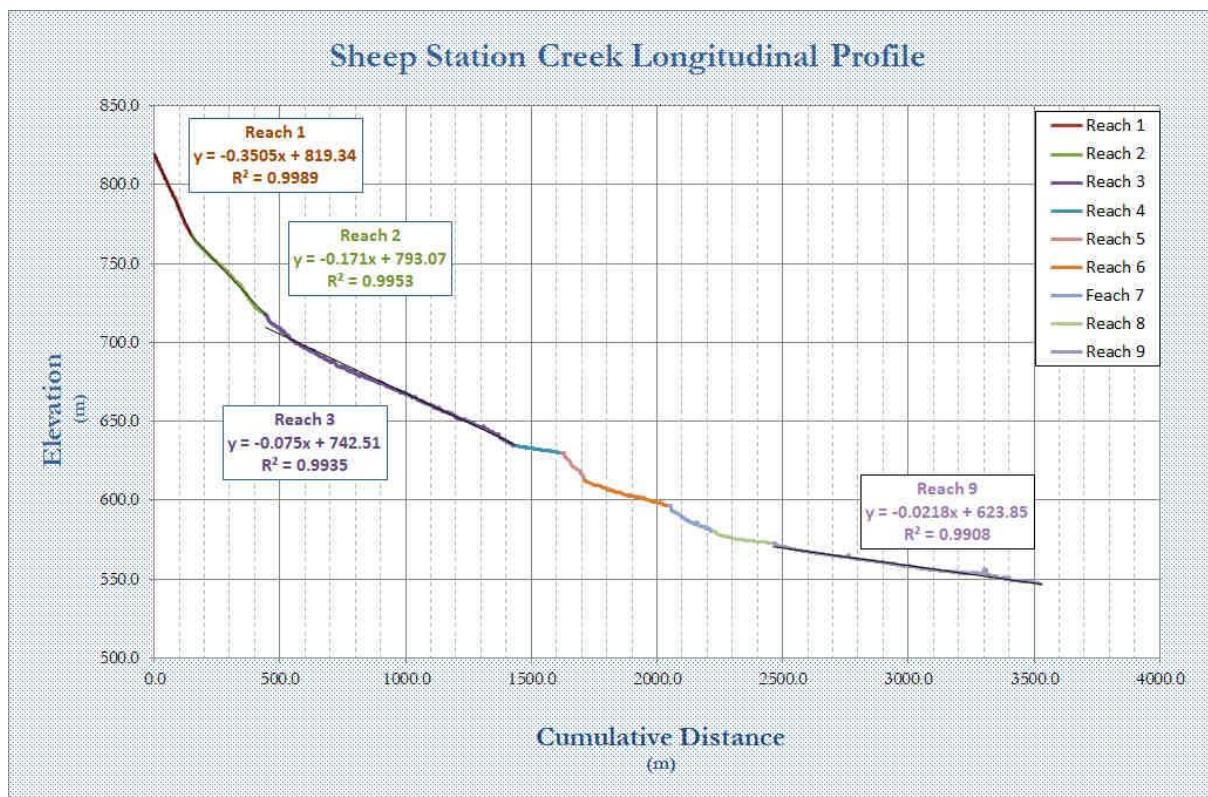
Figure 21 Sheep Station Creek longitudinal profile

Reaches 1 – 3 of Sheep Station Creek have a high slope and would have sufficiently high stream power sufficient to flush most sediment through these reaches. The residence time of sediment within the channel here would be very short (Figure 21). These Reaches represent a transfer zone for sediments passing through the system.

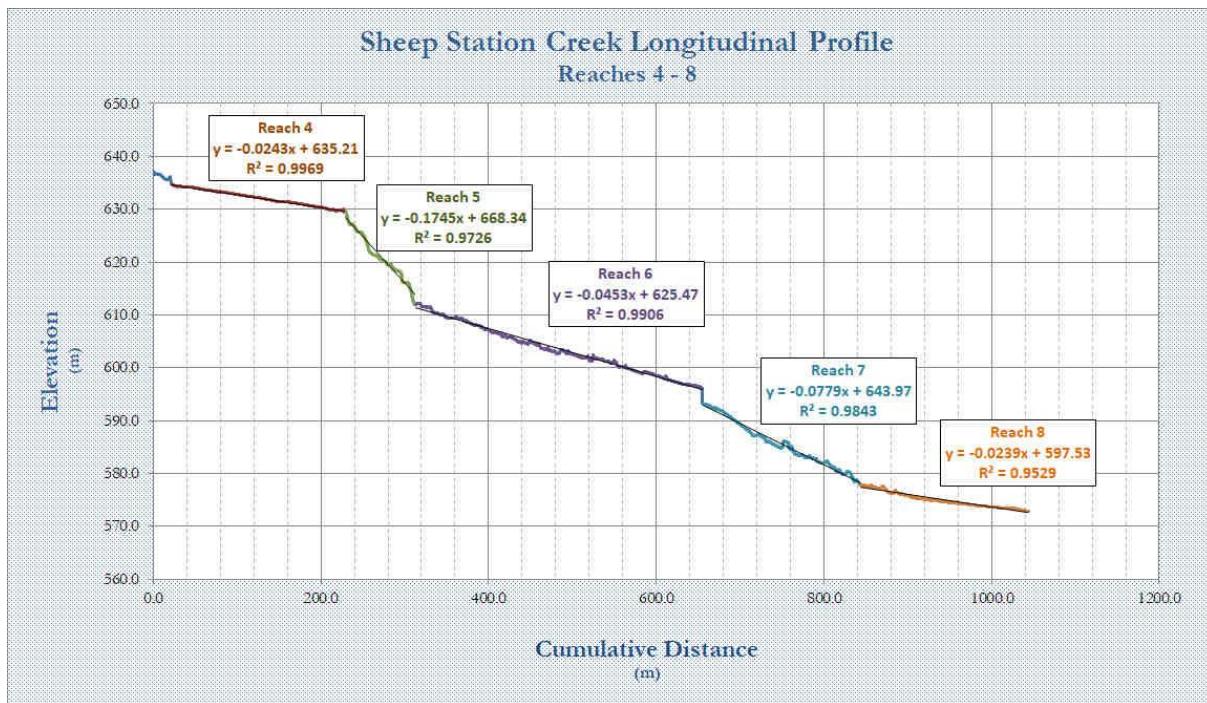
Figure 22 Sheep Station Creek Reaches 4 – 8

From Reach 4 there are a series of steps in the longitudinal profile that would allow greater deposition of sediment while maintaining a short to medium term residence time (Figure 22) of sediment stores within the channel.

Reach 4, with a slope of -0.0243 m/m, and Reach 8, with a slope of -0.0239 m/m, would represent the greatest potential for sediment retention within these reaches. These reaches were not visited during the fieldwork for this study. Channel capacity cannot be determined from aerial photograph interpretation and so an assessment of the existence of any sediment pockets, or floodplains, and whether the channel is coupled with the floodplain cannot be determined.

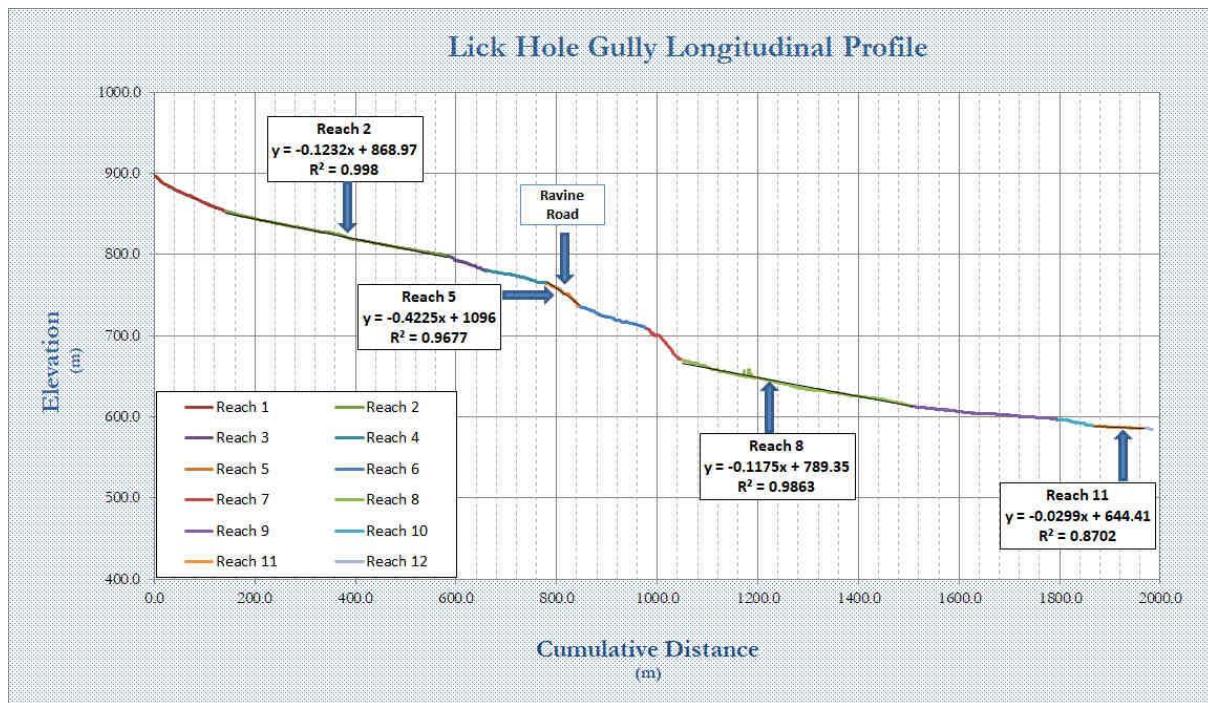
Figure 23 Lick Hole Gully longitudinal profile

Downstream the channel becomes incised into the valley fill and the channel is no longer coupled with the floodplain/valley fill surface. Sediment will pass through this zone rapidly.

Reach 11 is immediately upslope of the detention basin/sediment trap, upstream of the road crossing. Here the slope is very low and deposition will continue to occur here.

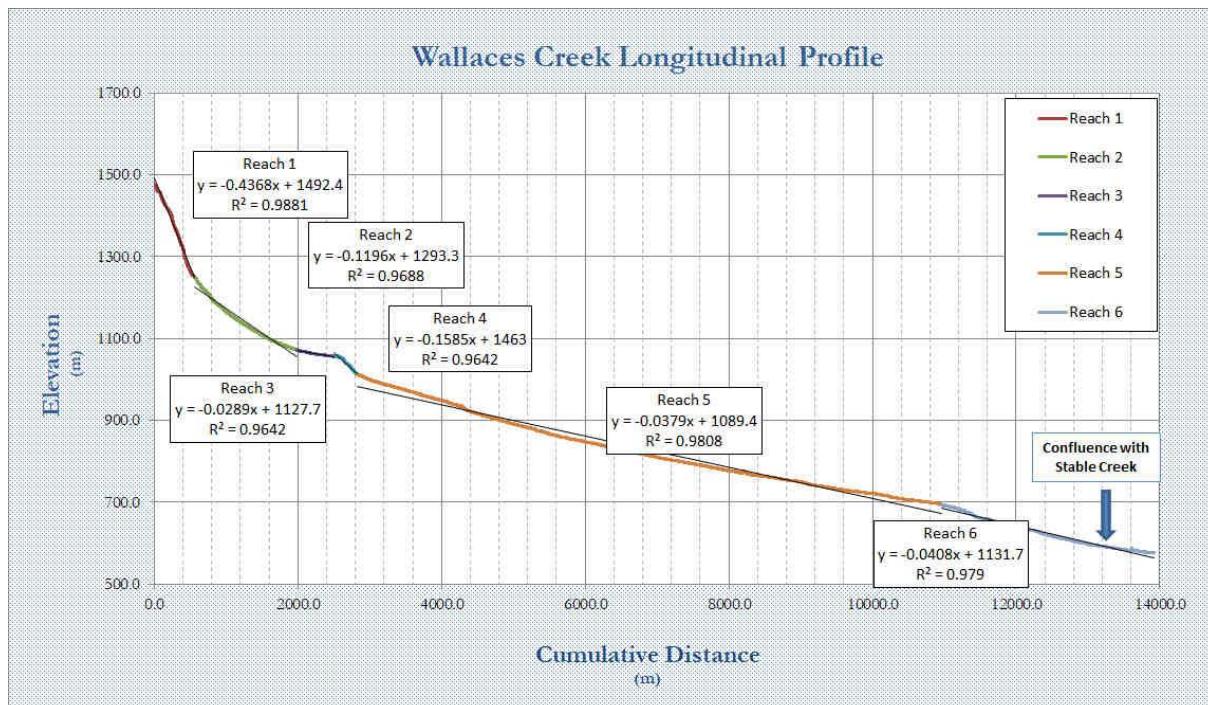
Figure 24 Wallaces Creek longitudinal profile

The upstream reaches of Wallaces Creek are high angle and would be characterised as having high stream power. Sediment that was delivered to these reaches from the surrounding catchment would have very short residence times and pass quickly to downstream reaches. Reach 3 has an anomalously low slope and there may be some short term deposition here. Reaches 5 and 6 have a more uniform and consistent slope and may, under other circumstances, represent zones of potential sediment storage. However, channel capacity is such that these would also be transfer reaches. Reach 6, where the two creeks merge, is worth further analysis.

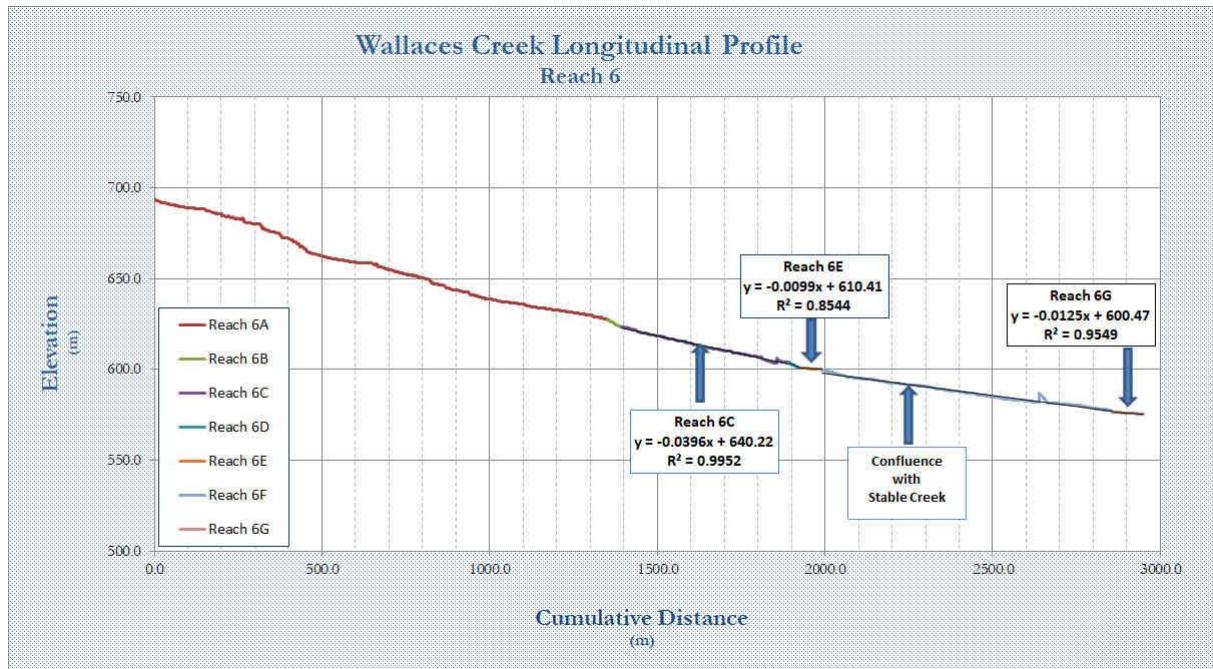
Figure 25 Wallaces Creek Reach 6

The slope through Reach 6 is moderately uniform, however, there are some instances where short to medium term sediment storage may occur; notably Reach 6E.

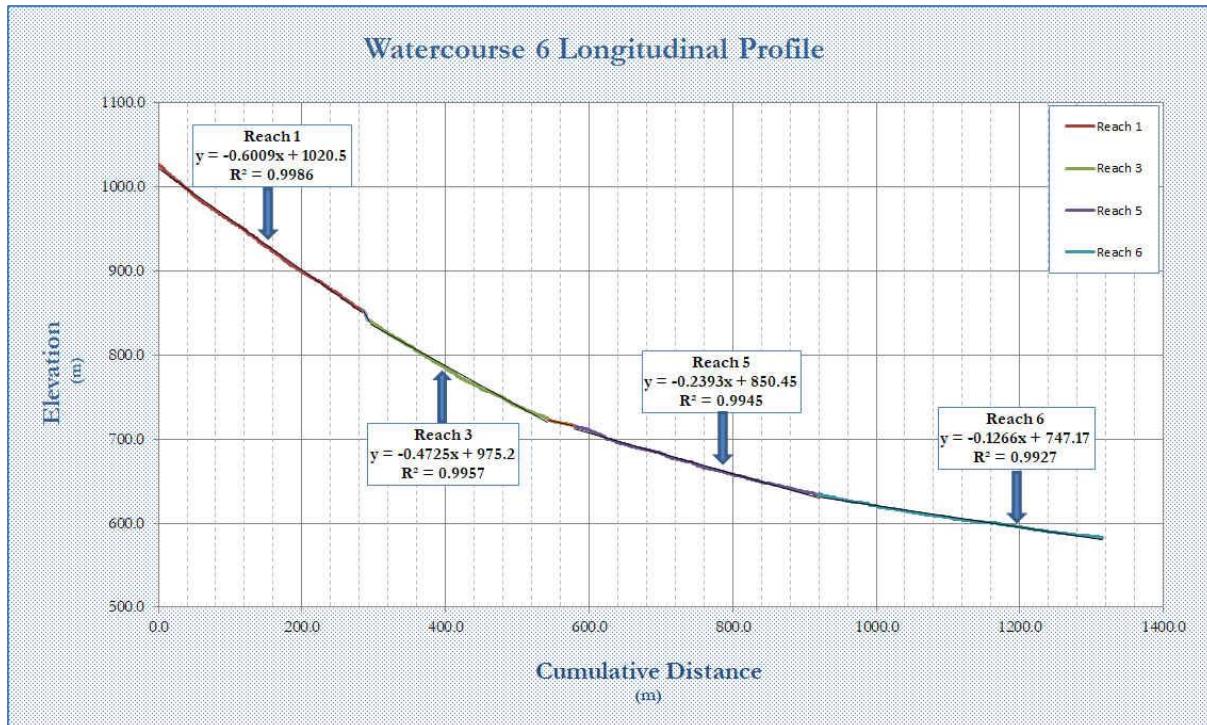
Figure 27 The longitudinal profile of Watercourse 6

The longitudinal profile of Watercourse 6 is presented in Figure 27. The overall length of Watercourse 6 is 1315 m and shows very little variation of slope. The catchment area of Watercourse 6 is 43 hectares and is relatively small for the volume of sediment that has been deposited from it. There is no obvious channel length of sufficiently lesser slope to reduce stream power and induce deposition. Instead, there is a gradual

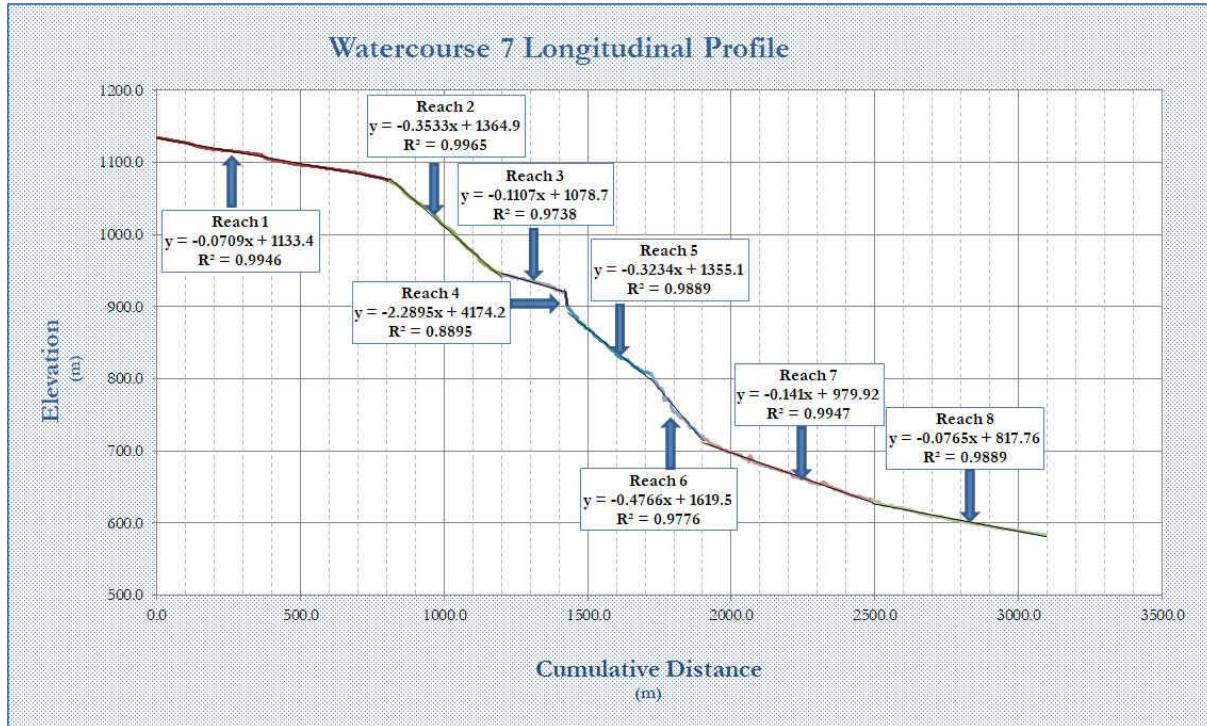
Figure 28 The longitudinal profile of Watercourse 7.

The longitudinal profile for Watercourse 7 (Figure 28) shows marked variability of slope throughout its length 3097 m. It has a catchment area of 215 hectares (Table 4). While there are multiple variations of slope throughout the length of the longitudinal profile none of the reaches present a slope sufficiently low enough to maintain a depositional environment and induce sedimentation. Reach 8 has the least overall slope and a closer examination of this reach is insightful.

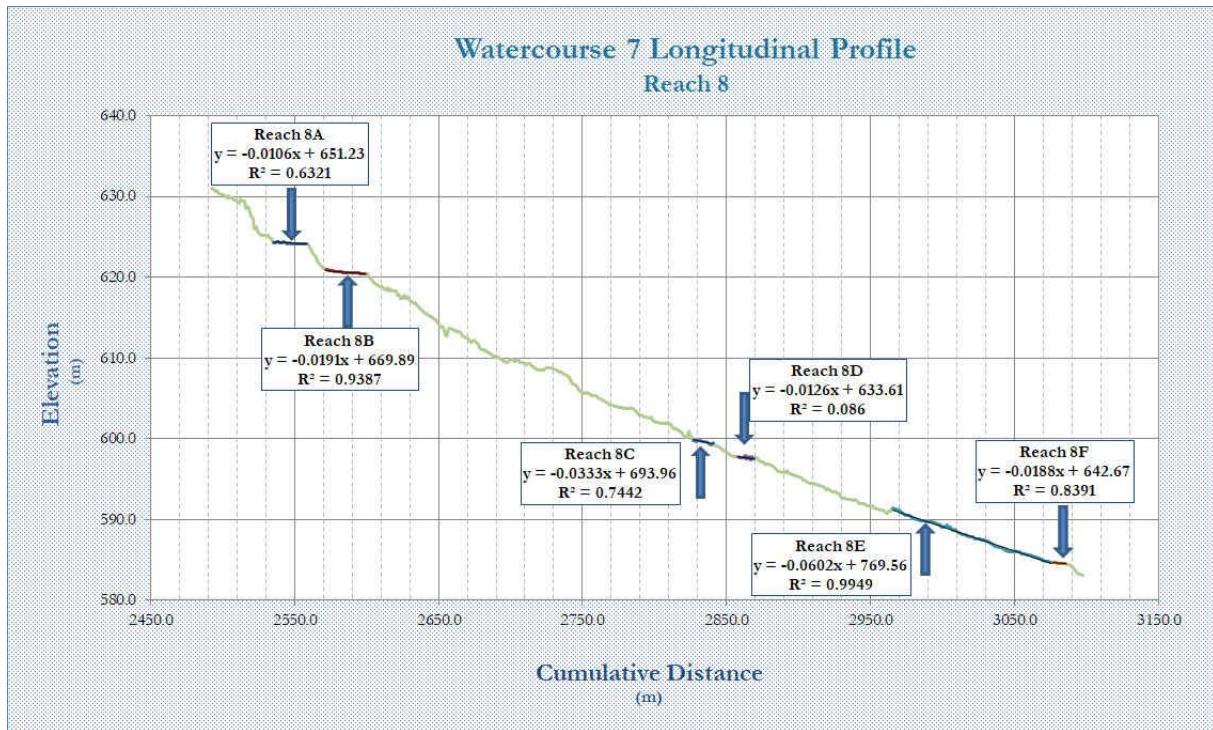
Figure 29 The longitudinal profile of Watercourse 7, Reach 8

The overall slope of Reach 8 is -0.0765 m/m but closer examination of Reach 8 five reaches with sufficiently low slope so as to induce deposition within each sub reach. The longitudinal profile for Watercourse 7, Reach 8, is presented in Figure 29.

Examining the profile for Reach 8 reveals that there are at least five reaches where the slope is sufficiently low enough to induce sedimentation with a mid to long term residence time. The slope of Reach 8E is presented because this reach is the last major reach, of uniform slope, before the Watercourse 7 exits from confinement onto the floodplain of the Yarrangobilly River. Within this reach there would only be opportunistic deposition of sediments within the channel that would have a short residence time.
